RE: Update on Structural Shoring for Damaged Roof Section  
Ref. Drawings:  
JM Albain Engineering, Dwgs S-1 to S-6 dated 10/25/10  
Dwgs. S-6, S-7 rev. 1, (DCN #1) dated 01/26/11  
Project # JMA10-327-06

RE: Structural Shoring for Damaged Roof Section  
Ref. Drawings:  
JM Albaine Engineering, Dwgs S-1 to S-6 dated 10/25/10  
As-built Dwgs. S-1 to S-8, dated March 5, 2011 Rev. 2  
Project # JMA10-327-06

Temporary Framing Inspection  
REPORT #1 --- October 31, 2022

Subject: Oswegatchie Fire Station  
Inspection /Assessment: Building Structural Safety  
Project # JMA22-327-062

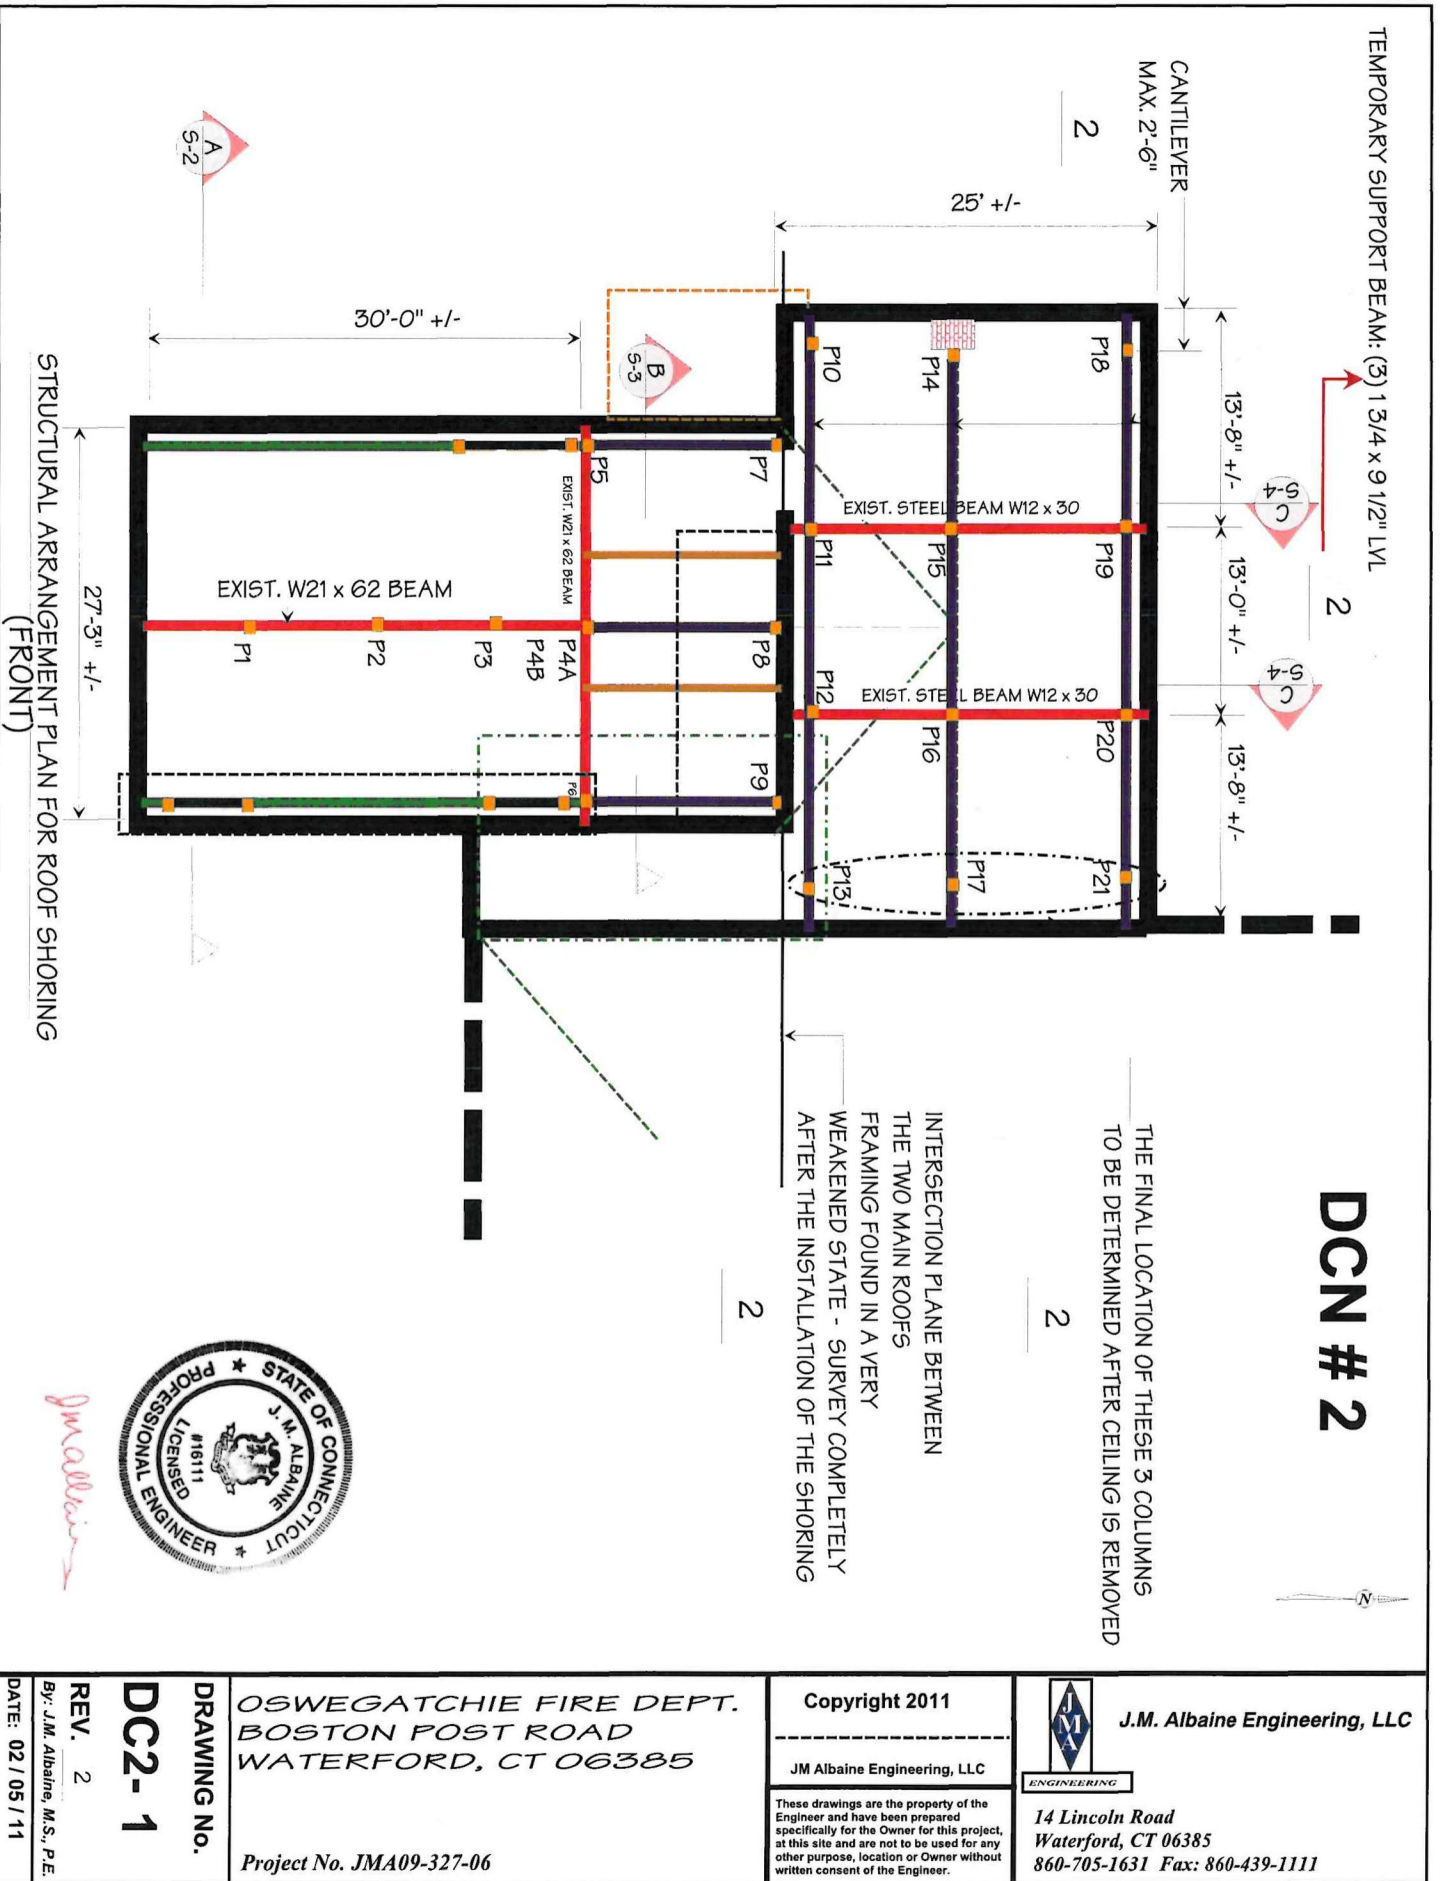
DRAWING No. **DC2-1**  
 REV. 2  
 By: J.M. Albaine, M.S., P.E.  
 DATE: 02 / 05 / 11

4. The new temporary roof supporting beams over the first floor Day Room and Kitchen will need to be increased to triple LVL's from double LVL's since we will need to cantilever those beams at each end of the room to avoid additional expensive work on the exiting features in the these rooms.

TEMPORARY SUPPORT BEAM: (3) 1 3/4 x 9 1/2" LVL

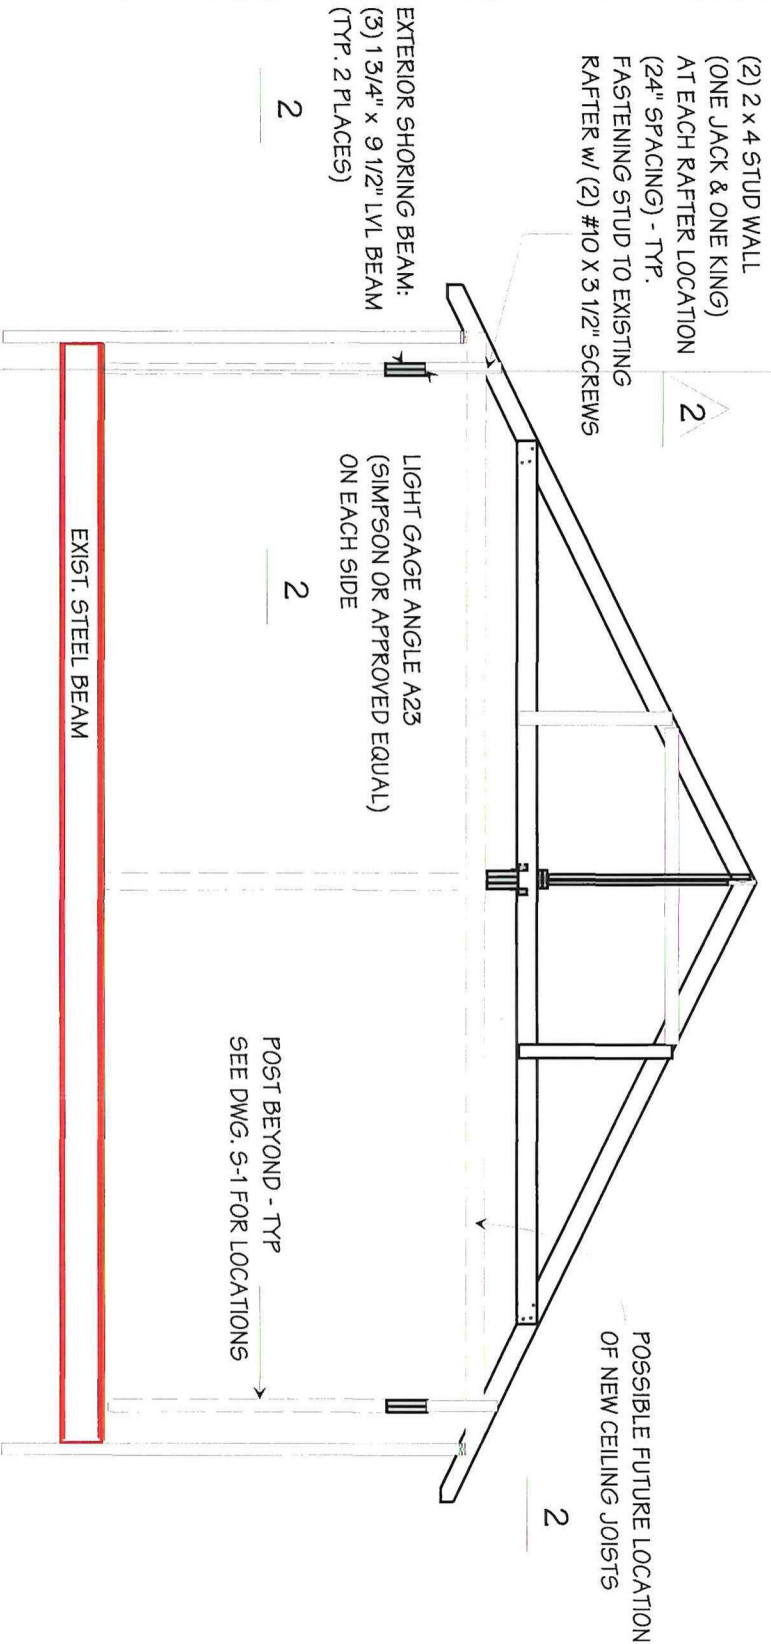
DRAWING No.  
**DC2-2**

3. The temporary beams supporting the exterior edges of the roof, at both above the Hall Room and Kitchen (second floor, see Sections A, B, & C (Dwgs S-2, S-3 and S-4) will be installed at a lower elevation, with a short double stud (one king and one jack) above it, to make room for the potential installation of the future new ceiling joist.

FOR SECTIONS A & B (DWGS. S-2 & S-3), THE EXTERIOR BEAMS  
ARE: (2) 1 3/4 x 9 1/2 LVL

FOR SECTION C (DWG. S-4) ALL THE BEAMS ARE (3) 1 3/4 x 9 1/2" LVL

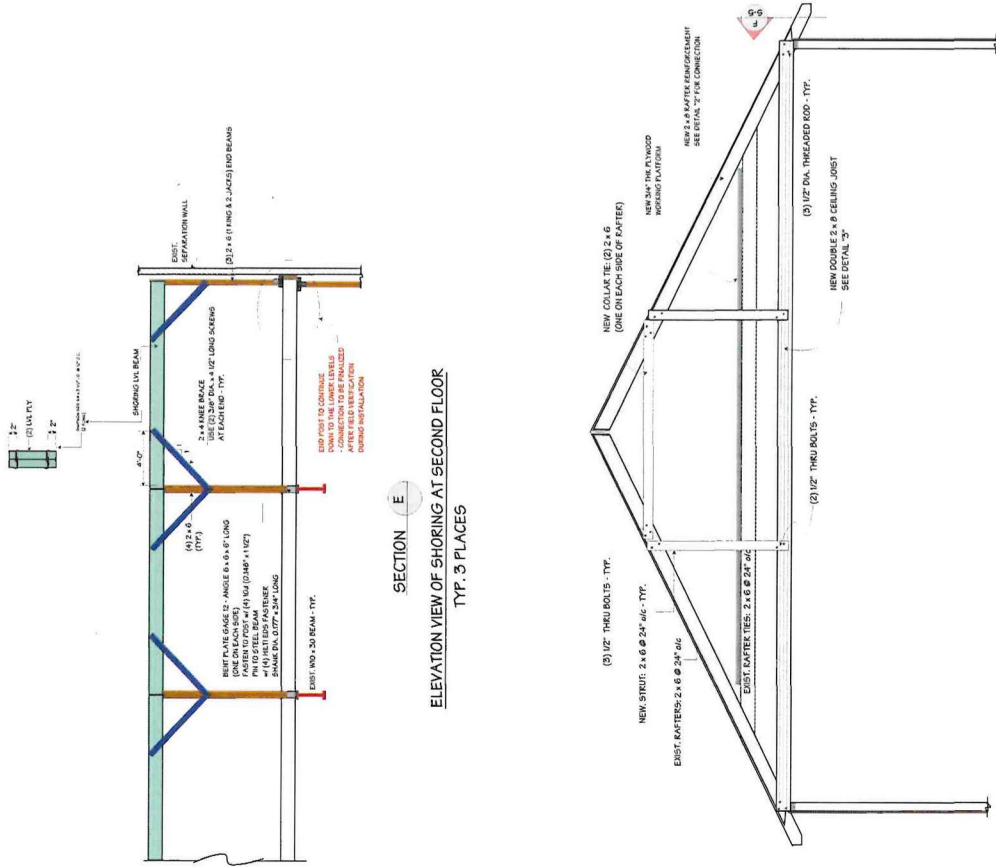
CONCEPTUAL DESIGN FOR ROOF REINFORCEMENT  
(FOR PRELIMINARY CONSTRUCTION ESTIMATE COST)

Reinforce existing roof in place as shown on Dwg. S-5. This option will not remove the current deflection (sag) on the ridge, but it will provide a strong roof capable of resisting the current building code load requirement. The "roof sag" will not be noticeable from the inside as the new inside ceiling finish will be plumb and straight.

Note that this is a conceptual design and that more analysis is required to develop the final design reinforcement to fit the existing condition.

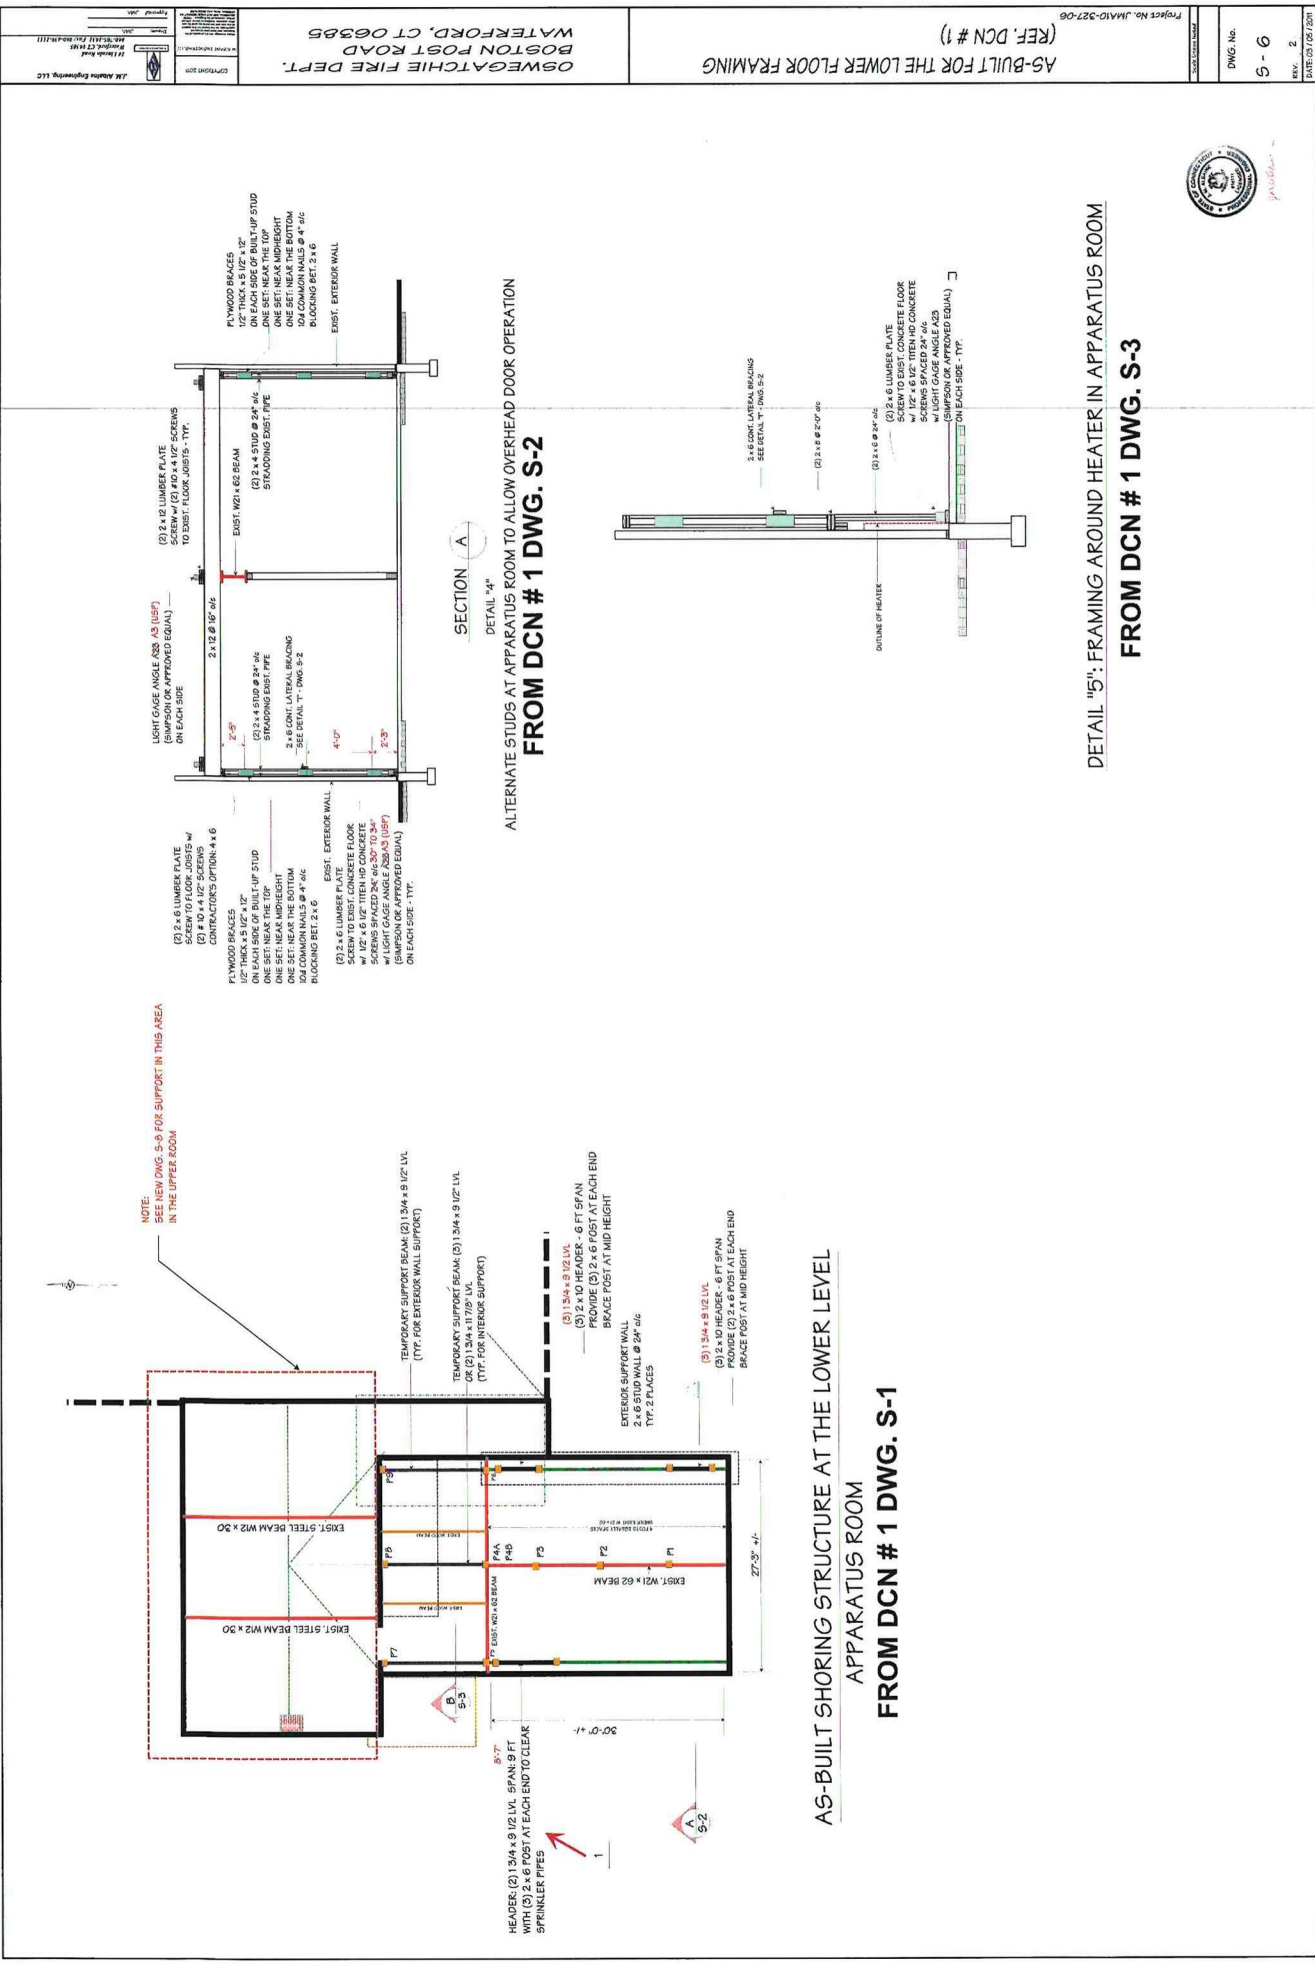
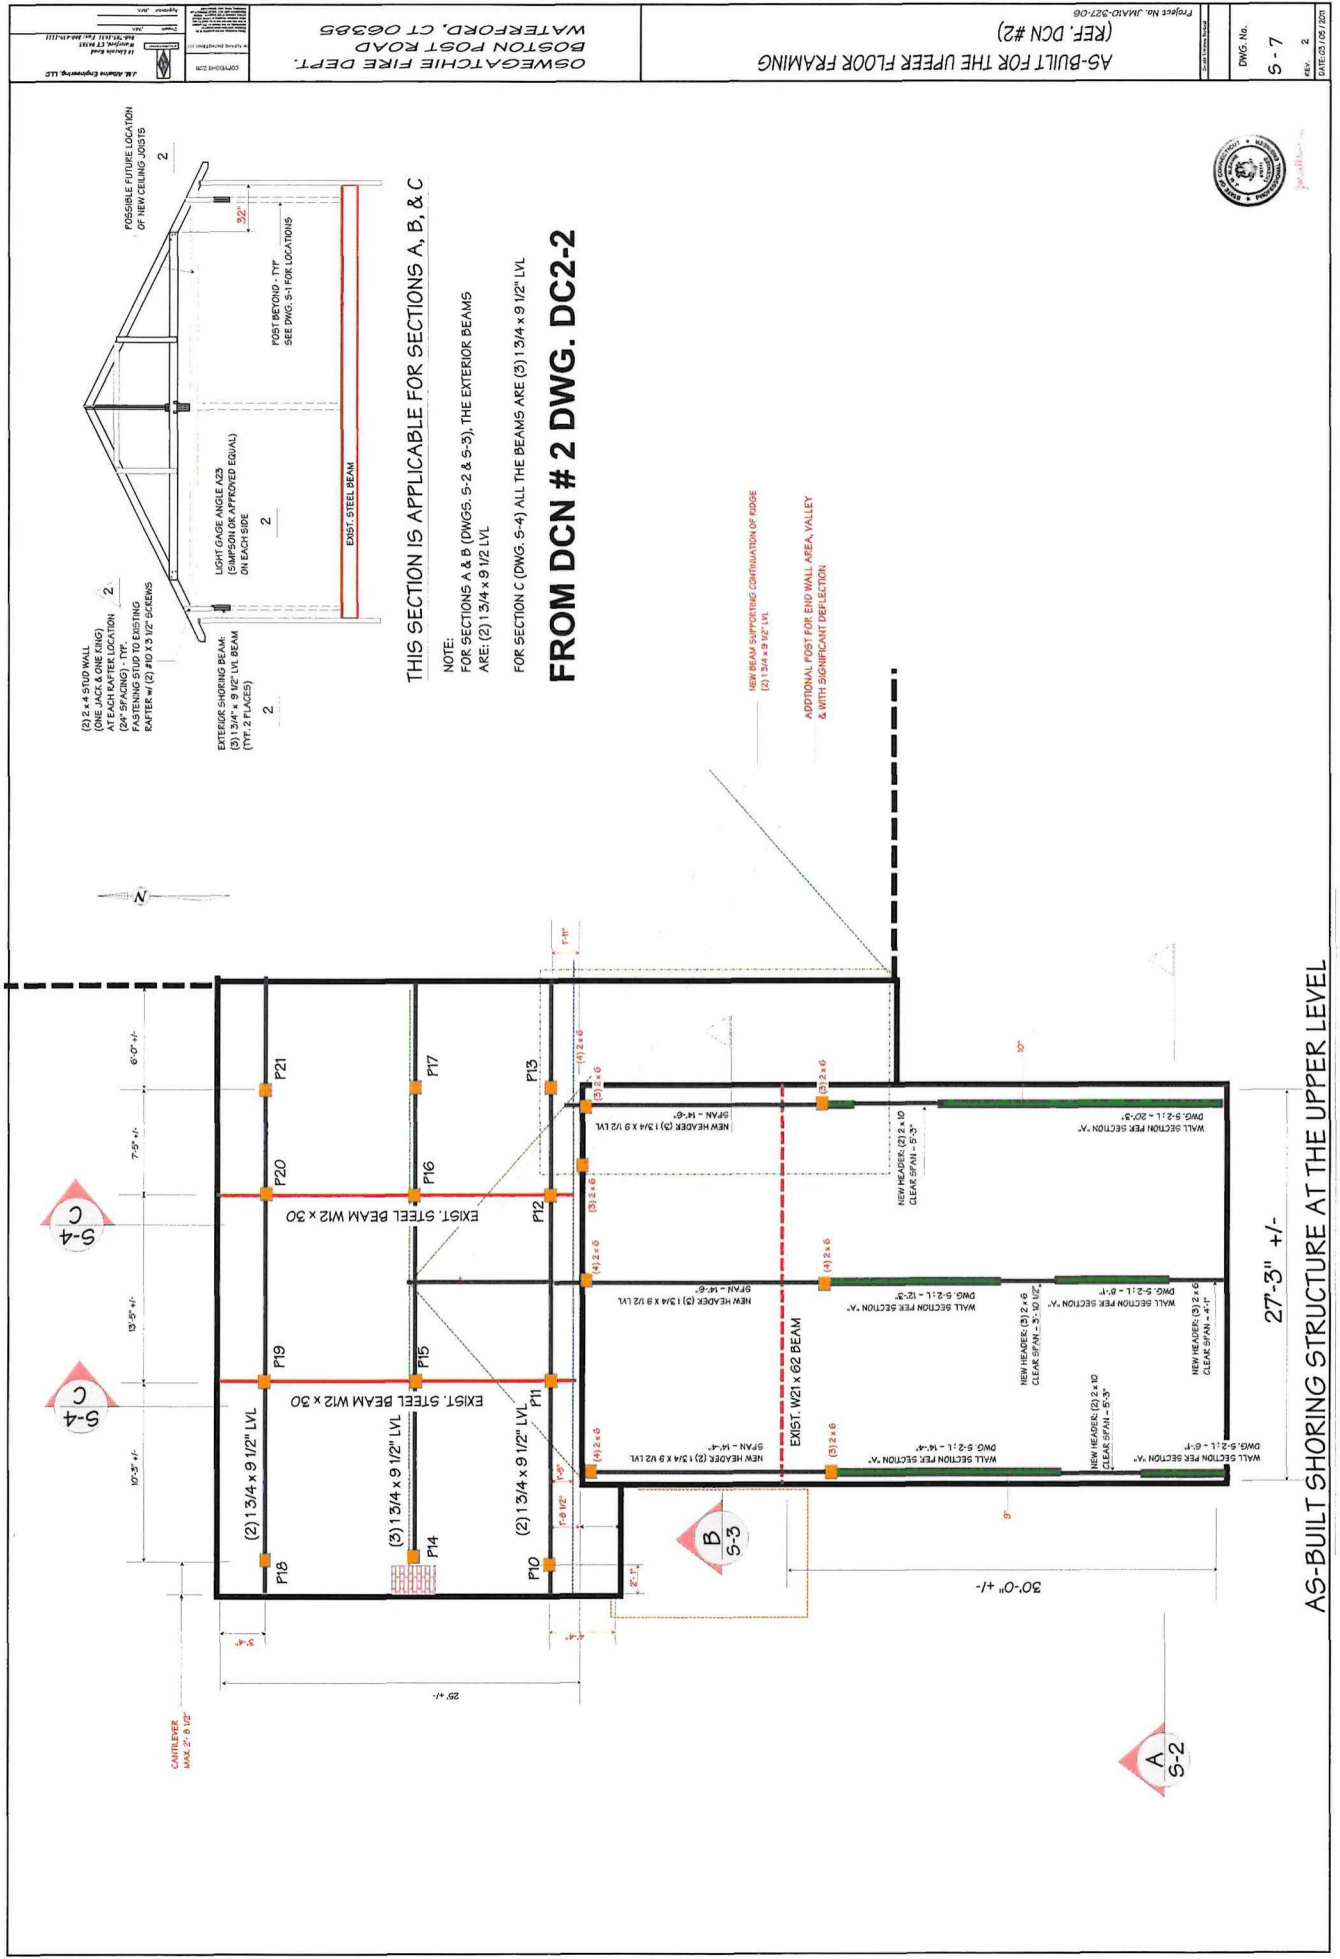
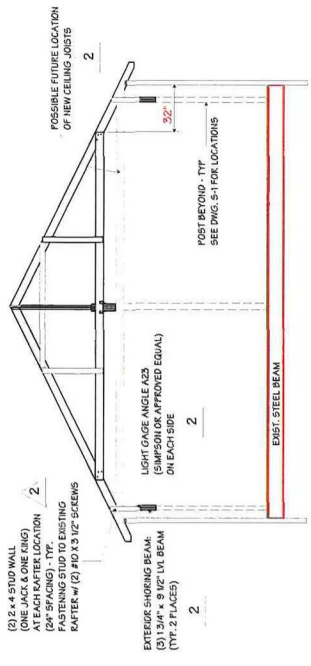
AS-BUILT FOR THE UPPER FLOOR FRAMING  
 (REF. DCN #2)

ADDITIONAL POST FOR END WALL AREA, VALLEY & WITH SIGNIFICANT DEFLECTION

NEW BEAM SUPPORTING CONTINUATION OF RIDGE  
 (2) 1 3/4 x 9 1/2\"/>
