**TOWN OF WATERFORD - DPW FACILITIES  
CAPITAL IMPROVEMENT PLAN  
PROJECT CONSOLIDATION FORM-FY 2022-2026**

The O'Neil Theatre Complex - Mansion House Building Evaluation Survey

The O'Neil Theatre Complex -Mansion House Building Evaluation Survey

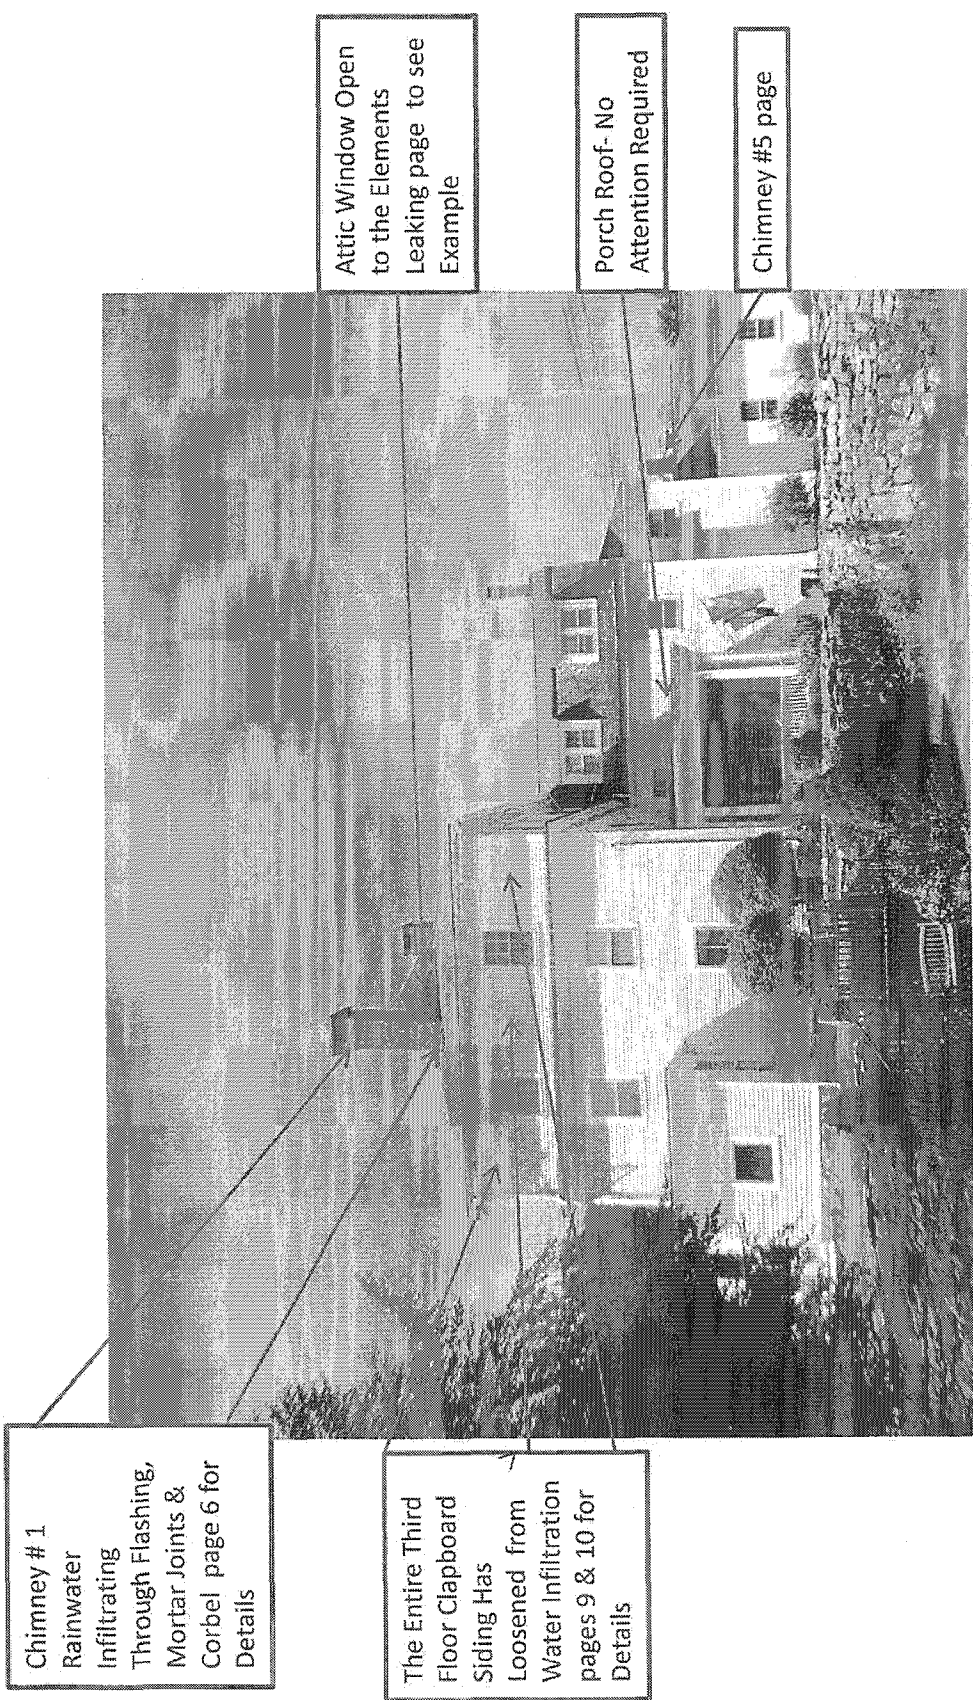
Chimney #2 Water Infiltration Spalling Corbel,  
Mortar Joints & Flashing page 5

Chimney #3 Water  
Infiltration Spalling  
Corbel, Mortar  
Joints & Flashing  
page 4

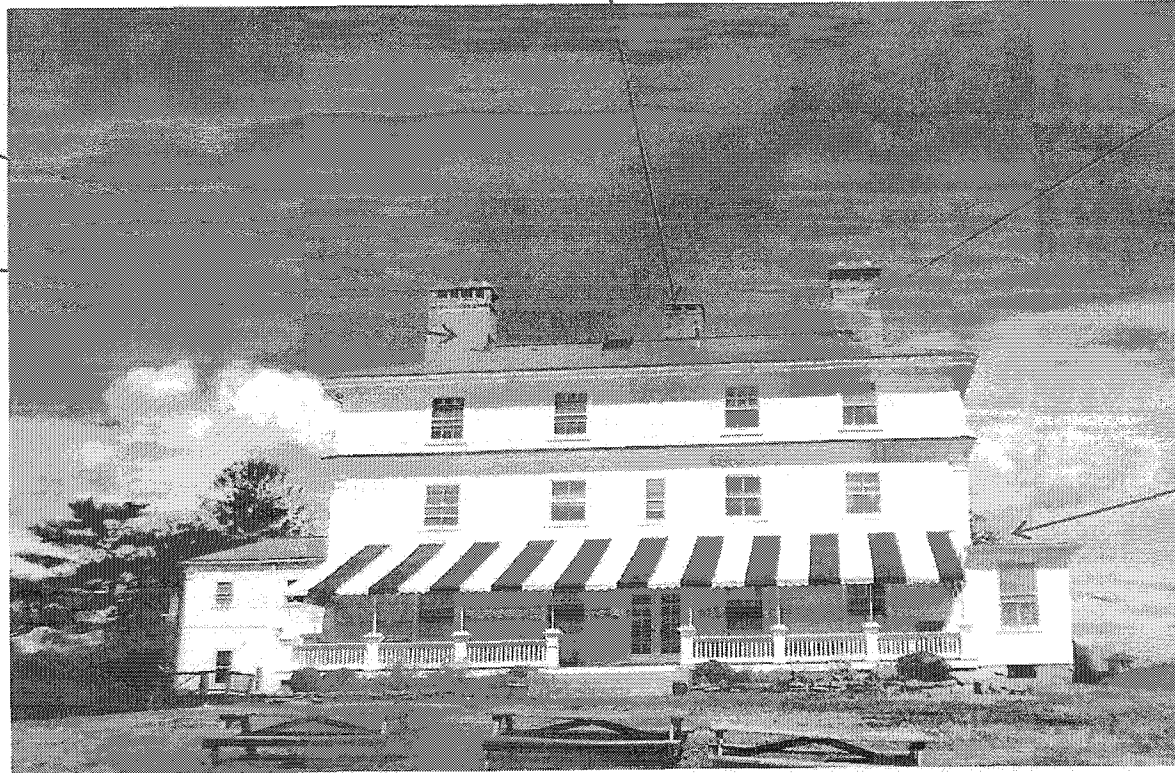
Chimney #1  
Spalling, Water  
Infiltration  
page 6

CEO's Office  
Almost Flat Roof  
With Damaged  
Shingles – As  
Such it Leaks in  
Heavy Rains

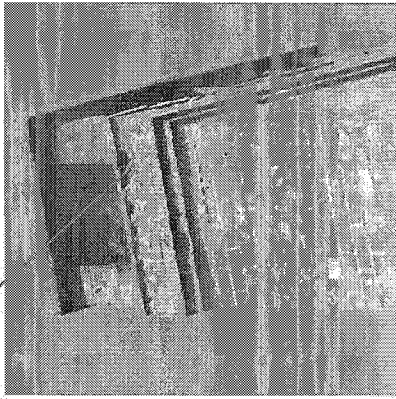
Chimney #3 Western Elevation Missing Brick & Spalling

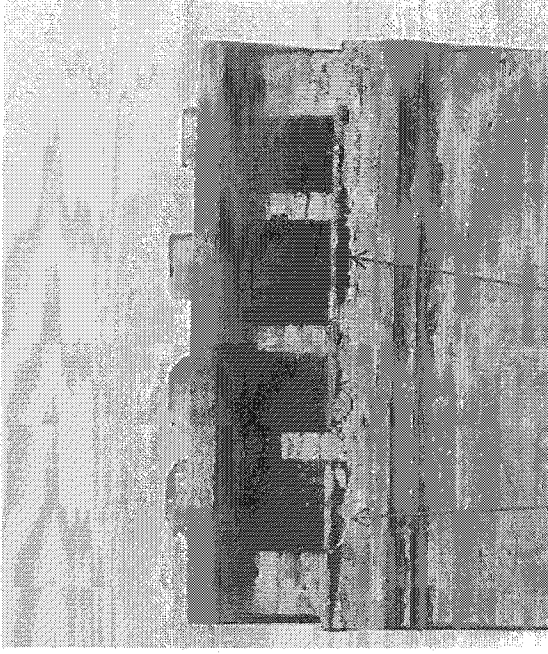
Chimney #3 Southern Elevation – Missing Brick & Spalling

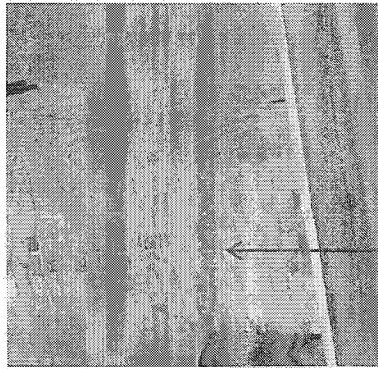
Chimney #3 Western Elevation Both Efflorescence and What Appears to be a Sealer Applied (over time)

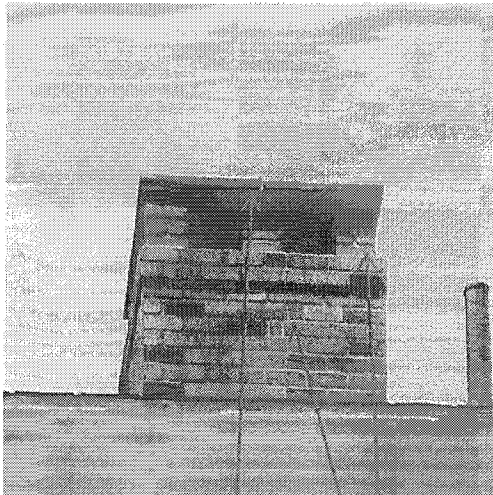
**Chimney # 2 Southern Elevation**  
 Some Repairs Have Been  
 completed over the years.  
 However, Efflorescence is evident  
 With traces Water Stains  
 (Internally) Directly Under its  
 Flashing. Cap is Open to the  
 Elements pages -14 & 15

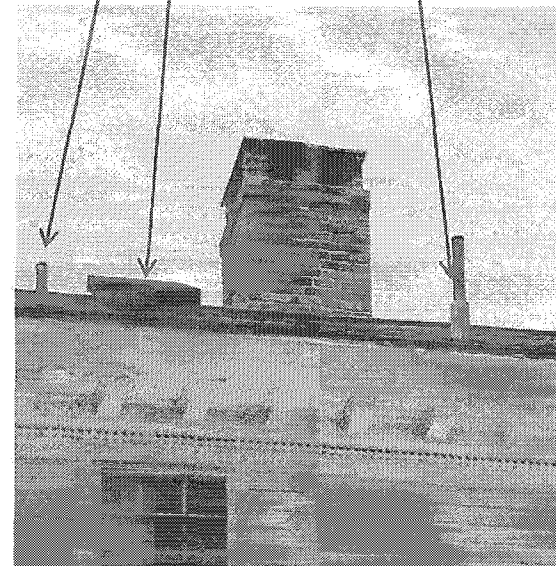
**Southern Elevation** Roof Access Hatch, & Vent Stacks  
 Water Stains (Internally) Directly Under Their Respective  
 Location(s) See Attic Section pages -14 & 15

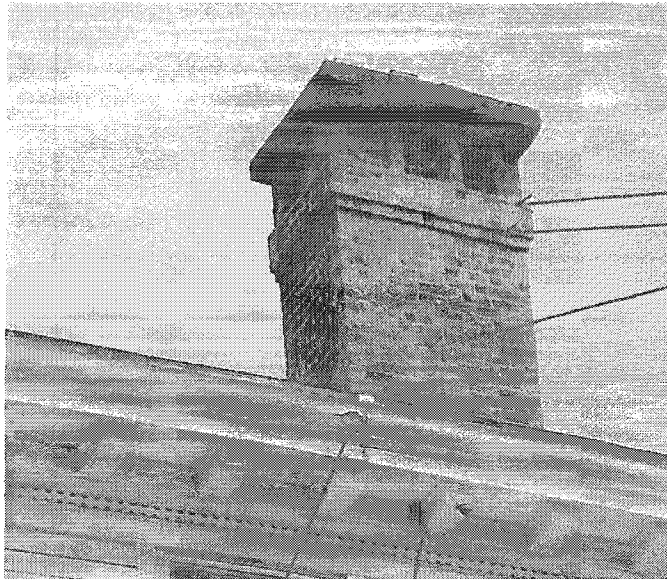
Chimney #1 **Southern Elevation** – Evidence of Spalling is Apparent With Signs of Both Efflorescence & Attempt to a Sealer page

Wooden Gutter **Southern Elevation**  
Broken Seam Water entering Soffit  
Resulting in Damage

Chimney #1 **Southern Elevation** Failed Flashing  
Water Infiltration Evident  
Internally page

This Cap Was Replaced After  
it Had Collapsed Onto The  
Adjoining (CEO's) Roof  
Below

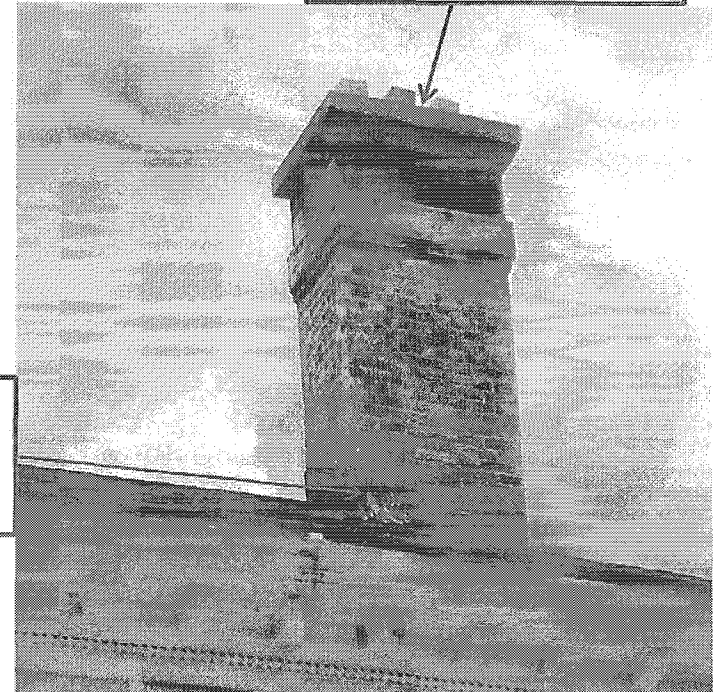
Right - Chimney #4 Western – South  
Western Elevation Broken Bricks /  
Spalling – Failed Mortar Joints –  
Flashing Failure – Efflorescence &  
Sealer Application Apparent.

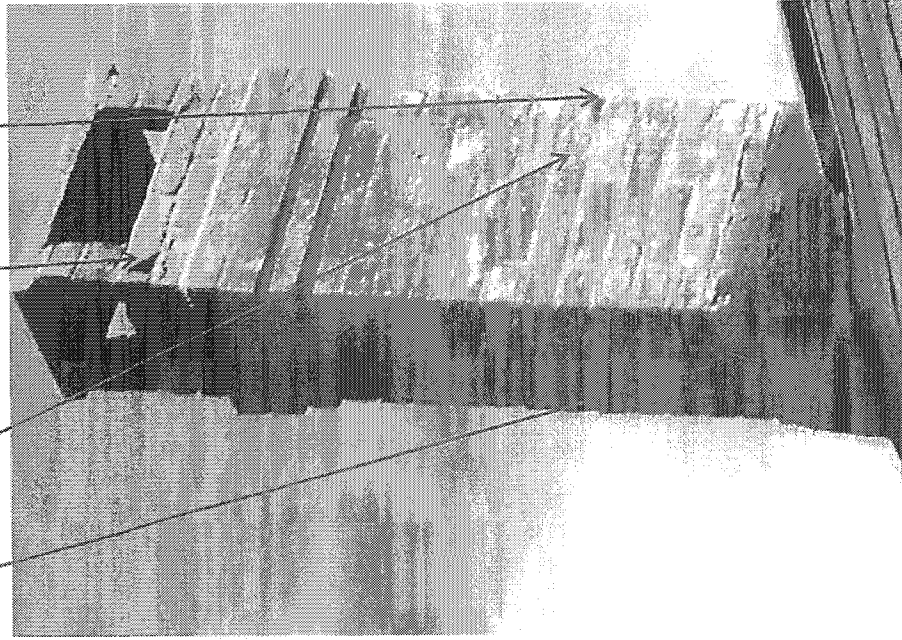
Left – Chimney #5 Western  
Elevation Flashing Failure

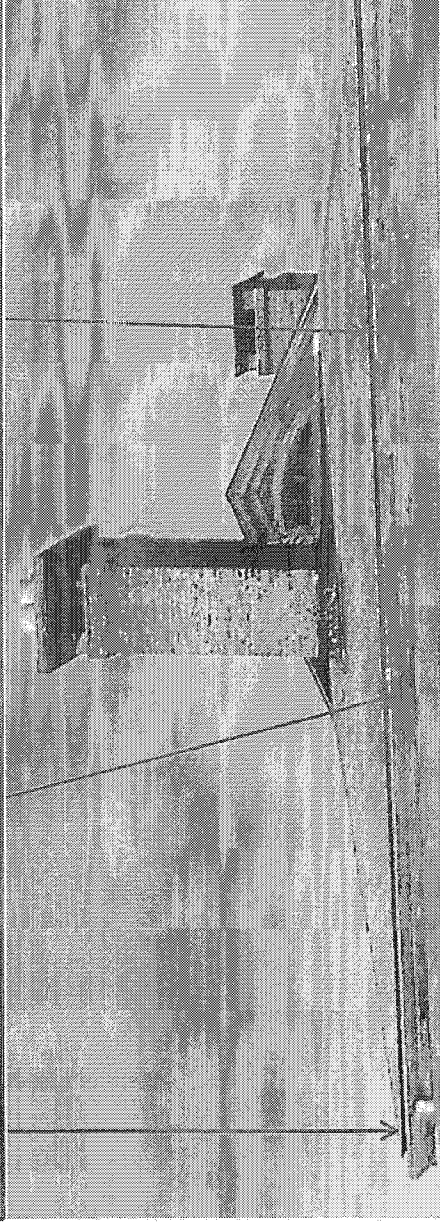
- The unattended long term damage caused by wind and or storm to this structure. This resulting in both missing and damaged shingles. This condition is allowing the infiltration of the elements (rainwater) to enter directly into this structure. Please refer to page eight (8)

The Asphalt Roofing System -- Southern Elevation -- Storm Damage Resulting in Direct Water Infiltration -- page

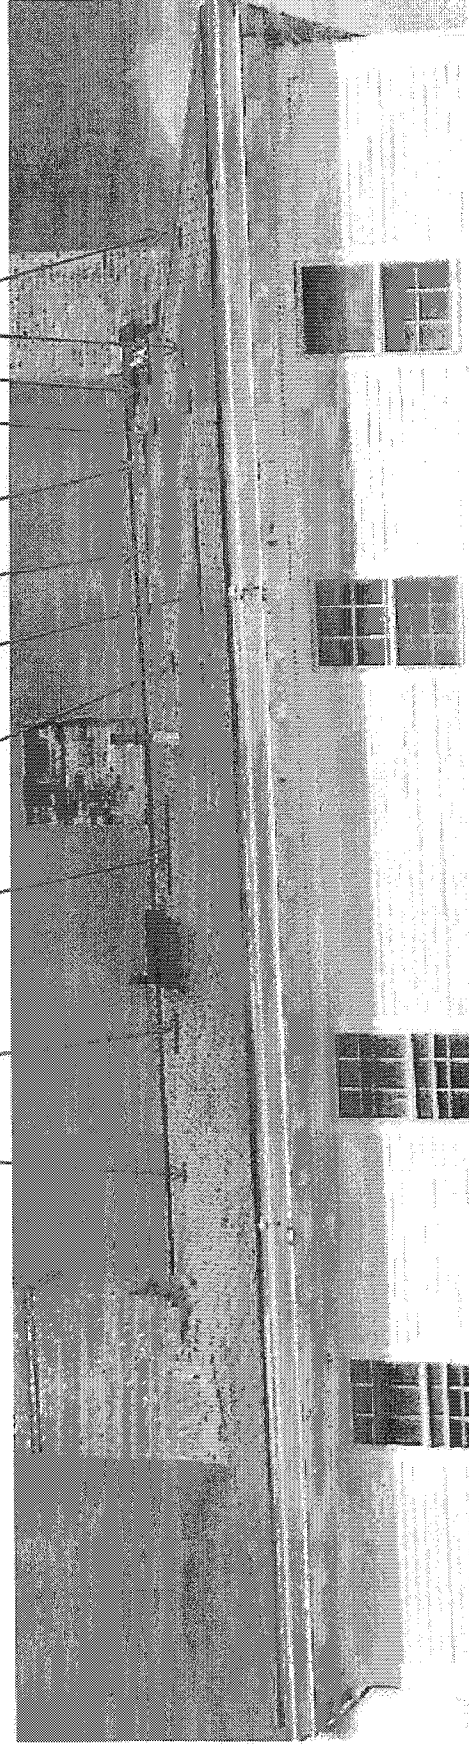
The Wooden Gutter – Third Story – **Eastern Elevation** – A Look From Underneath . Almost Complete Failure of The Gutter, Trim and Soffit Below. This Water Flow is Finding Its Way Behind The Clapboard & When it Freezes – Pushes The Siding Out & Away

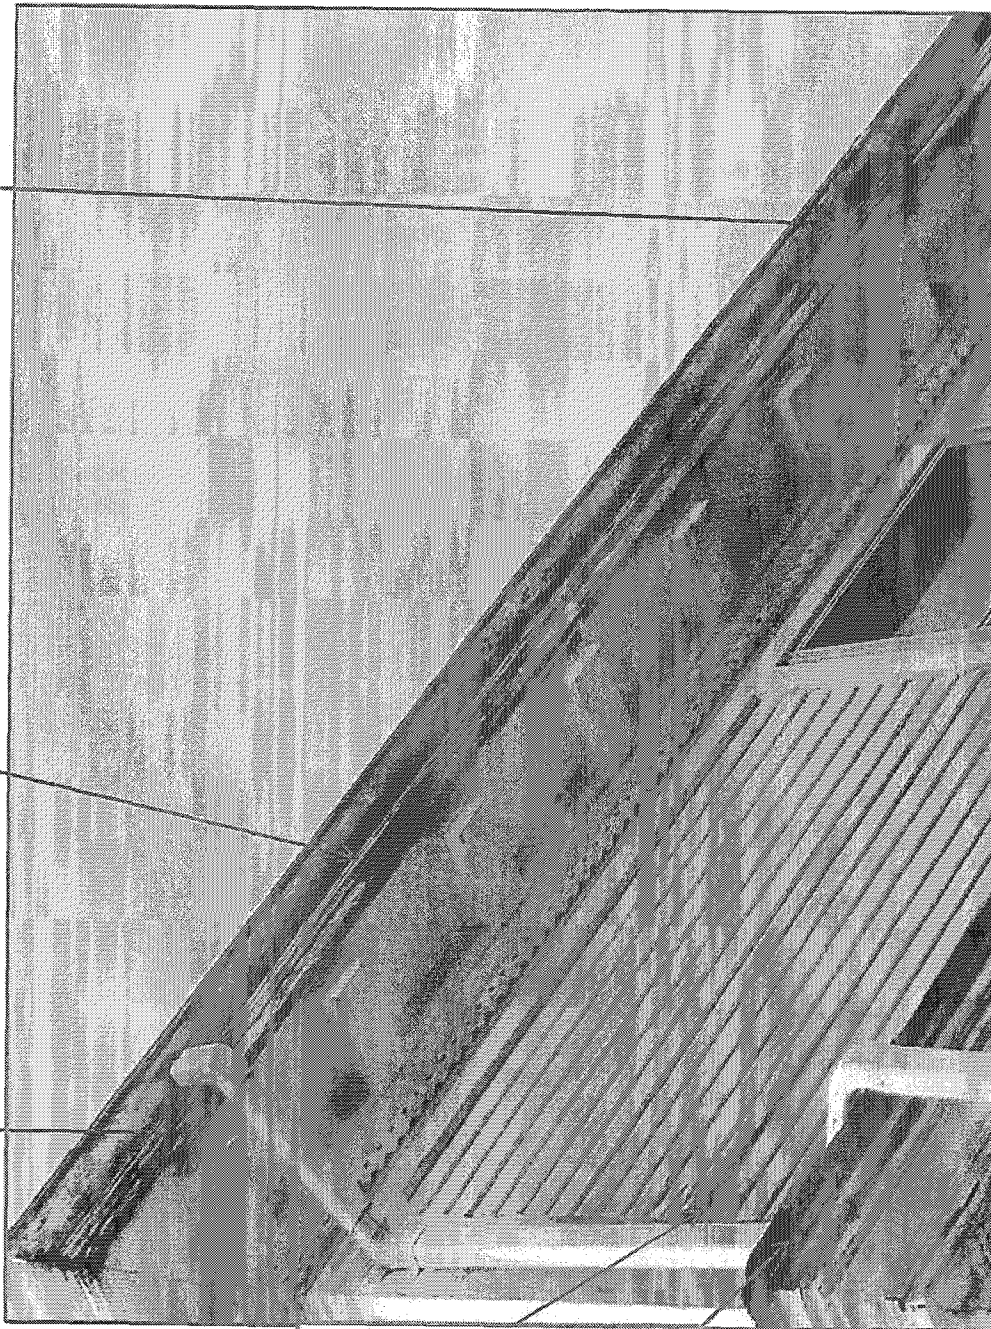
Water  
Entering  
Directly  
Behind  
Clapboard  
Siding –  
Moving  
Siding  
Away From  
The  
Building -

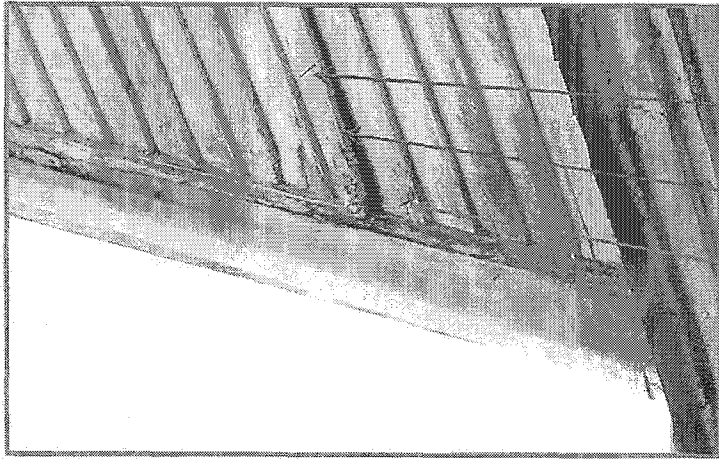
**Eastern – Southeast Corner Above  
The CEO's Office Where this Lower  
Roof Intersects the Clapboard –  
Loose Siding and Nails Visible**

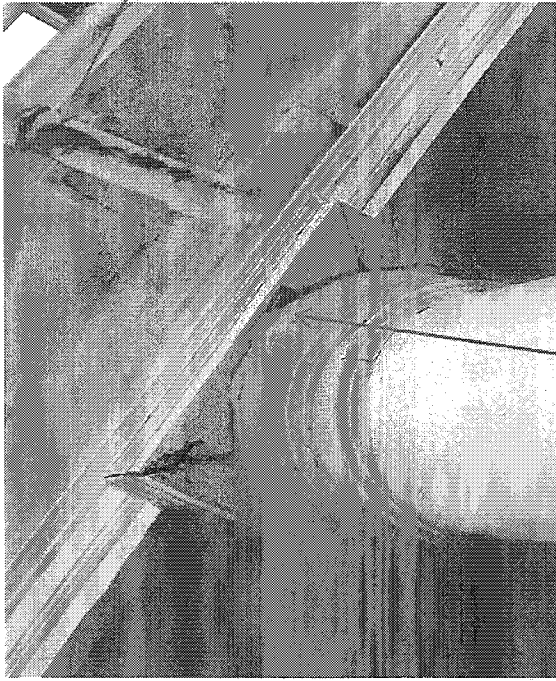
A Leaking Gutter Drain Line is Compromising The Capital of This Doric Porch Column – Along With the Surrounding Trim Work

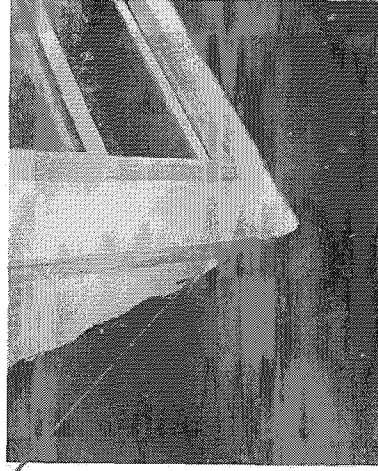
Standing on Top of The Flat Roof is an Addition (by The Hammond Family) – Looking South – Southeastern Elevation – One May See The General and Extensive Decomposing of the Wooden Gutter /Drainage System Along With The Over Due Painting and Repair

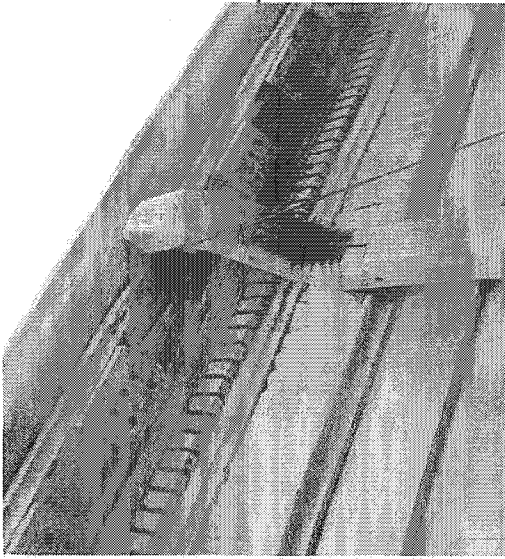
There Are Two Downspouts Above This Roof – This is Their Condition

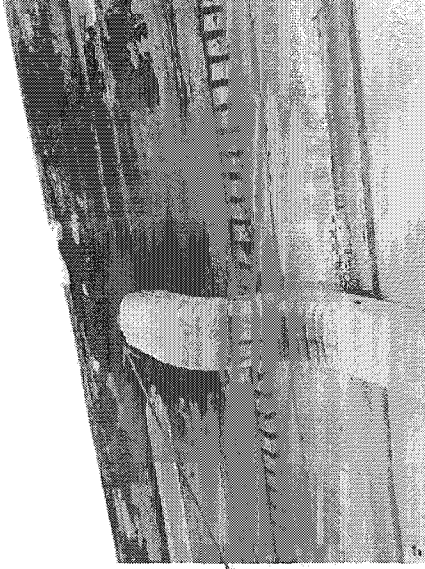
Flat Roof – Between Exhaust Fan and Adjacent Wall - There is No Plywood or Other Structural Support Substrate Here - Under This Area! Should One Step Here One Would Likely Step Through into the Room Below

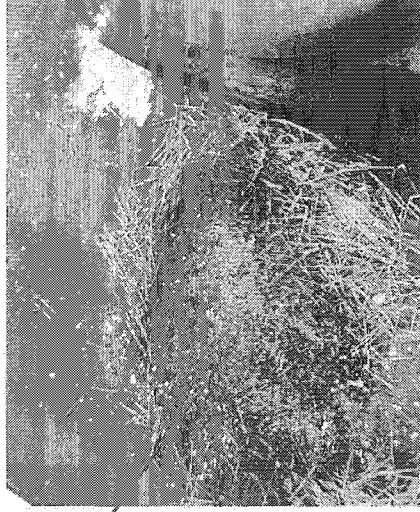
Attic- Interior – Southern Elevation -  
Water Stain on Truss & Supports

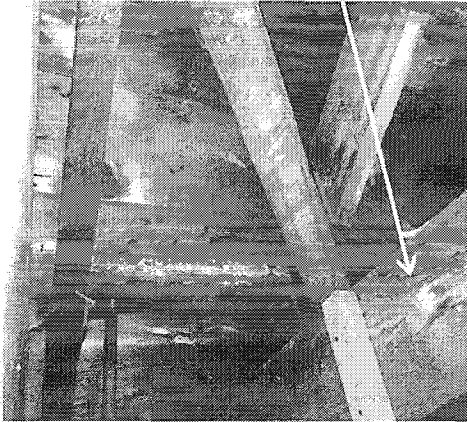
Attic – Interior – Western Elevation –  
Open to The Elements

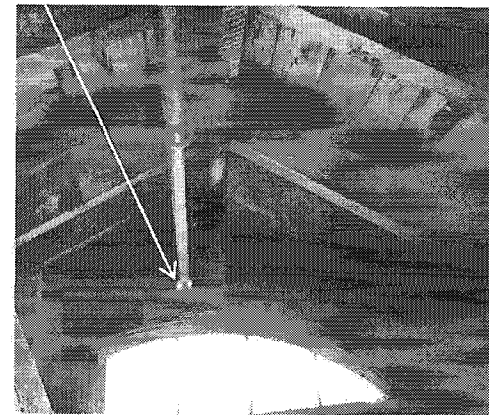
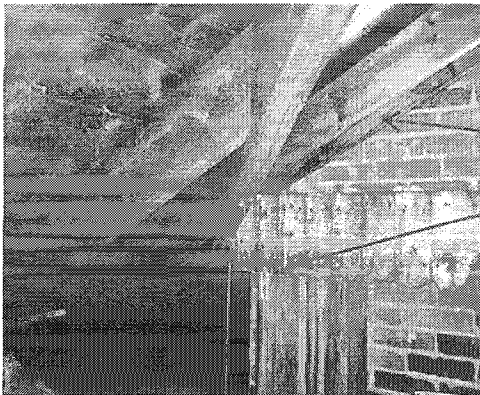
Attic – Interior –  
Chimney #3 –  
Western  
Elevation-  
Flashing Failure  
& Masonry  
Wicking

Attic – Interior –  
Chimney #2  
Western  
Elevation –  
Flashing Failure  
& Masonry  
Wicking

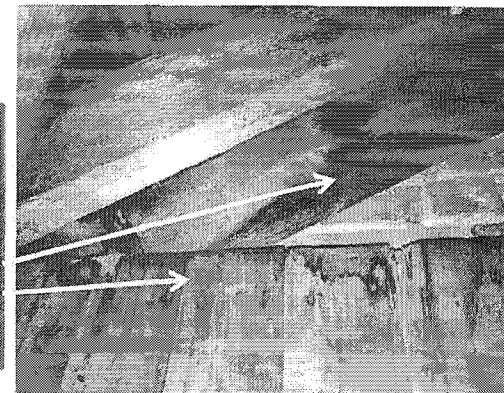
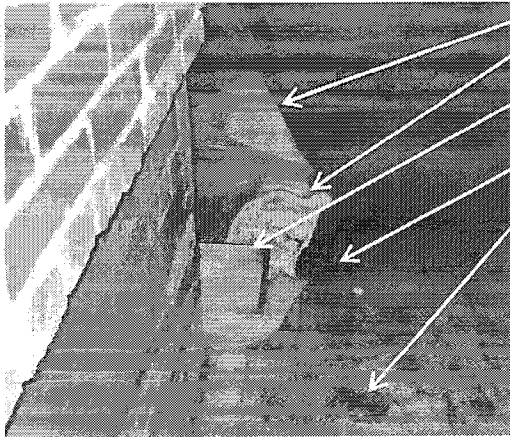
Contained with the photographs enclosed there are several examples of this water infiltration abounding all – heretofore manmade temporary remedies/ obstacles. Please note the plastic sheathing, used rags, metal pan to catch and or divert this rainwater entry. Please refer to page fifteen (15).

Attic- Chimney #1 –Eastern Southeastern Elevation Catch Pan, Plastic and Rags to Capture Rainwater- Floor Previously Saturated – Note Stains

Attic-Chimney #2 Interior Eastern Elevation- Roofers & Framing Previously Saturated

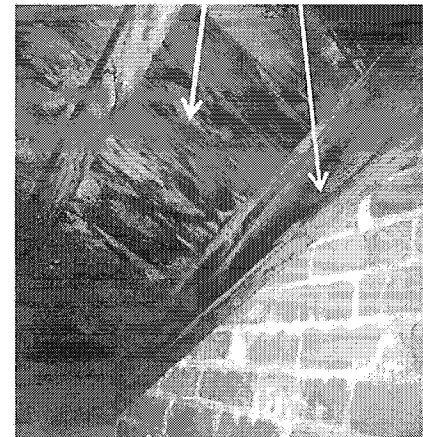
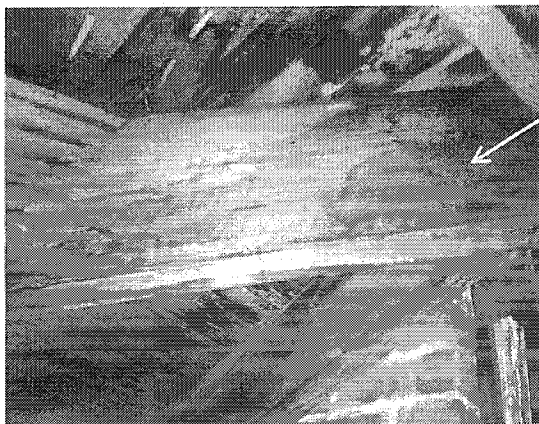
Attic- Left -Chimney #2 Western Elevation Truss Framing Previously Saturated – Note Stain

Attic – Right - East – Northeast Elevation- Rafters Show Signs of Previous Water Infiltration

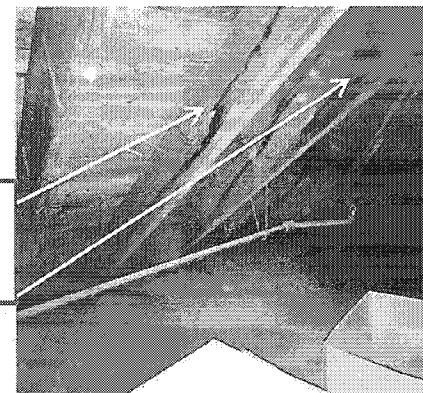
- The copper roof on top of the Northern elevation dormer has become so corroded and pitted that the elements (rainwater and their like) are allowed to flow directly into this building. Please refer to page sixteen (16).

North Elevation Dormer Copper Roof & Roof  
Flashing Leaking Directly Into This Building

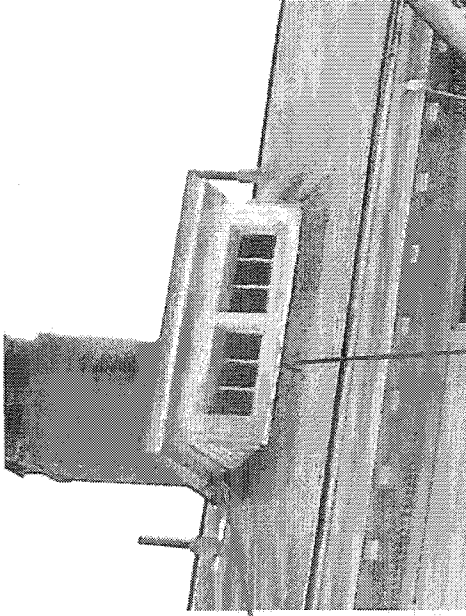
North Elevation -  
Under The  
Dormer Window  
Flashing - Note  
Water Stains

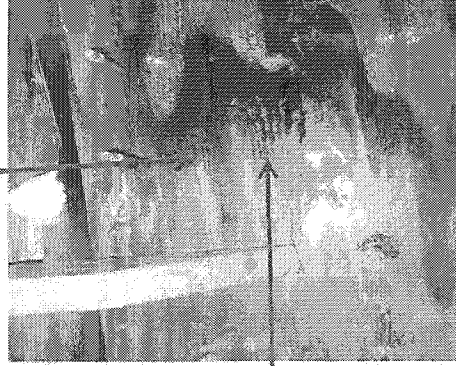
Third Floor Stairwell - Eastern Elevation - Under The Rear  
Section of the Copper Roof

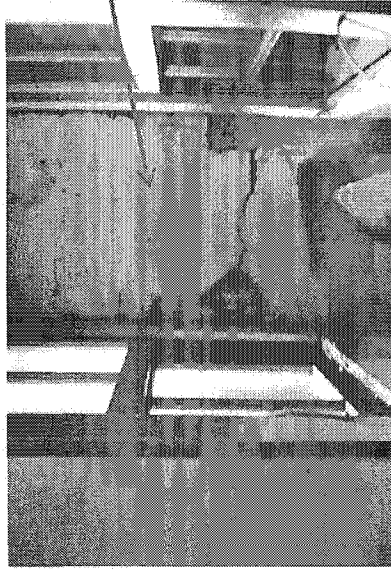
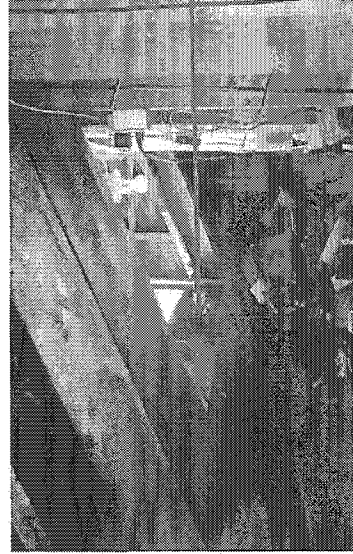
Western Elevation-The Primary Issues Here Are Very Much The Same – The Decomposing of The Drainage System – Along With The Concerns Regarding The Scheduling Preventive Maintenance

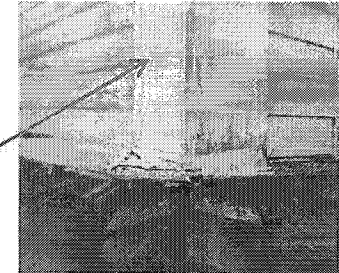
Above – Open Wood Trim  
Failed Caulk Joint -Peeling Paint

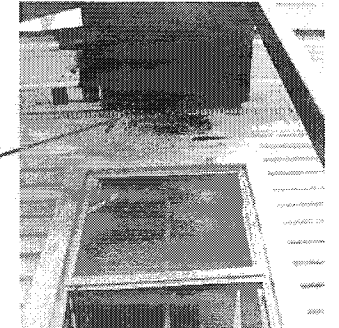
Above- Failed Drainage System  
Below- Full View of This Window  
Requires Attention

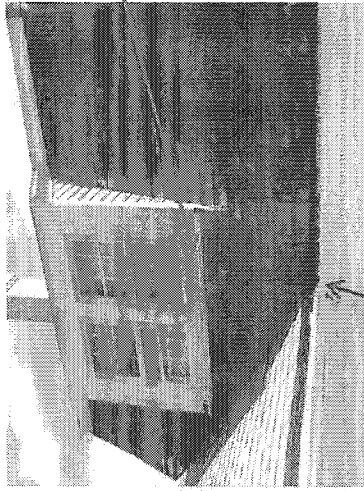
Western Elevation – The Addition-  
Note All of the Exposed Wood On  
These Windows and Gutters – A  
Typical Third & Attic Floor Condition.

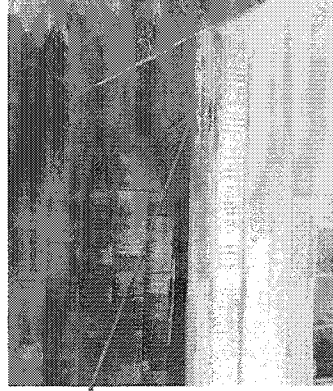
Attic – Northern Elevation -The Staff is Concerned About This Wiring as They Nor Does Their Electrician Understand Where Any of This Leads. There is More Than What is Shown in This Photograph

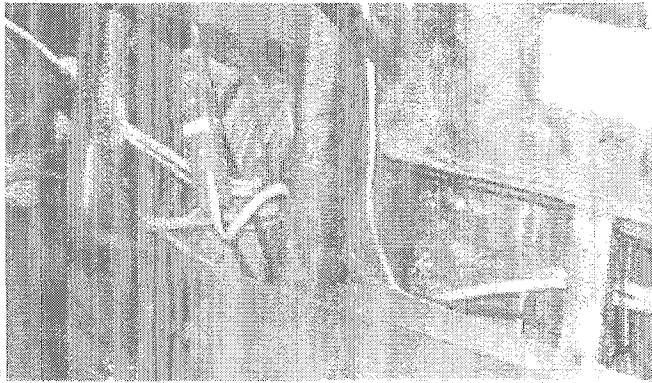
Attic- Southwestern Elevation – Near Water Infiltration – Wicking Chimney. Again Here The Staff Brought This to Our Attention

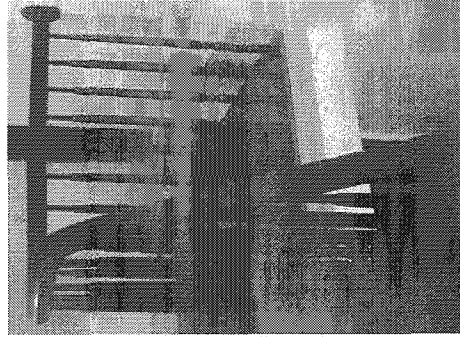
The Separation From Minor Age Settlement  
Is Demonstrated Here

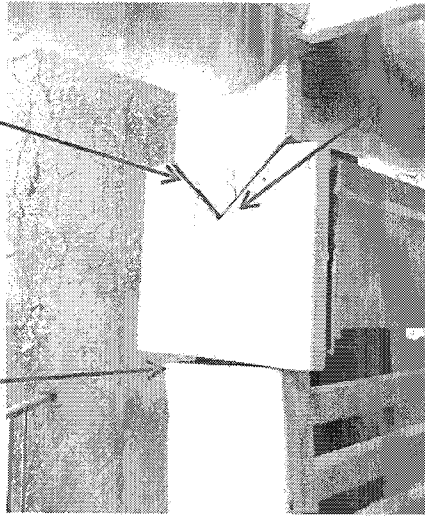
Likewise Age Related Repair Required Here  
The Bottom Trim is Just Leaning Against The Larger  
Baluster
