**TOWN OF WATERFORD - DPW FACILITIES  
CAPITAL IMPROVEMENT PLAN  
PROJECT CONSOLIDATION FORM-FY 2022-2026**

**TOWN OF WATERFORD  
CAPITAL PROJECT REQUEST FORM**

Eugene O'Neill Mansion Roof Replacement

The O'Neil Theatre Complex -Mansion House Building Evaluation Survey

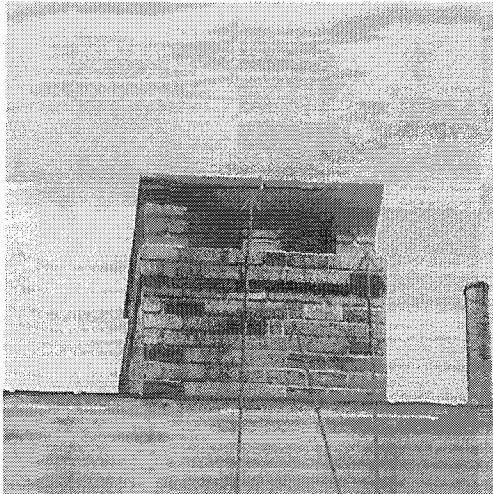
**Chimney # 2 Southern Elevation**  
Some Repairs Have Been completed over the years. However, Efflorescence is evident With traces Water Stains (Internally) Directly Under its Flashing. Cap is Open to the Elements pages -14 & 15

**Southern Elevation** Roof Access Hatch, & Vent Stacks  
Water Stains (Internally) Directly Under Their Respective Location(s) See Attic Section pages -14 & 15

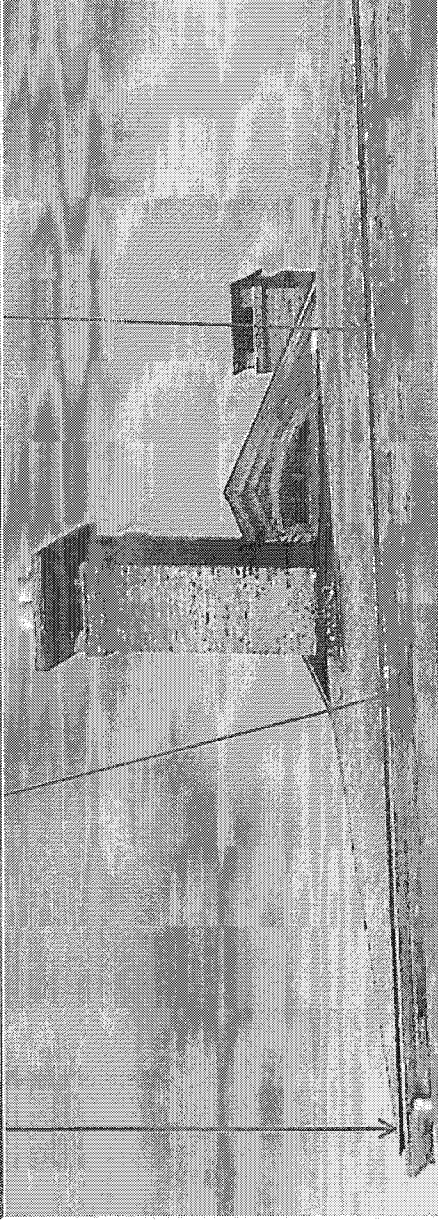
The Asphalt Roofing System -- Southern Elevation -- Storm Damage Resulting in Direct Water Infiltration -- page

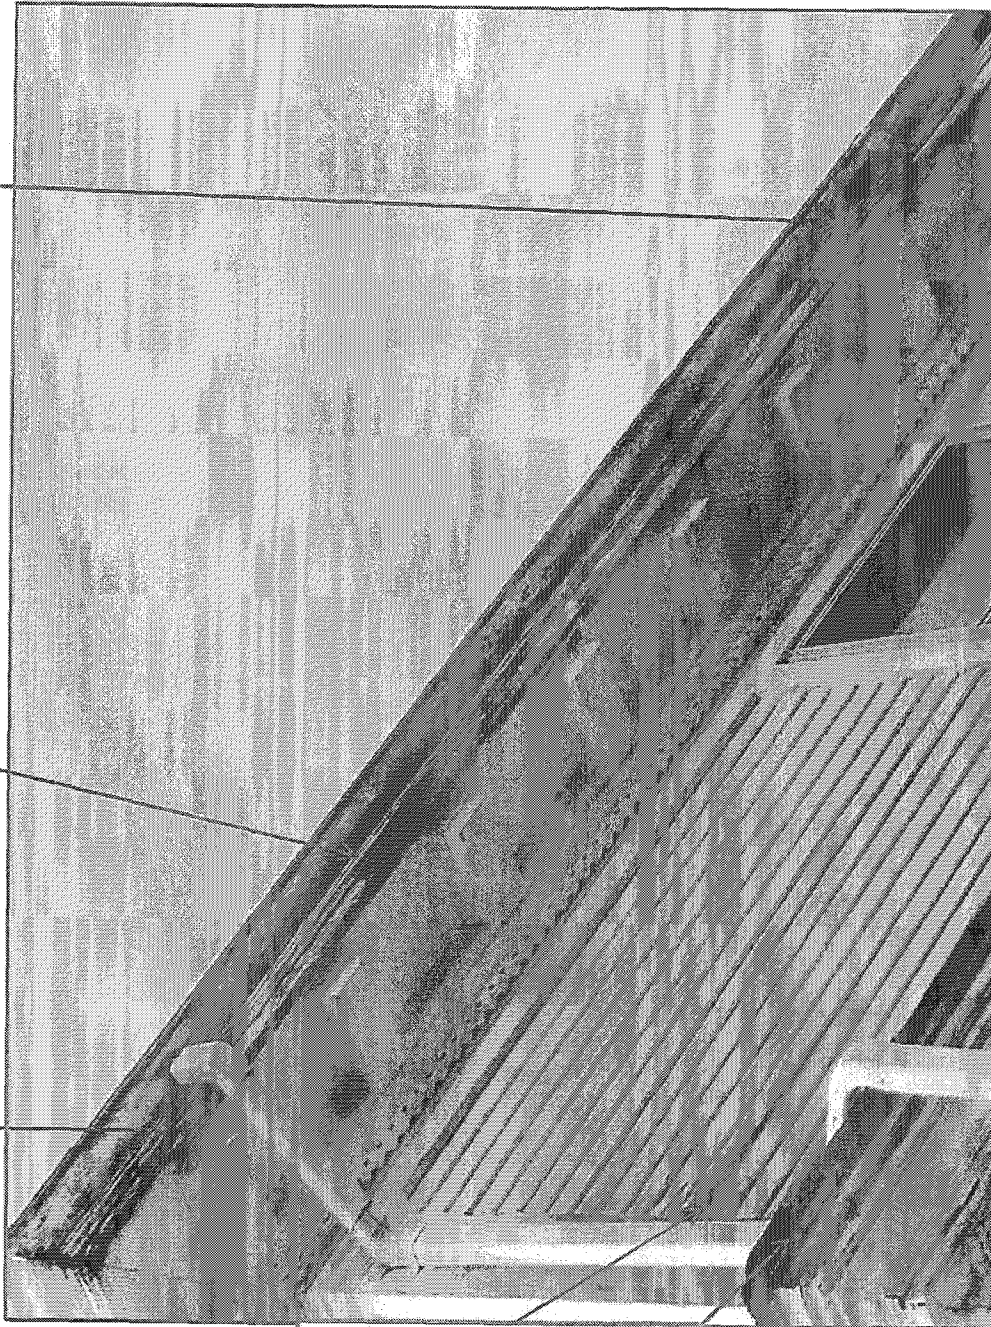
The Wooden Gutter – Third Story – **Eastern Elevation** – A Look From Underneath . Almost Complete Failure of The Gutter, Trim and Soffit Below. This Water Flow is Finding Its Way Behind The Clapboard & When it Freezes – Pushes The Siding Out & Away

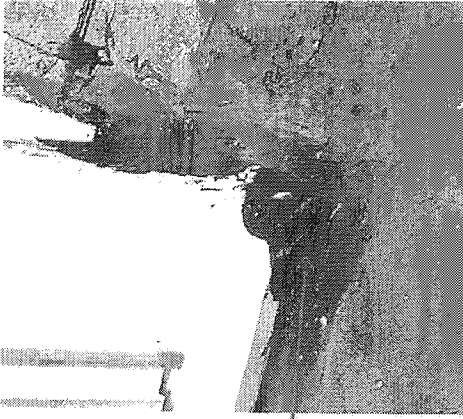
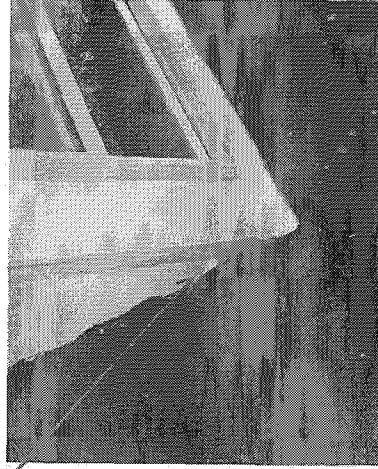
Western Elevation Flat Roof Problematic Leaking – The Flashing Around Both The Dormer Window & Chimney #5 (page 7) Have Had Temporary Repairs Made to Them

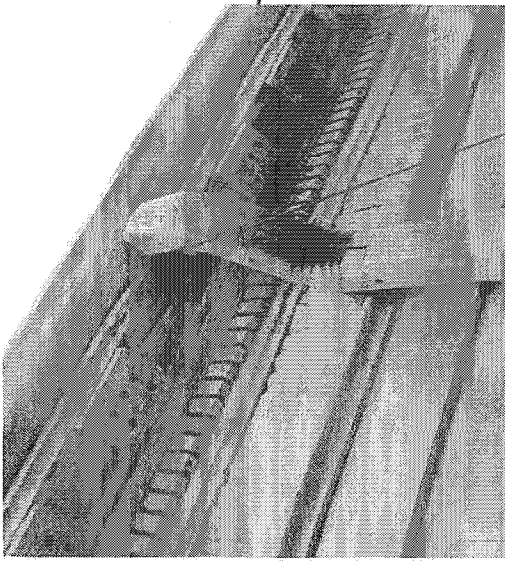
Standing on Top of The Flat Roof is an Addition (by The Hammond Family) – Looking South – Southeastern Elevation – One May See The General and Extensive Decomposing of the Wooden Gutter /Drainage System Along With The Over Due Painting and Repair

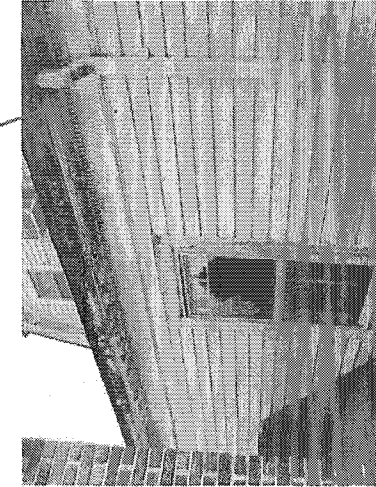
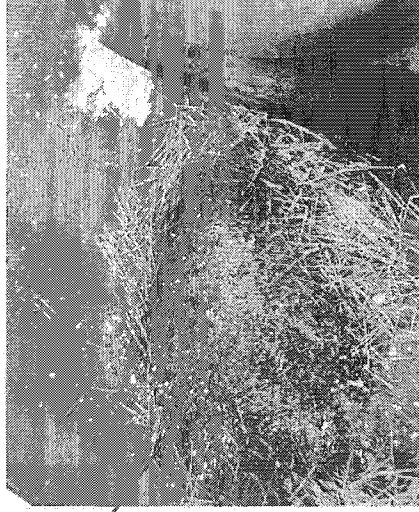
Flat Roof – Between Exhaust Fan and Adjacent Wall - There is No Plywood or Other Structural Support Substrate Here - Under This Area! Should One Step Here One Would Likely Step Through into the Room Below

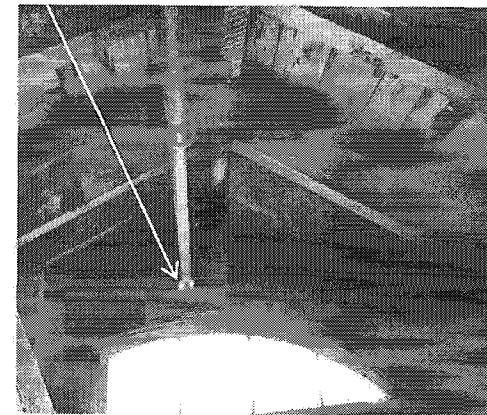
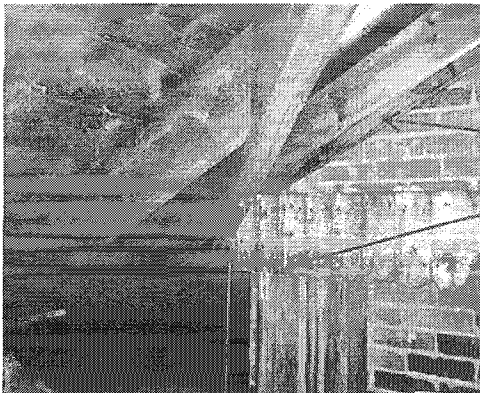
Attic – Interior – Western Elevation –  
Open to The Elements

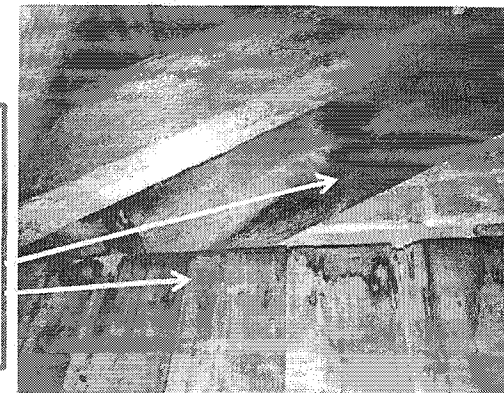
Attic – Interior –  
Chimney #3 –  
Western  
Elevation-  
Flashing Failure  
& Masonry  
Wicking

Attic – Interior –  
Chimney #2  
Western  
Elevation –  
Flashing Failure  
& Masonry  
Wicking

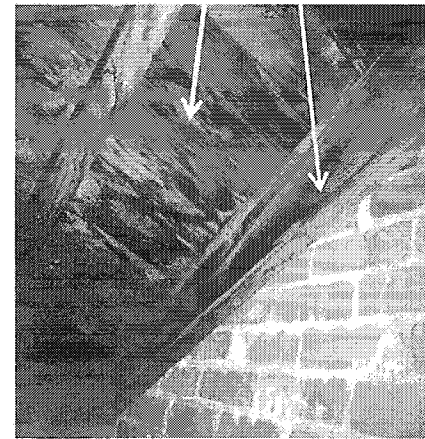
Attic- Chimney #1 –Eastern Southeastern Elevation Catch Pan, Plastic and Rags to Capture Rainwater- Floor Previously Saturated – Note Stains

Attic-Chimney #2 Interior Eastern Elevation- Roofers & Framing Previously Saturated

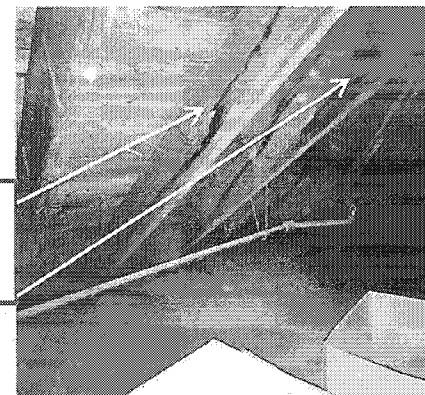
Attic- Left -Chimney #2 Western Elevation Truss Framing Previously Saturated – Note Stain

Attic – Right - East – Northeast Elevation- Rafters Show Signs of Previous Water Infiltration

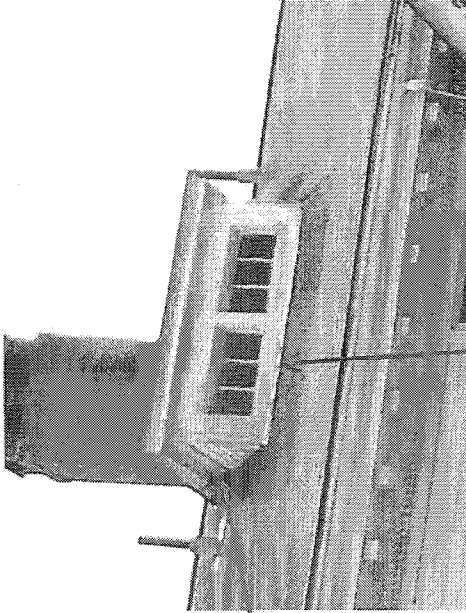
North Elevation Dormer Copper Roof & Roof  
Flashing Leaking Directly Into This Building

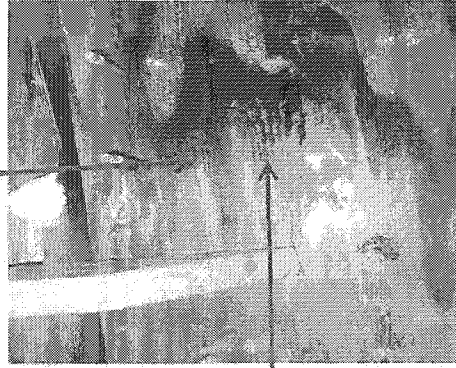
North Elevation -  
Under The  
Dormer Window  
Flashing - Note  
Water Stains

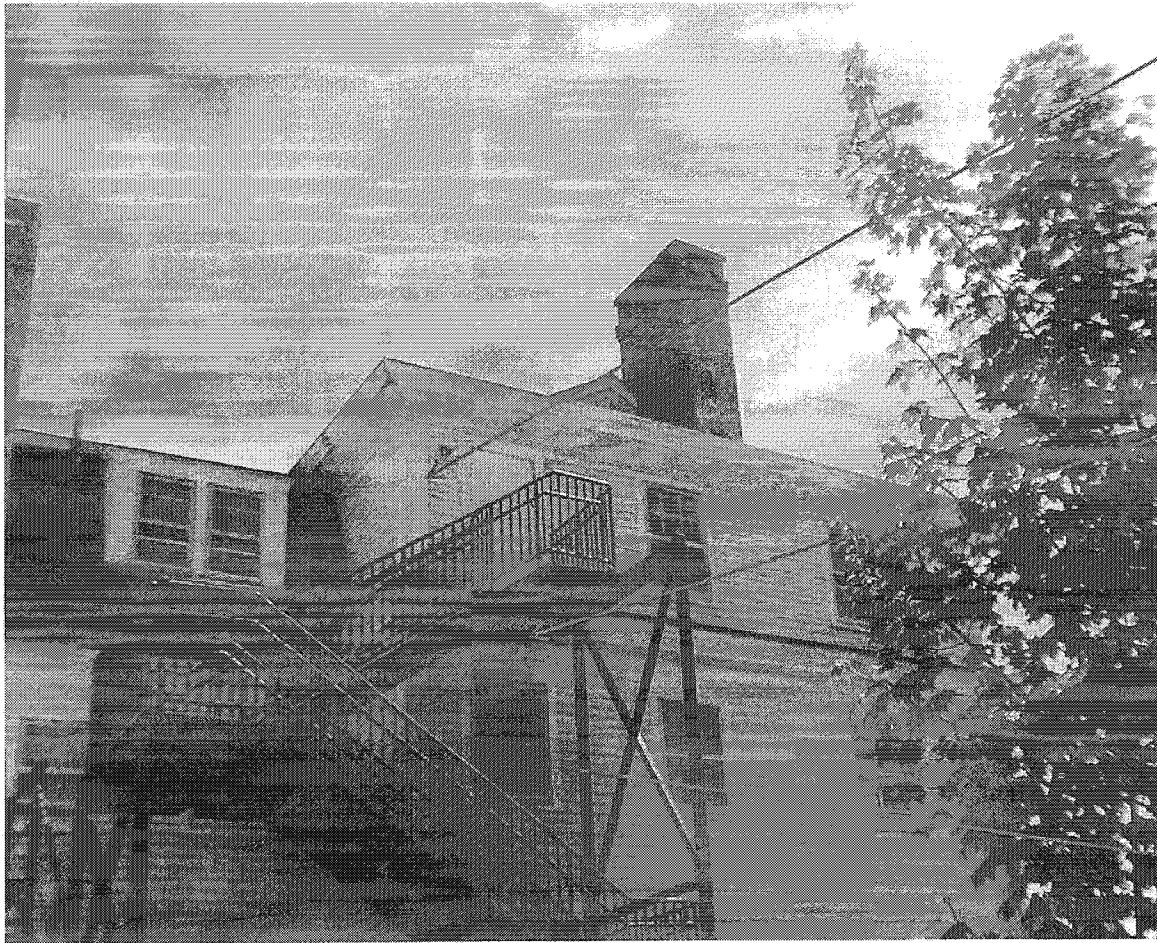
Western Elevation-The Primary Issues Here Are Very Much The Same – The Decomposing of The Drainage System – Along With The Concerns Regarding The Scheduling Preventive Maintenance

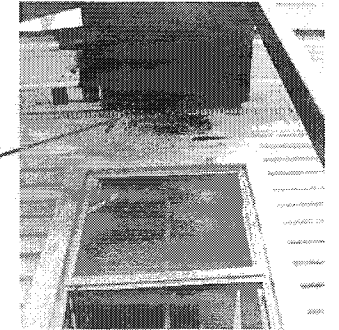
Above- Failed Drainage System  
Below- Full View of This Window  
Requires Attention

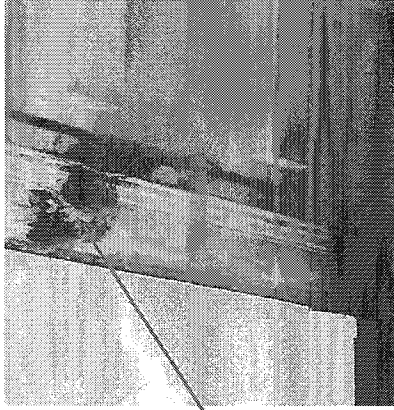
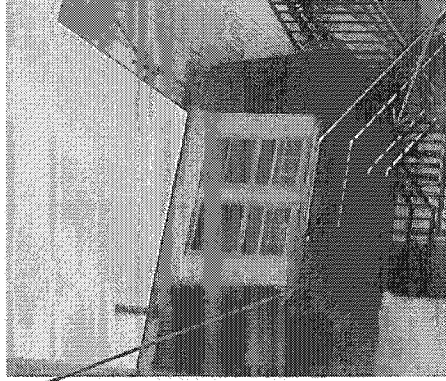
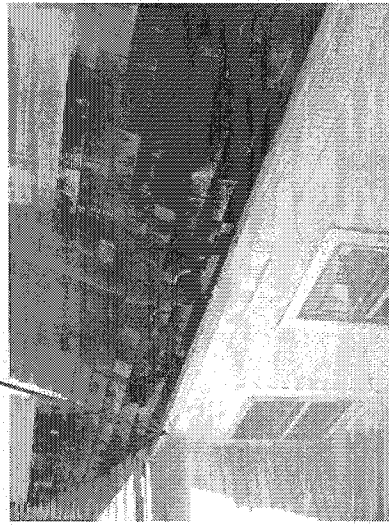
Attic – Northern Elevation -The Staff is Concerned About This Wiring as They Nor Does Their Electrician Understand Where Any of This Leads. There is More Than What is Shown in This Photograph

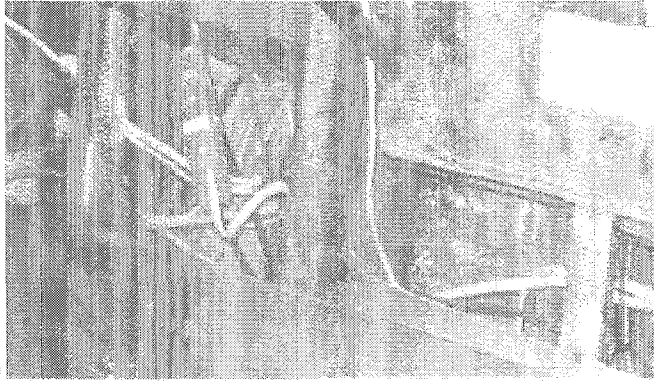
Attic- Southwestern Elevation – Near Water Infiltration – Wicking Chimney. Again Here The Staff Brought This to Our Attention

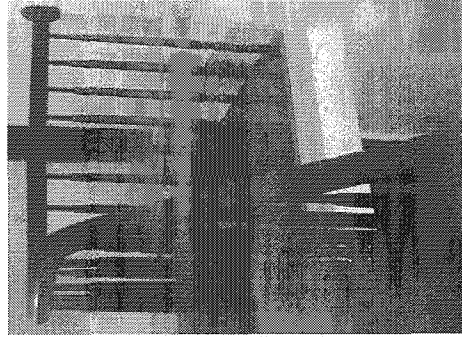
The Separation From Minor Age Settlement  
Is Demonstrated Here
