# TOWN OF WATERFORD

## Application for Inland Wetland / Watercourse Permit

## Design Report

January 2026

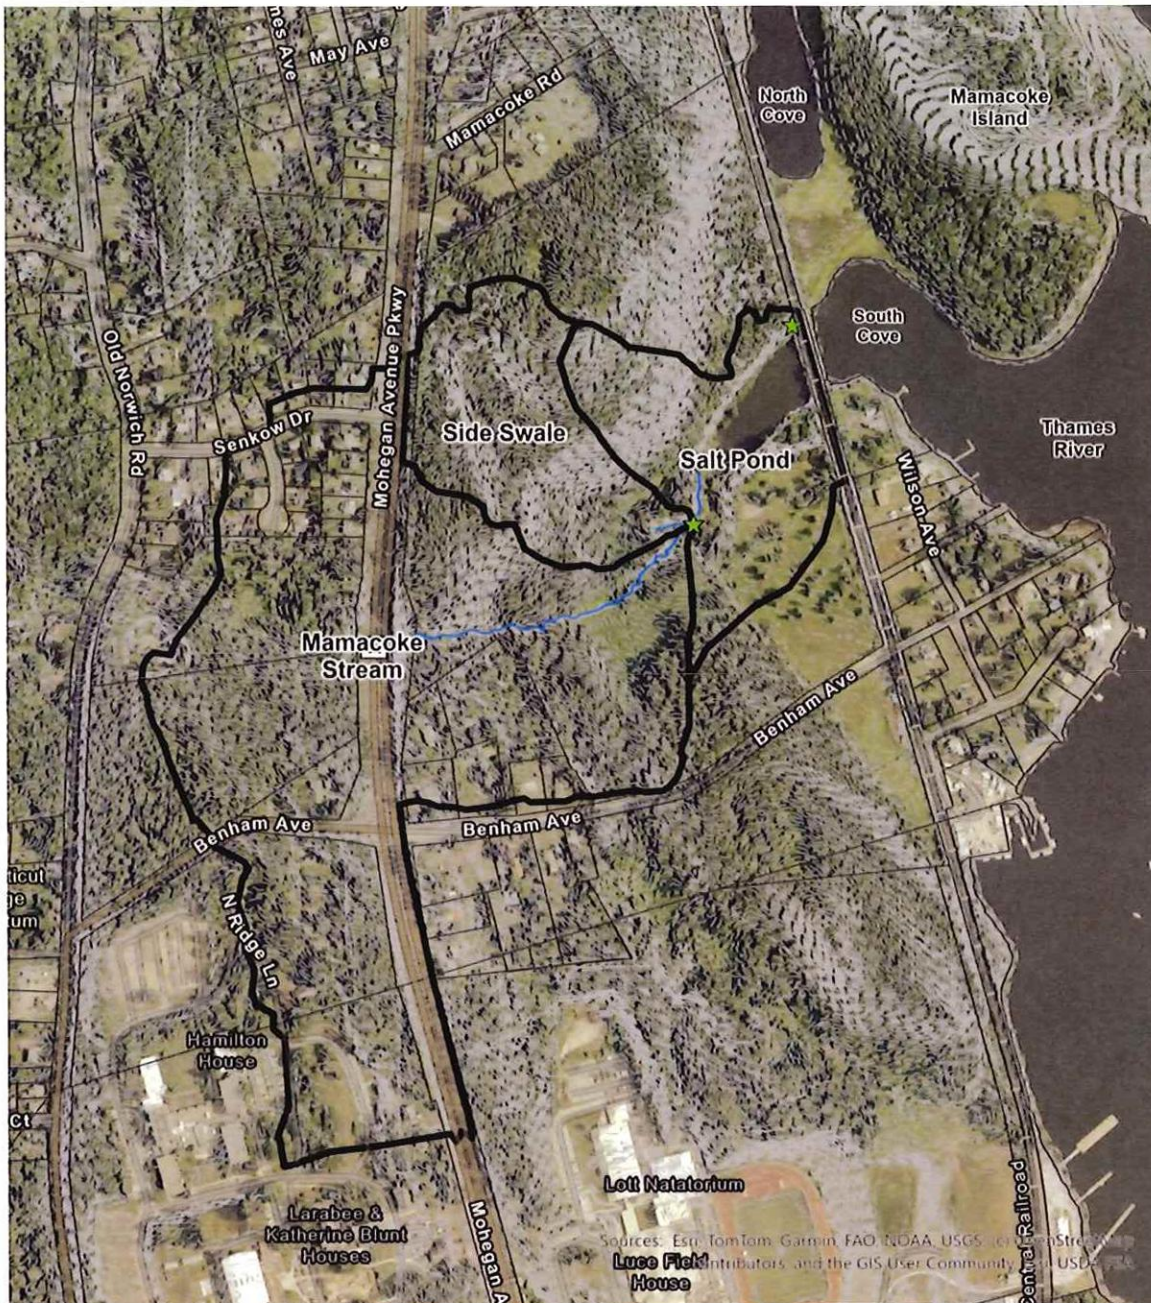
**Figure 3: Drainage Area Map**

Biohabitats identified and evaluated two delineation points and three sub-watersheds for hydrologic analysis throughout the project reach. The overall drainage area includes portions of the Connecticut College Arboretum, residential neighborhoods and College properties west of Route 32, an undeveloped portion of the watershed immediately west of Route 32, and a segment of Route 32 itself. A drainage area map showing the three sub-watersheds is shown below in Figure 3. The watershed contains 14.2% impervious surfaces.

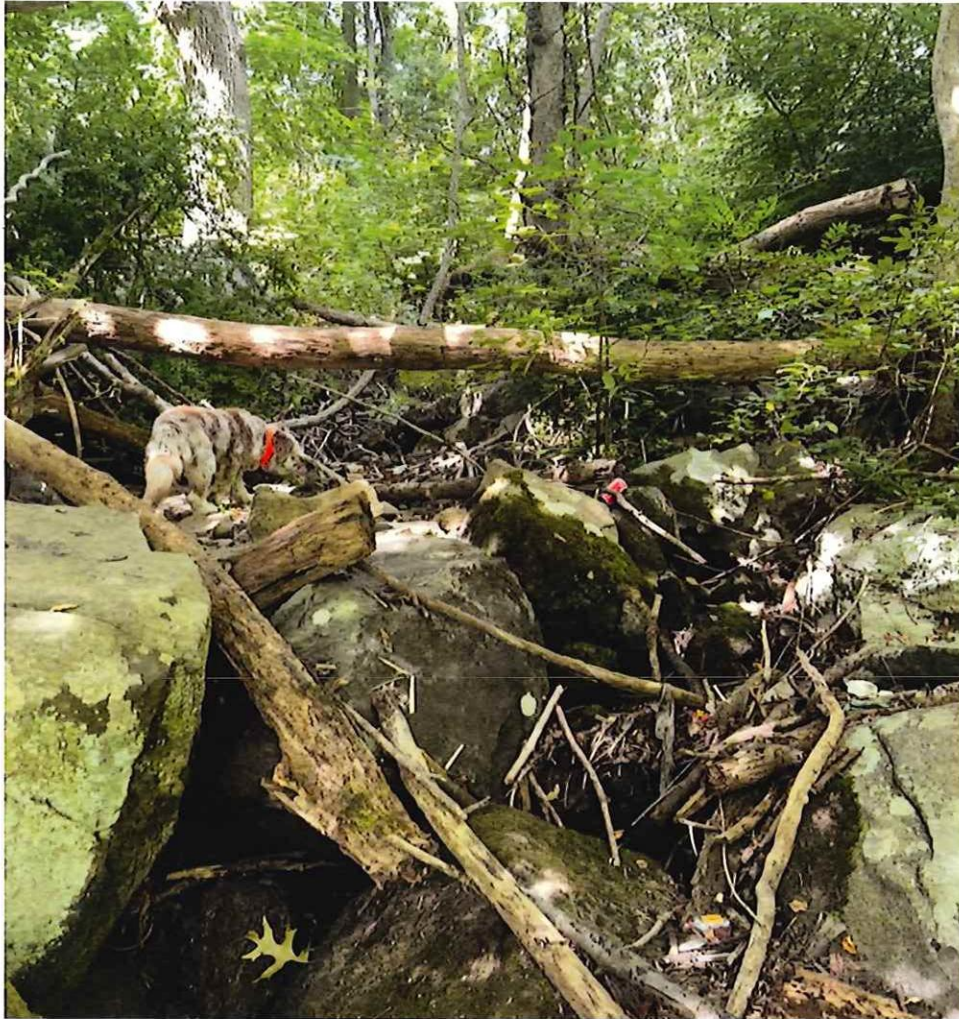
**Figure 7. Typical Reach 1 Stream Condition**

Reach 1 stream channel is a 14% gradient, high energy boulder dominated channel within a forested riparian buffer. The upstream limits of the reach begin at two headwalls located east of Route 32 where four stormwater pipes enter at the top of the system. Despite the initial flow concentrated condition, the channel is relatively stable given the presence of large immobile boulders (approximate D50 of boulders is greater than 4 feet) within the flowpath. There is significant woody material load within or overhanging the channel. There is often not a clear distinction between the channel bed and bank and no obvious bank erosion. Channel planform is very straight and down-valley, the channel was dry during the field survey.

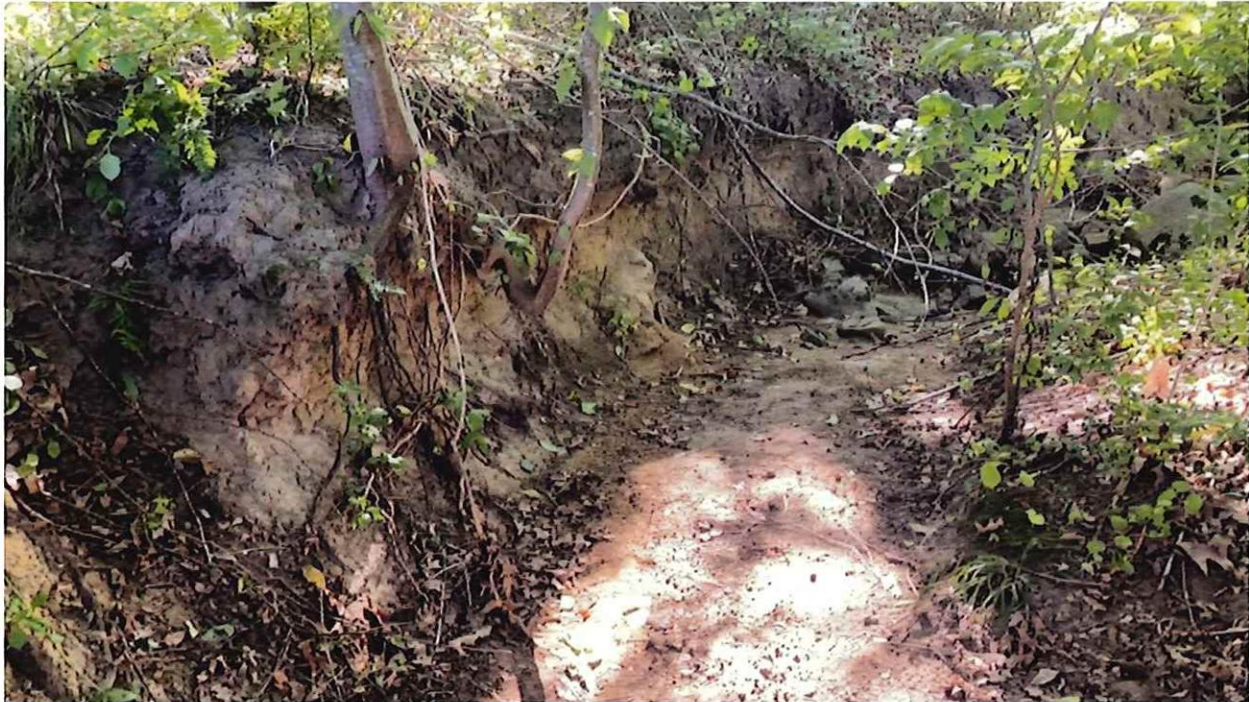
**Figure 8. Typical Reach 2 Stream Condition**

Reach 2 is the most complex of the reaches and is experiencing active headcutting and upstream migration. The upstream limit of the reach begins where a stone wall, located on either side of the channel, once likely crossed the flowpath, near a 90 deg bend at the property line. The stone wall is no longer present within the crossing and has likely fallen into the channel. Similarly, to Reach 1, the upstream half of this reach remains relatively steep and boulder-dominated. However typical boulder size is smaller (approximate D50 of 2 feet) and the channel has downcut and widened around the boulder dominated channel bed, resulting in less consistent grade control provided by the boulders. There is a wooden pedestrian footbridge spanning the channel approximately halfway through this reach. Immediately upstream and downstream of the pedestrian bridge the channel exhibits significant erosion, including downcutting to bedrock exposure. Impacts of erosion are evident in the existence of the bridge itself, this crossing was previously a low water crossing and

was replaced with the footbridge in recent years due to the need to span the incising channel. This location is the upstream extent of a knickpoint caused by active headcutting and channel enlargement. There are some gaps in canopy cover throughout this reach, and significantly less woody material load than Reach 1. Although the majority of the reach is within a forest, the downstream does extend into the meadow. The overall channel slope is 7% and the channel was dry during the field survey.

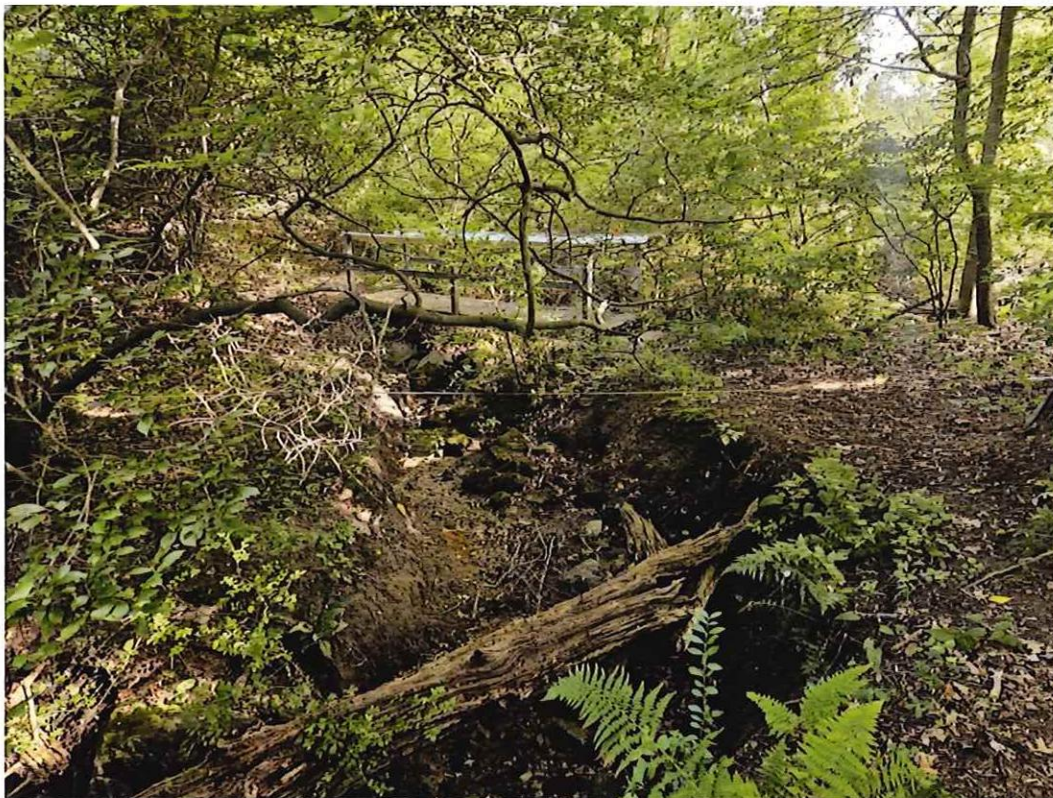
**Figure 9. Reach 2 Cross Section**

A geomorphic cross section (oriented in the downstream direction, perpendicular to stream flow) was surveyed in Reach 2, the reach which is experiencing the most active erosion. The cross section was surveyed at a location which represented typical channel condition, had a bankfull indicator and evidence of recent particle deposition. The longitudinal reach profile was obtained from the field-survey completed by MCA. A Wolman pebble count of the existing channel substrate was performed at the surveyed cross section. This data was processed and evaluated in the Reference Reach Spreadsheet (Mecklenburg 2006). The Mecklenburg spreadsheet uses the Manning equation for discharge given the bankfull elevation, local channel geometry, slope, and Manning's roughness coefficient. The Manning's roughness coefficient "n," was approximated using the results of the Wolman pebble

count to account for bed material roughness, as well other factors that influence channel roughness observed in the field.

Results from the Mecklenburg spreadsheet bankfull discharge calculations are compared to the hydrological model results outlined in Section 2.5 above and are used to inform proposed channel sizing. Bankfull measurements were recorded as a width of 7.1 feet, mean depth of 0.8 feet and a cross-sectional area of 5.7 square feet. Average grain size from the pebble count was D50 of 8.8 mm (gravel). The bankfull discharge was calculated at 45.4 cfs, which falls between the 2 and 5-year storm hydrologic model results. While this bankfull discharge trends higher than typically anticipated bankfull recurrence intervals, it makes sense given the intermittent stream condition and relatively small drainage area.

Additional geomorphic ratios include the bank height ratio and entrenchment ratio, both of which can be used to quantitatively assess the vertical containment of a river. For the surveyed section location, the bank height ratio was calculated at 2.1 (deeply incised) and the entrenchment ratio was calculated at 1.1 (entrenched). See the Mecklenburg cross section spreadsheet in Appendix E.

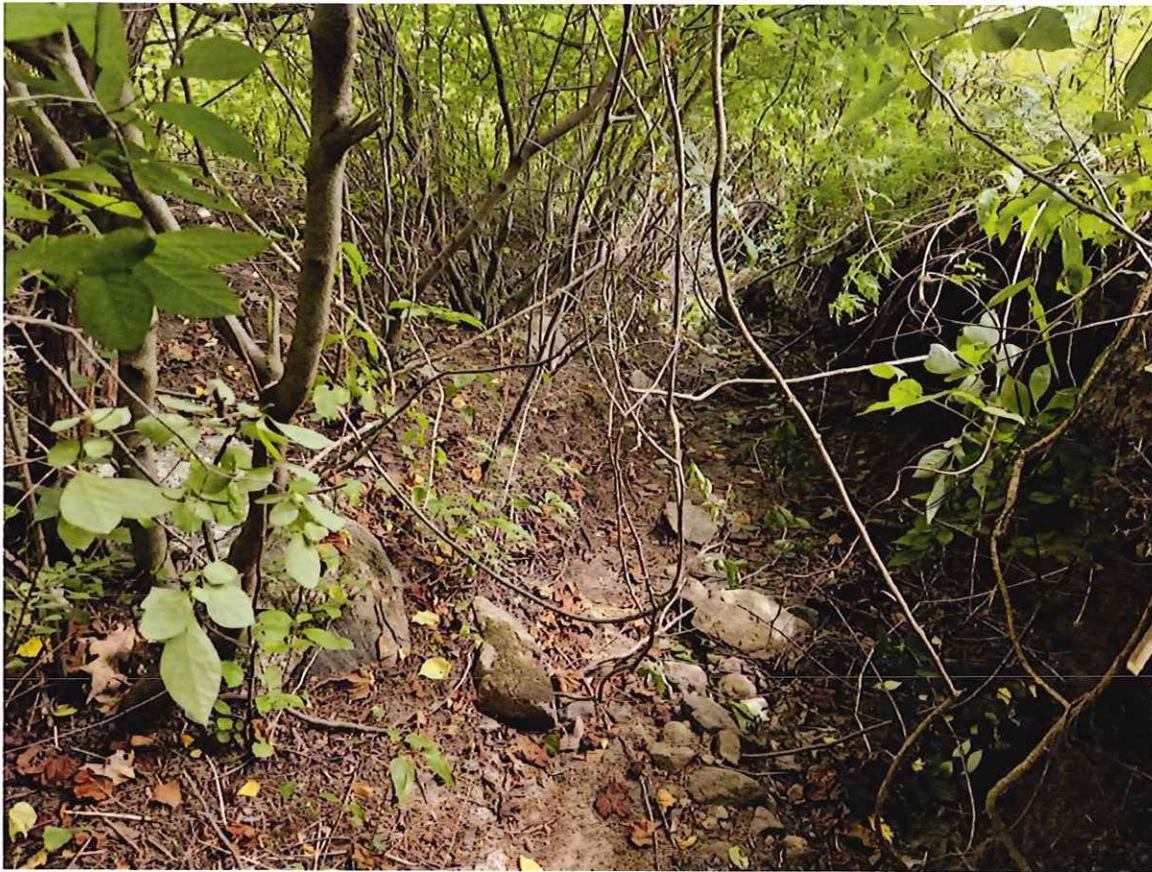
**Figure 11. Typical Reach 3 Stream Condition**

Reach 3 generally is an incised channel due to past headcut migration through it, dominated by actively eroding streambank. A 24" reinforced concrete pipe and timber mat bridge cross partway through this reach. This culvert was recently damaged during a storm event and replaced in its current configuration as a temporary measure. Some portions of the stream banks downstream of the 24" RCP show signs of past failure and are beginning to re-stabilize and re-vegetate.

The reach lacks floodplain connection and consistent bed protection throughout, select embedded boulders as well as the 24" RCP pipe have maintained channel profile at discrete spot locations. The streambed is mainly composed of sediment deposition (silt, sand and gravel), small boulders, and cobble-sized material. The overall slope of Reach 3 is 7%, however the downstream-most 40 feet of this reach lessens in gradient and widens, thus improving the relative stability of the channel at this location. The majority of this reach runs through the meadow and has either a narrow, immature treed streamside buffer or no treed buffer at all. Reach 3 was dry during field survey.

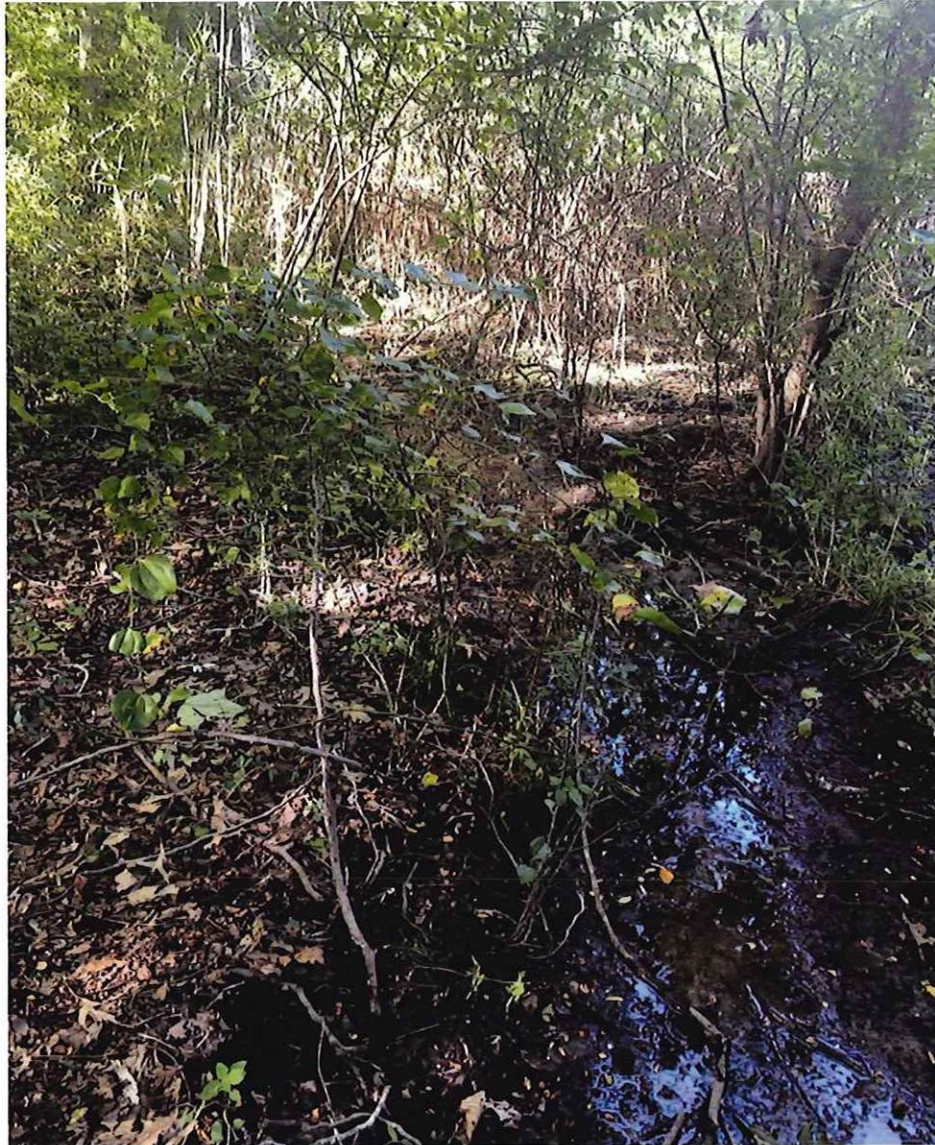
**Figure 12. Typical Reach 4 Stream Condition**

Reach 4 is visually and morphologically different than the upstream three reaches. It is a perennial, low-sloped channel that feeds into, and is likely occasionally backwatered by, the Mamacoke Salt Pond. A stable, well-connected channel (banks less than 1 foot), the channel runs along the toe of slope on the west side of the valley. A side channel joins the flowpath here that originates from the west. The bed material consists of silt and sand. The floodplain is stable but dominated by phragmites. The entirety of reach 4 was delineated by a wetland.
