Niantic River Road Erosion Report

Approved December 1, 2021

## Waterford Flood & Erosion Control Board Special Meeting Minutes for October 6, 2021

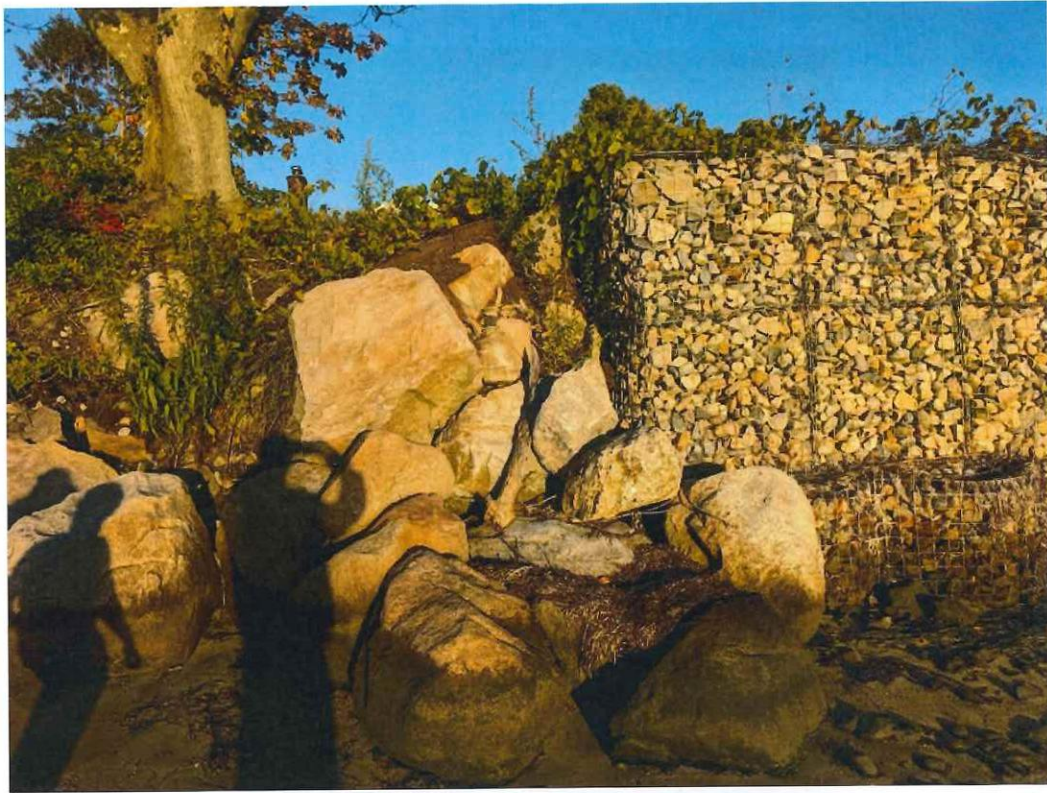
- c. The existing erosion control consists of large boulders that were placed along the beach at the base of the bank. The river flows freely in & around the boulders eroding the base of the bank. Vegetation is present on the bank however; it is not of the types that would help to absorb or stabilize any runoff.

End of the erosion barrier and the beginning of the eroding bank.

We strongly recommend that a professional survey of this area be completed to prevent any risk to the integrity of Niantic River Road. Possible solutions may depend on the significance of the erosion underneath the road, but will likely require the extension of the erosion barriers across this section of the embankment.

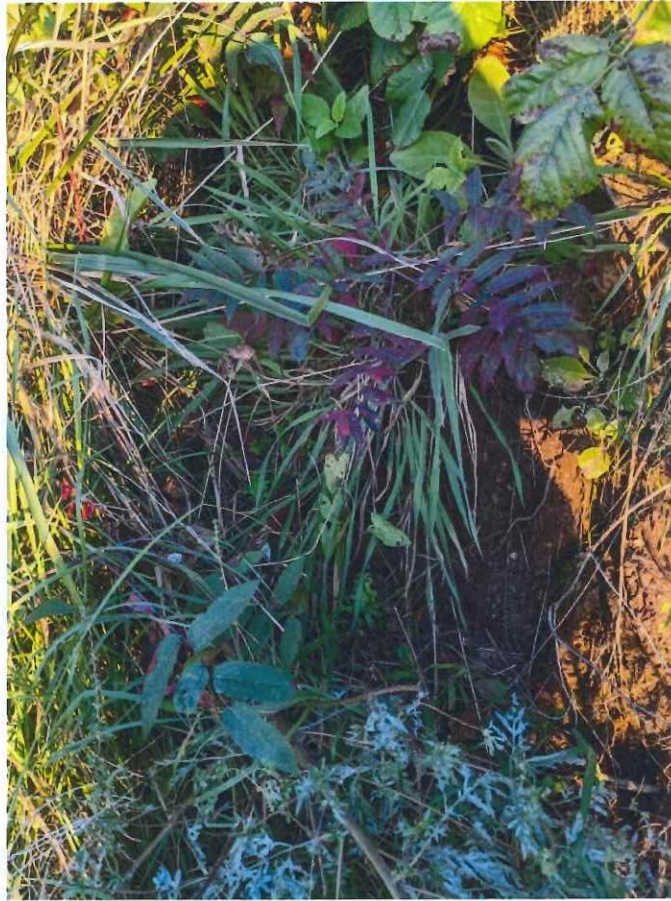
- d. Additionally, previous strong storms have produced runoff that flows across the road & flows down the bank causing further erosion of the bases of the 5 power poles and the edge of Niantic River Road.

Evidence of erosion underneath the road surface.
