**2021 Monitoring Report**

**Seaview Terrace  
305-317 Rope Ferry Road  
Waterford, Connecticut**

May 3, 2021

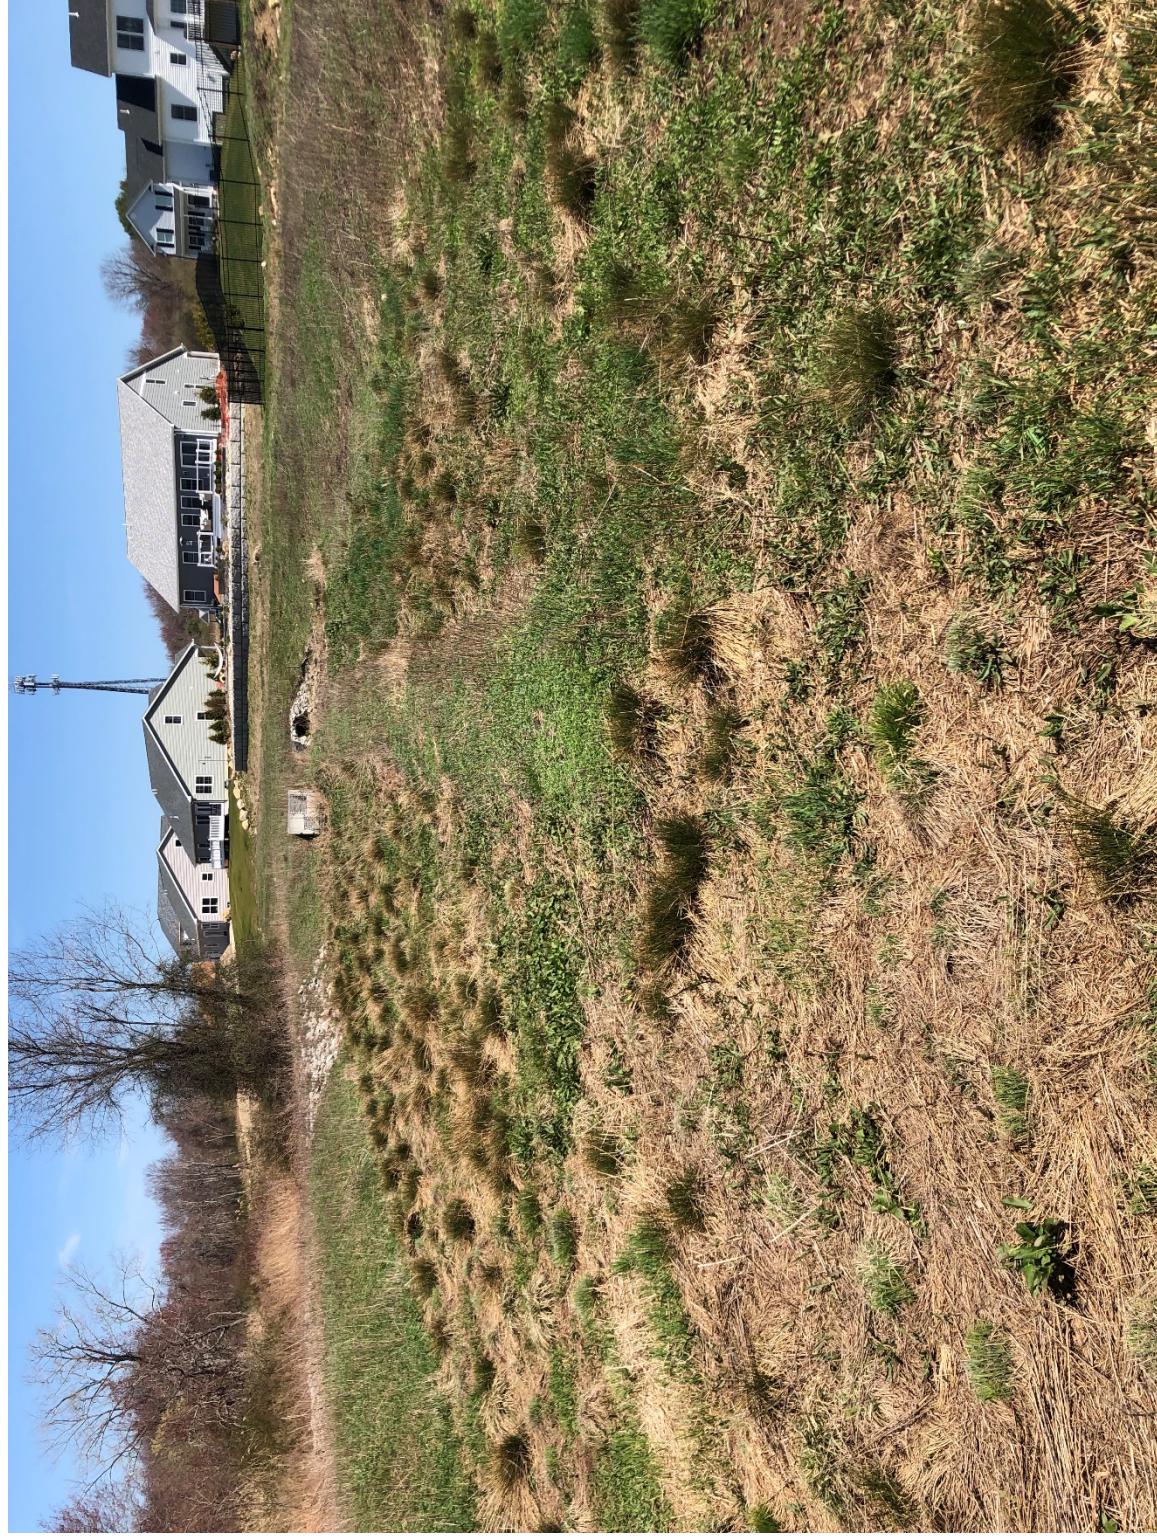
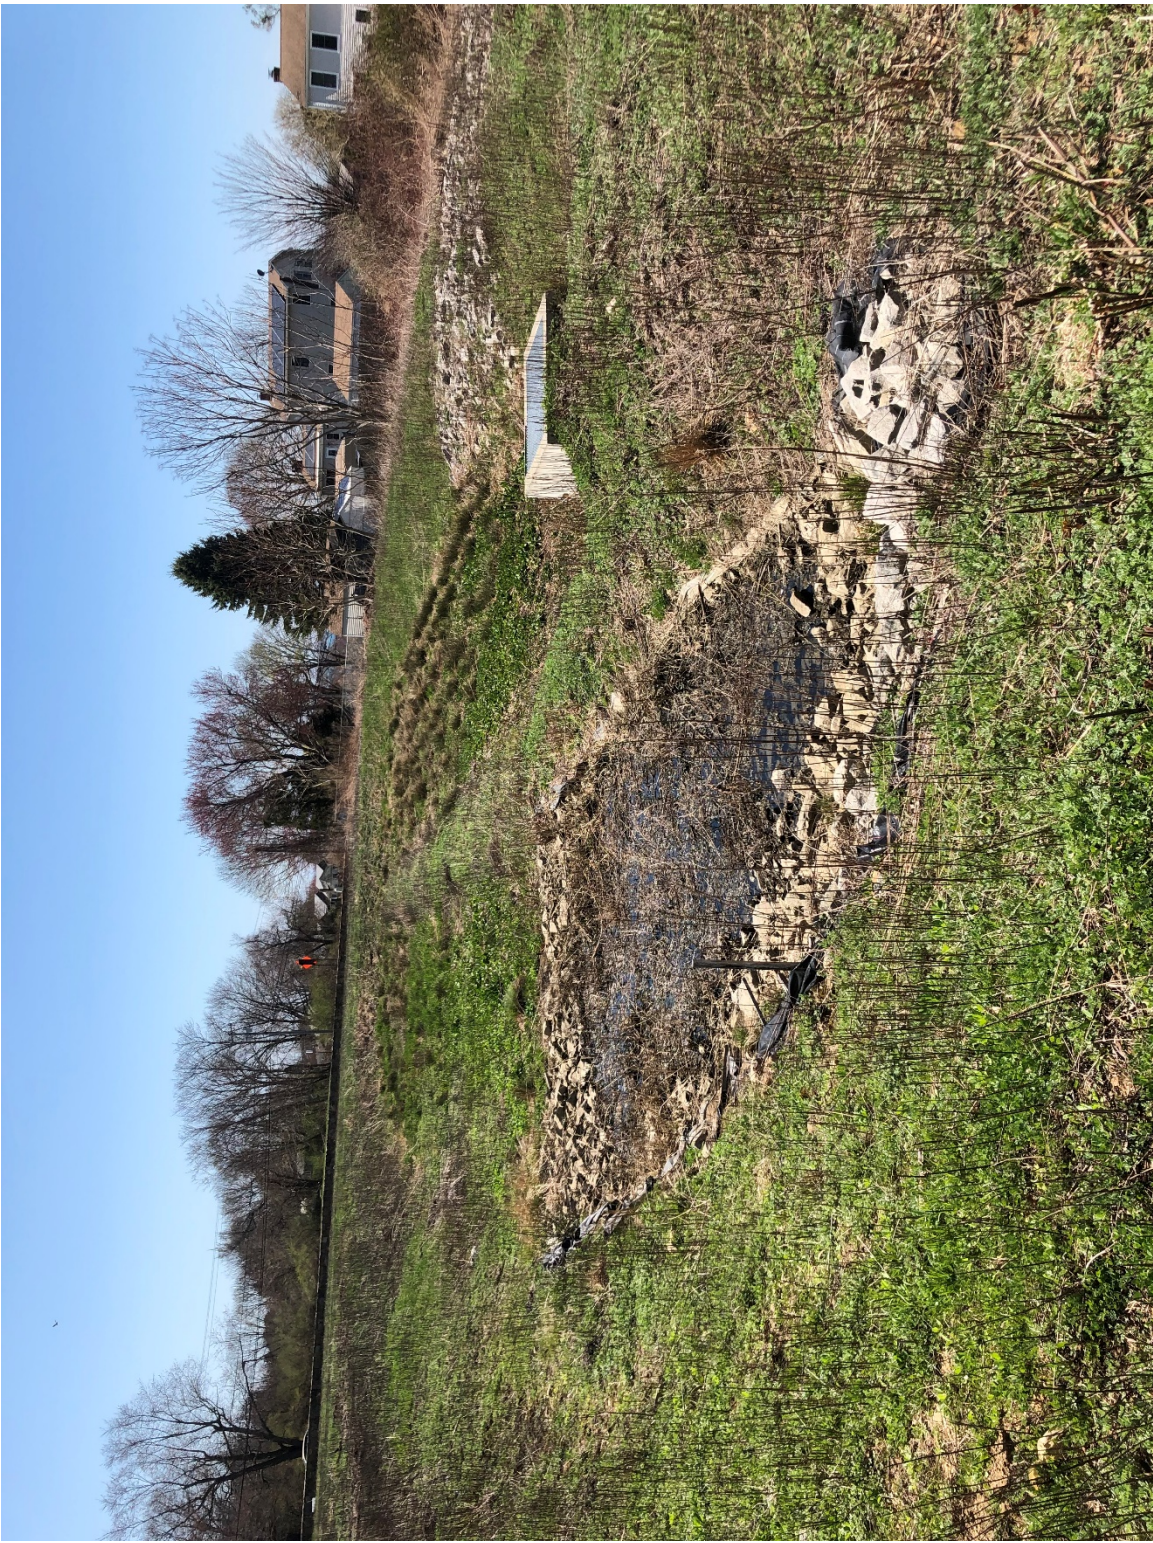
Southwestern Biofilter  
April 14, 2021

Some of the herbaceous plant species could not be identified because the biofilter basin has been mowed and due to the time of the year. The dominant vegetation is Tussock Sedge, Wool Sedge, Curl Dock, Soft Rush, Goldenrod, Reed Canary Grass and Bidens. Phragmites is growing in the forebay. Mugwort is the dominant plant species growing on the central berm and side slopes of the biofilter. The biofilter basin is fully vegetated and the side slopes are stabilized. There is no sediment in the rip-rap spillway.

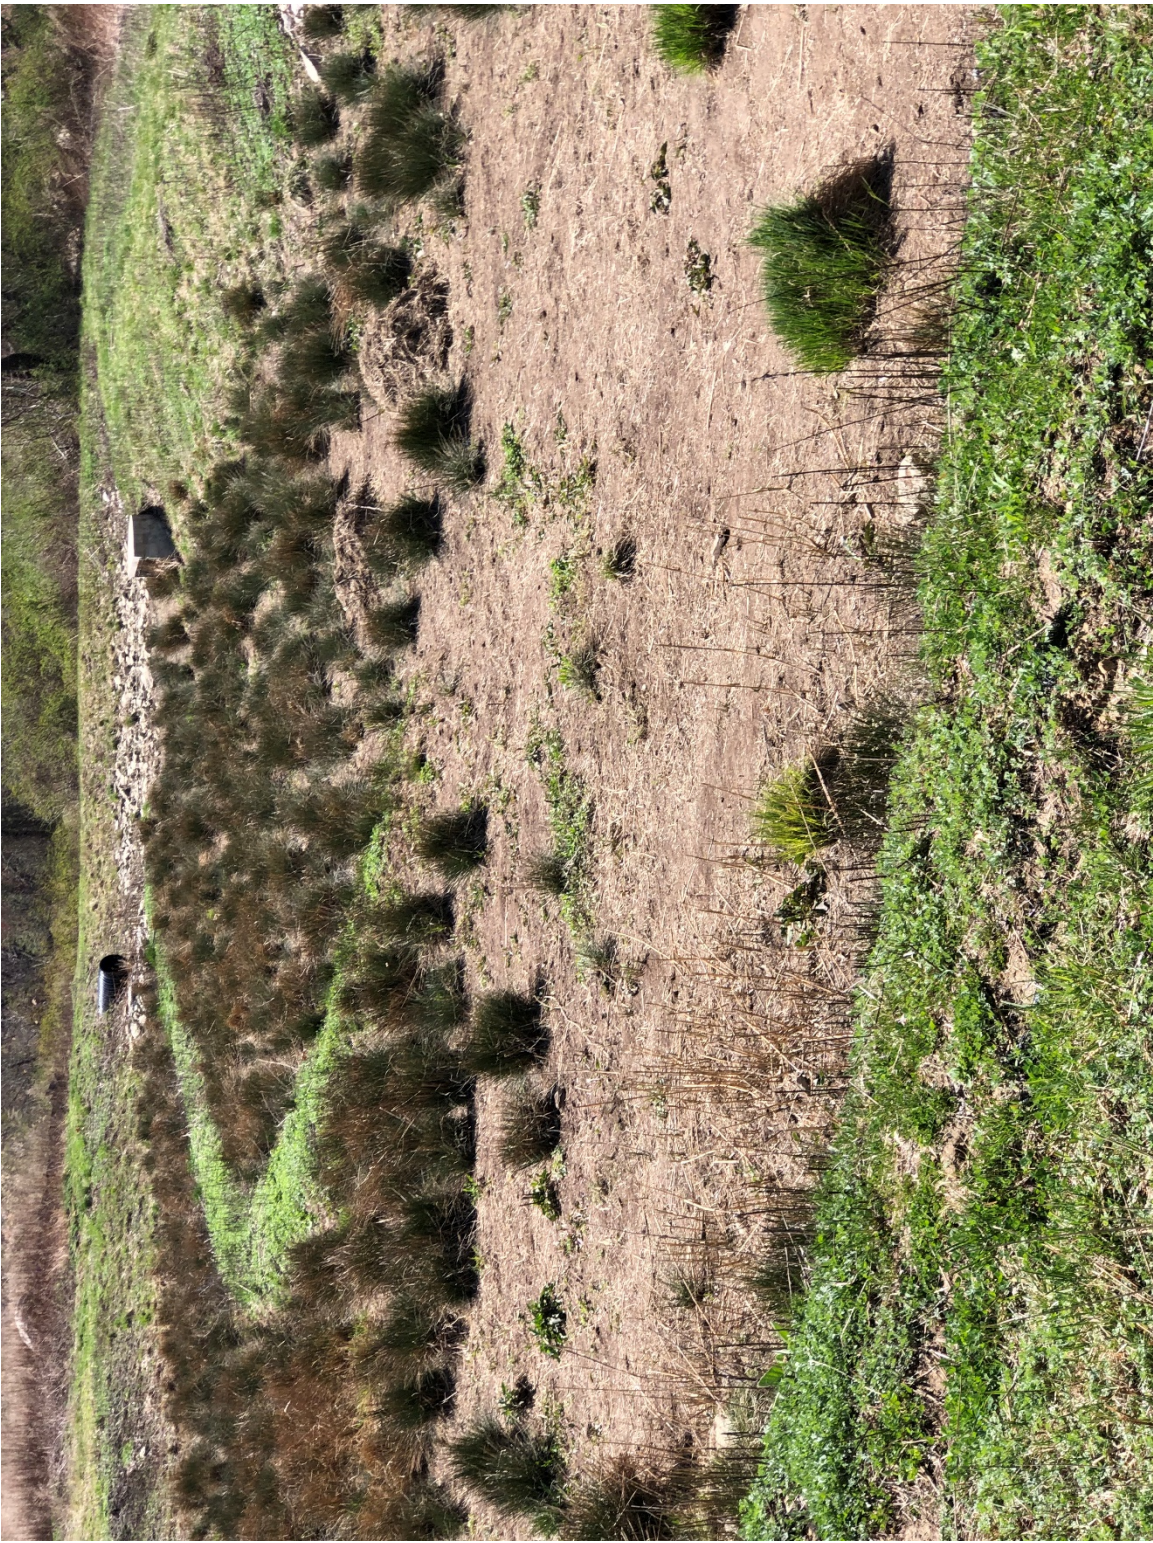
Northern Biofilter Basin  
April 14, 2021

Soft Rush occupies approximately 95 percent of the basin. Other species include Tussock Sedge, Curl Dock and Goldenrod. The basin has been mowed and was being hand raked the day of monitoring. Mugwort is the dominant plant species on the side bank of the biofilter basin. Sediment (silt) is abundant in the forebay and some of the rip-rap spillway.

1. Replace the rip-rap and sediment in the forebay of the northern biofilter.
2. Remove the branches and 2"x6" board in the watercourse.
3. I believe replanting the shrubs in the wetland buffer area east of the pond is not practical due to the area being dominated by Phragmites and Mugwort, which are an exotic invasive plant species.

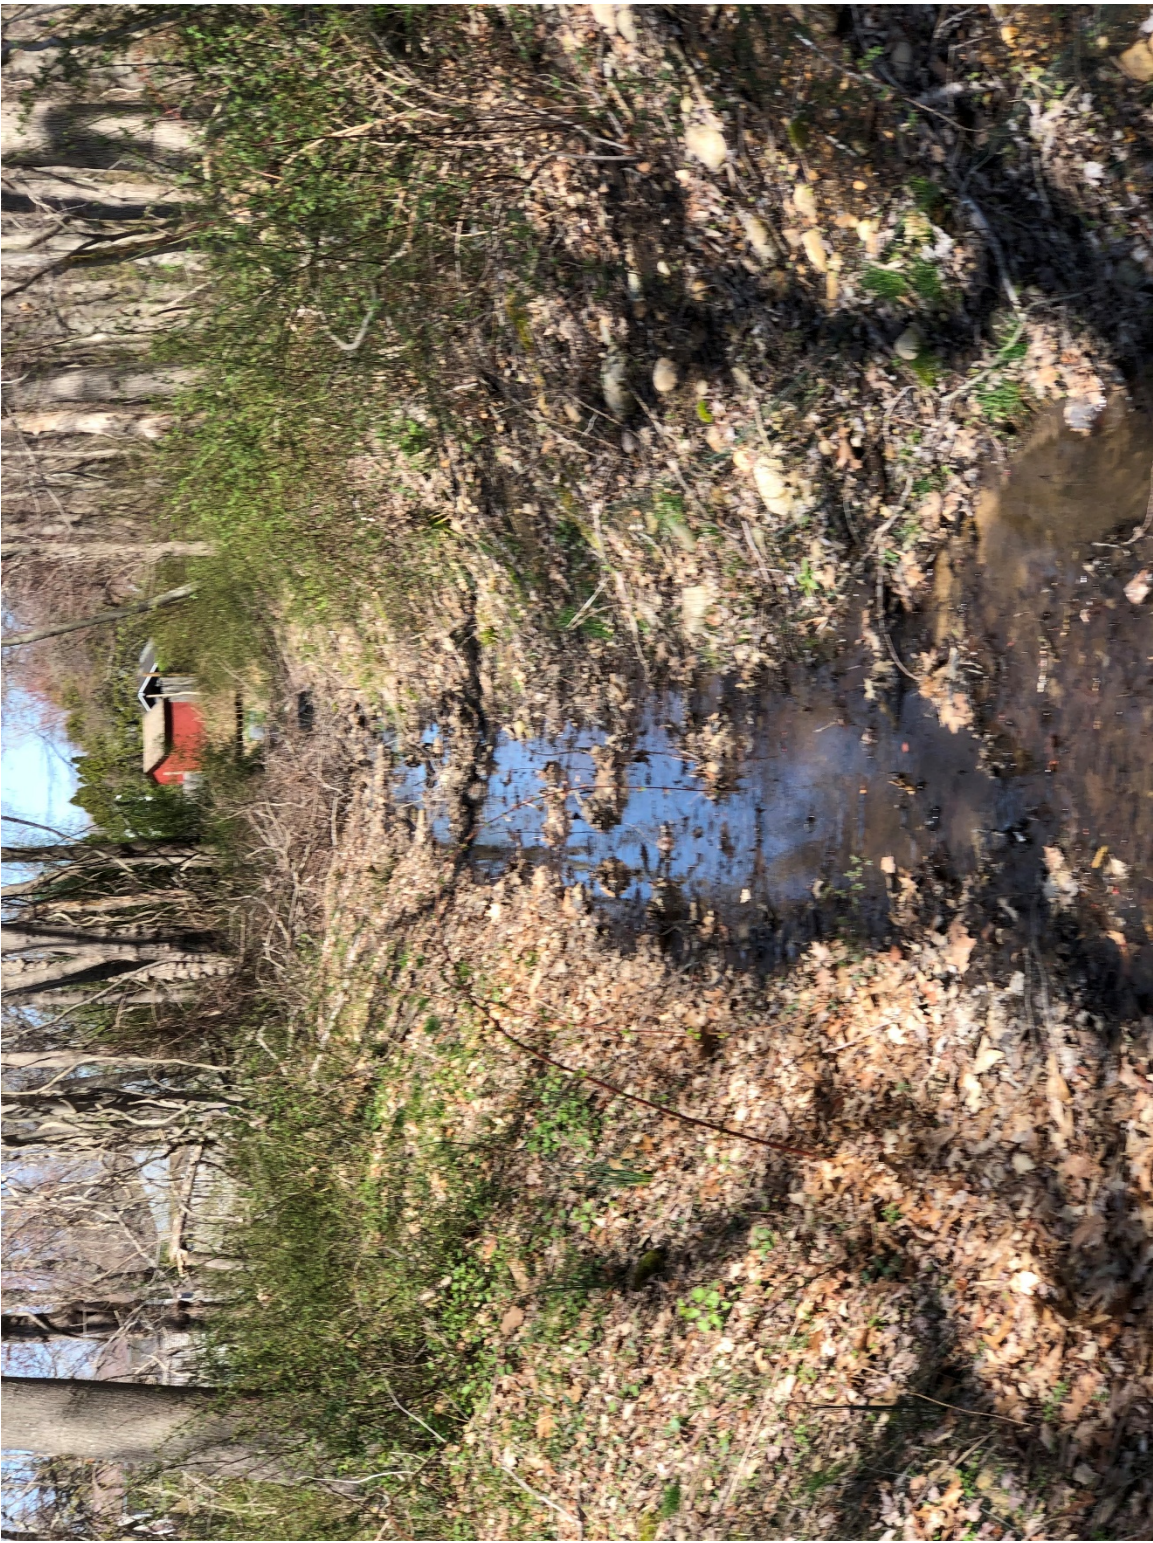
Restored Wetland/Watercourse – Northern View  
April 14, 2021

The vegetation species in and on the side banks of the watercourse includes Reed Canary Grass, Multiflora Rose and Skunk Cabbage. Vegetation in the watercourse is sparse, as was the case in 2019. There is a thin silt film on the leaves in the watercourse. There is no erosion in the channel or side bank. There are several large branches and a 2"x6" board in the watercourse.
