**2021 Monitoring Report**

**Seaview Terrace  
305-317 Rope Ferry Road  
Waterford, Connecticut**

November 30, 2021

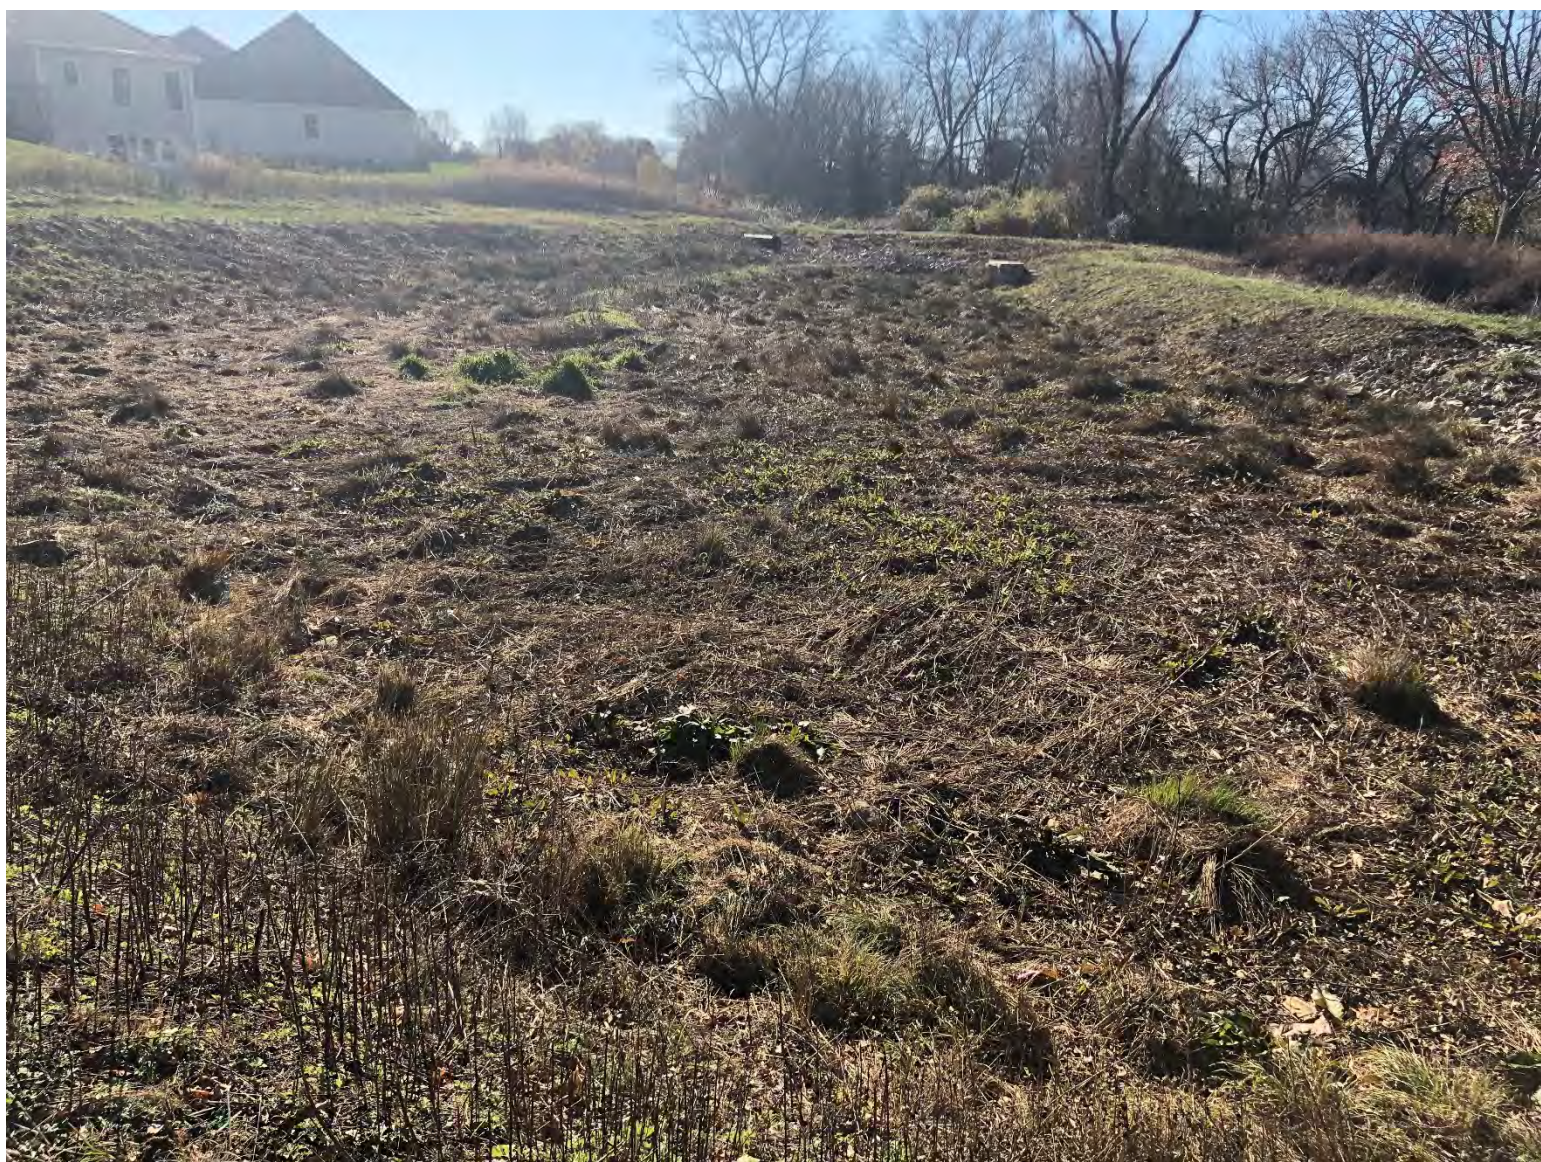
Southern view of the northern biofilter

The basin was cut earlier in the year. Soft Rush occupies approximately 85 percent of the basin. Other plant species include Curl Dock, Bidens, and Goldenrod. The basin has been mowed and was being hand raked the day of monitoring. Mugwort is the dominant plant species on the side bank of the biofilter. The riprap in the forebay was replaced and there was no silt sediment. In 2020, silt sediment was abundant in the forebay.

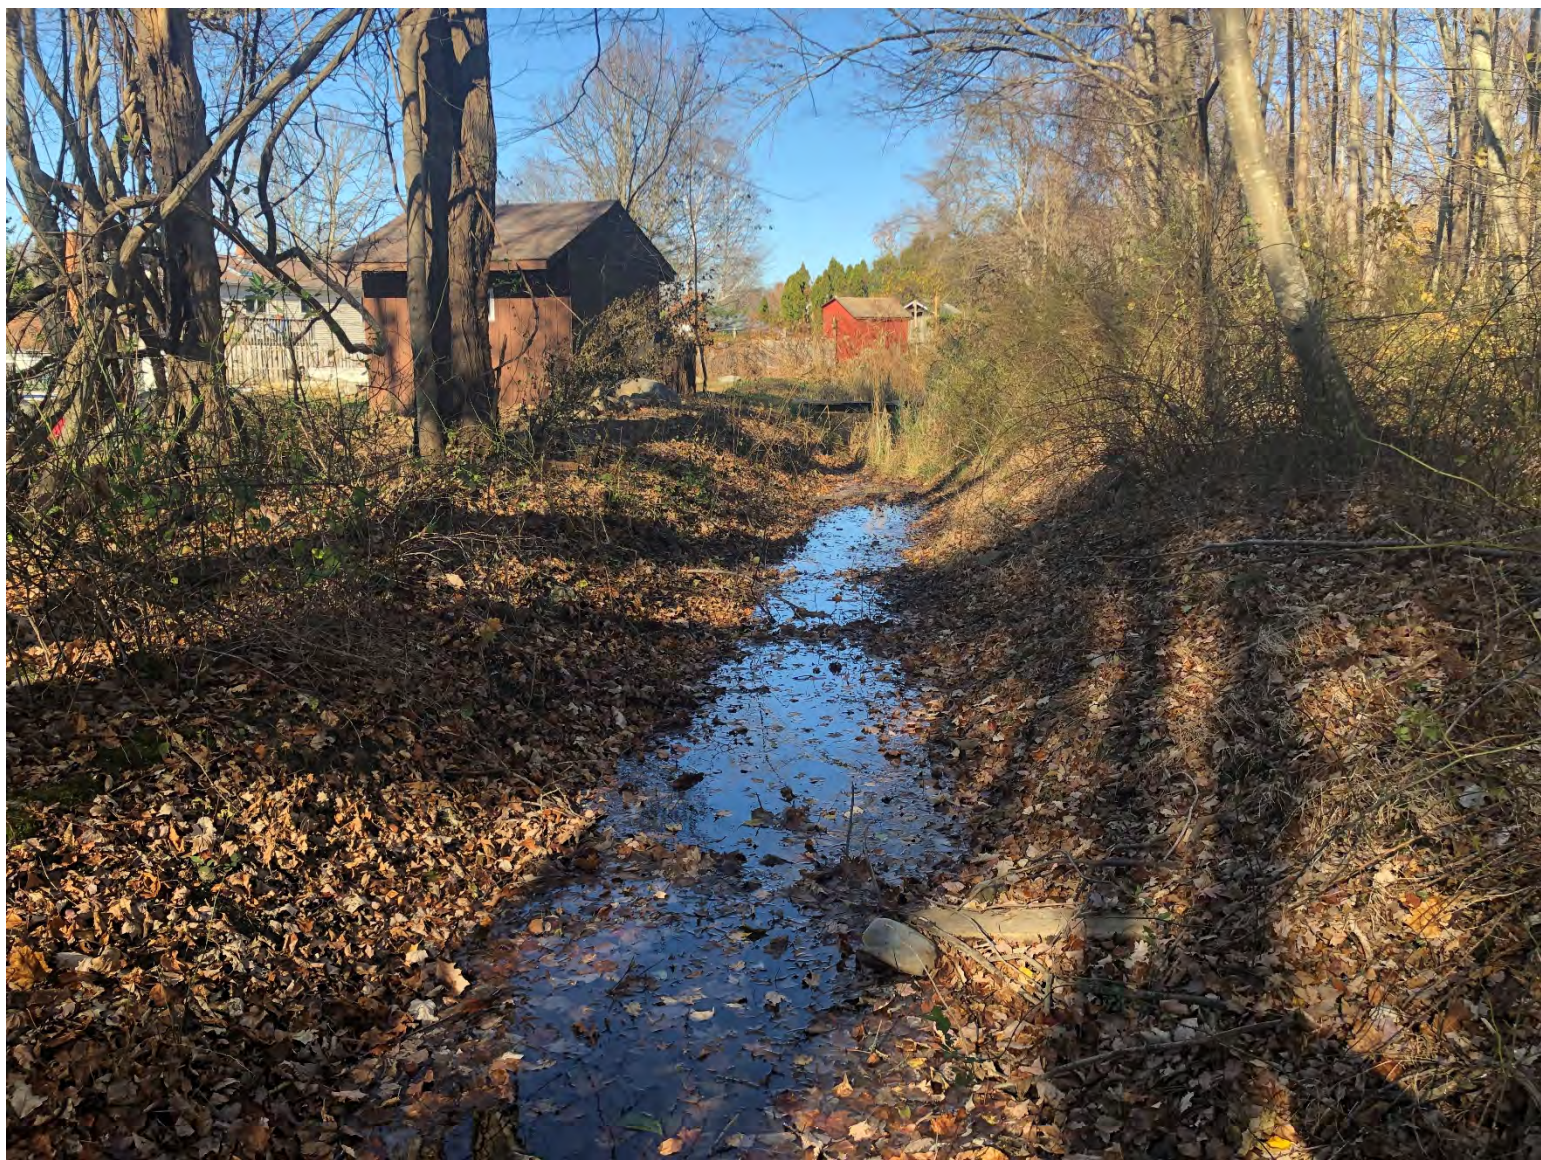
Northern view of restored wetland swale

The wetland swale has a leaf cover with very sparse vegetation. Reed Canary Grass is growing in the swale. The vegetation growing on the side slopes of the swale includes Multiflora Rose and Goldenrod. There is no recent sediment present in the swale. There is no erosion in the swale or the side slopes.

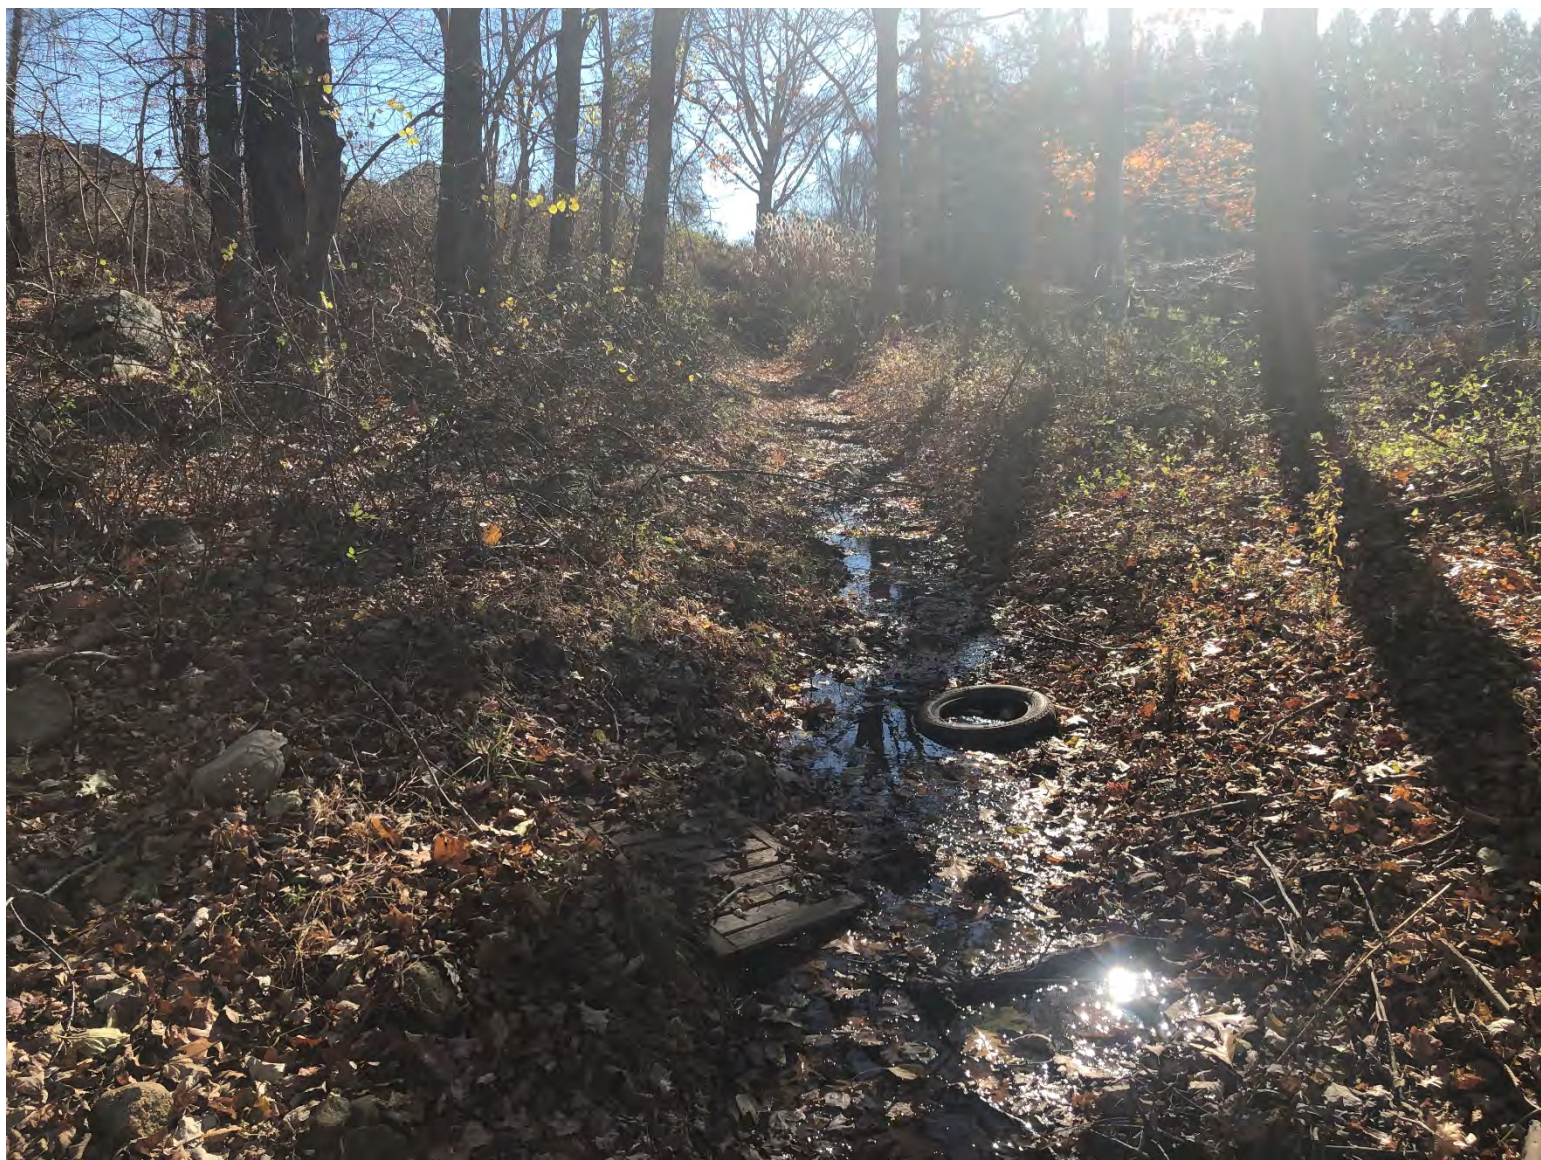
Southern view of the restored wetland swale

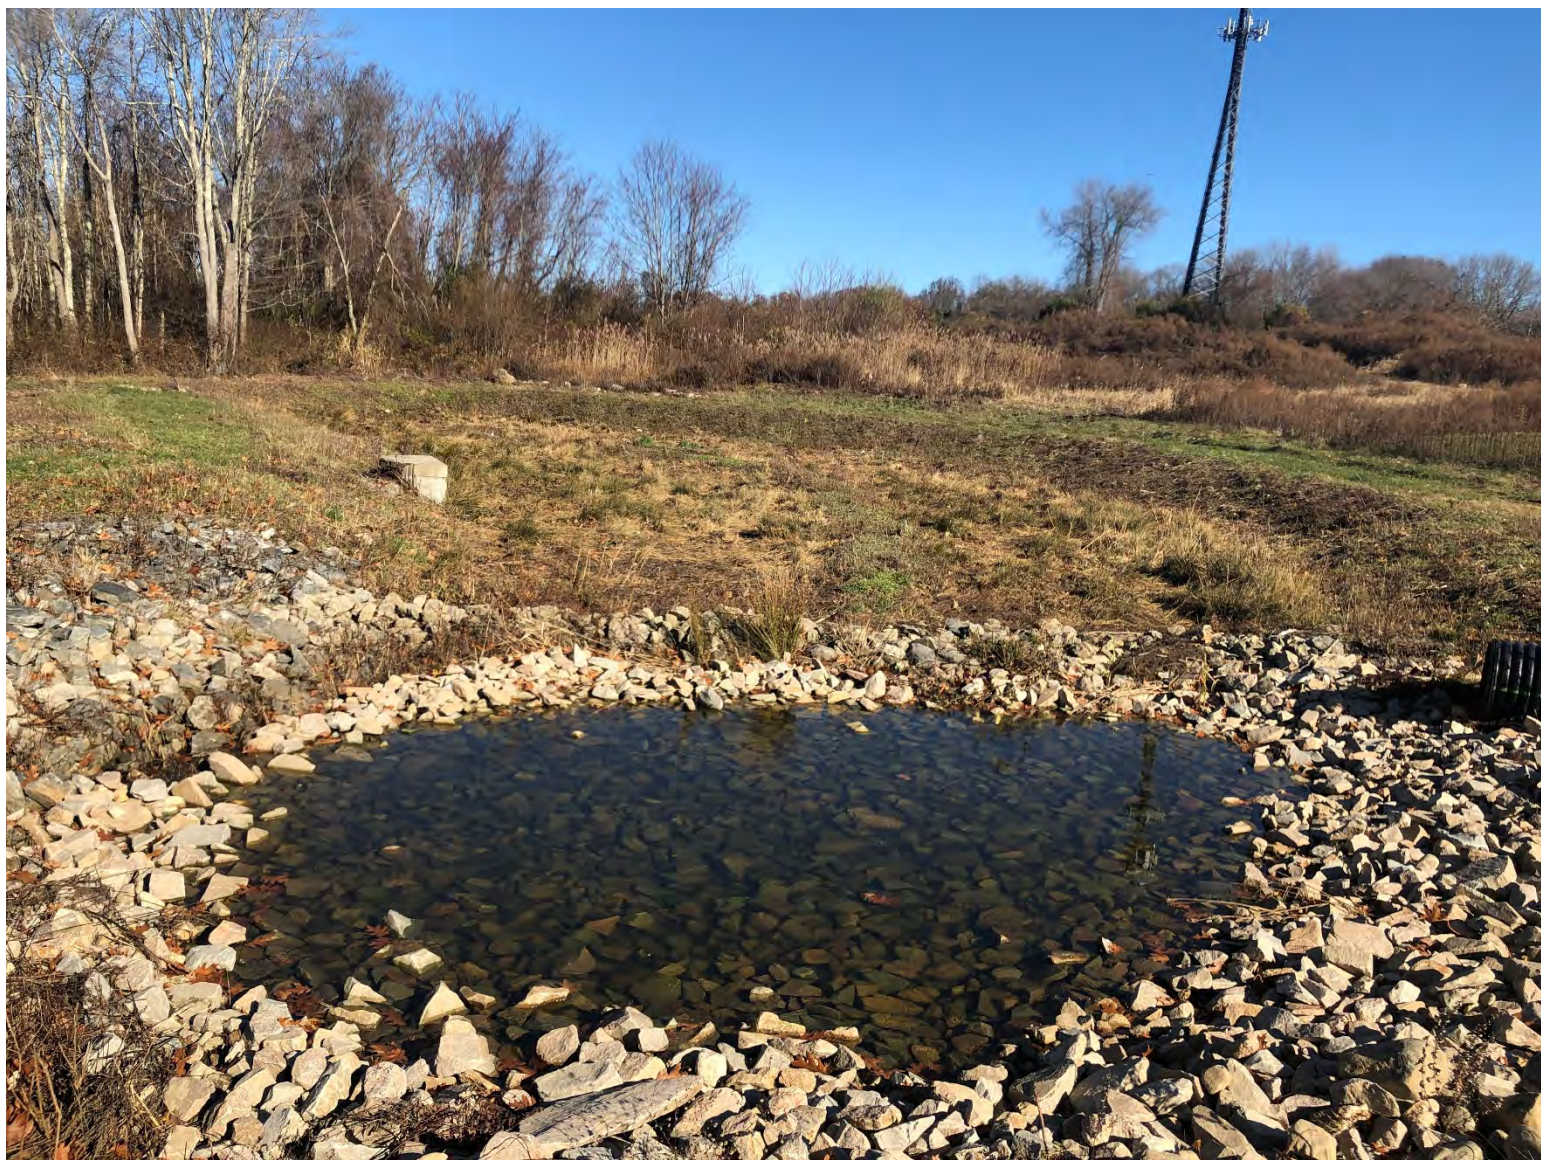
Northern view of northern biofilter

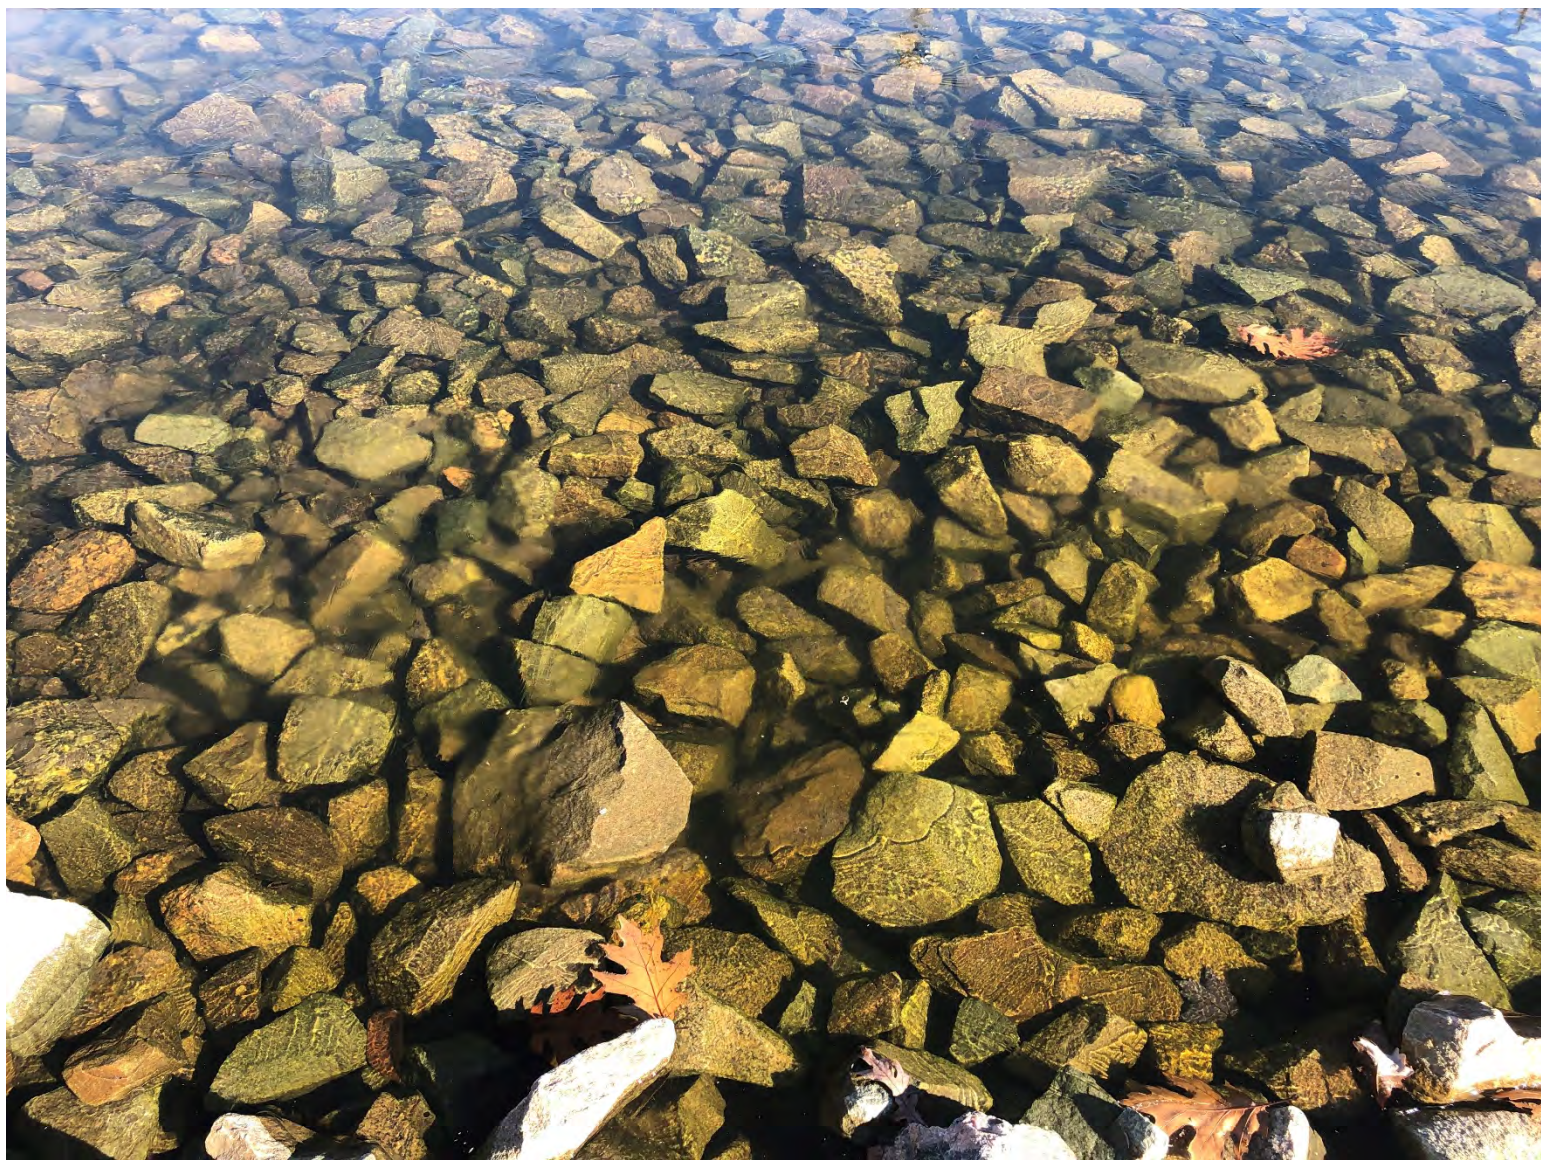
Replaced riprap in northern biofilter forebay

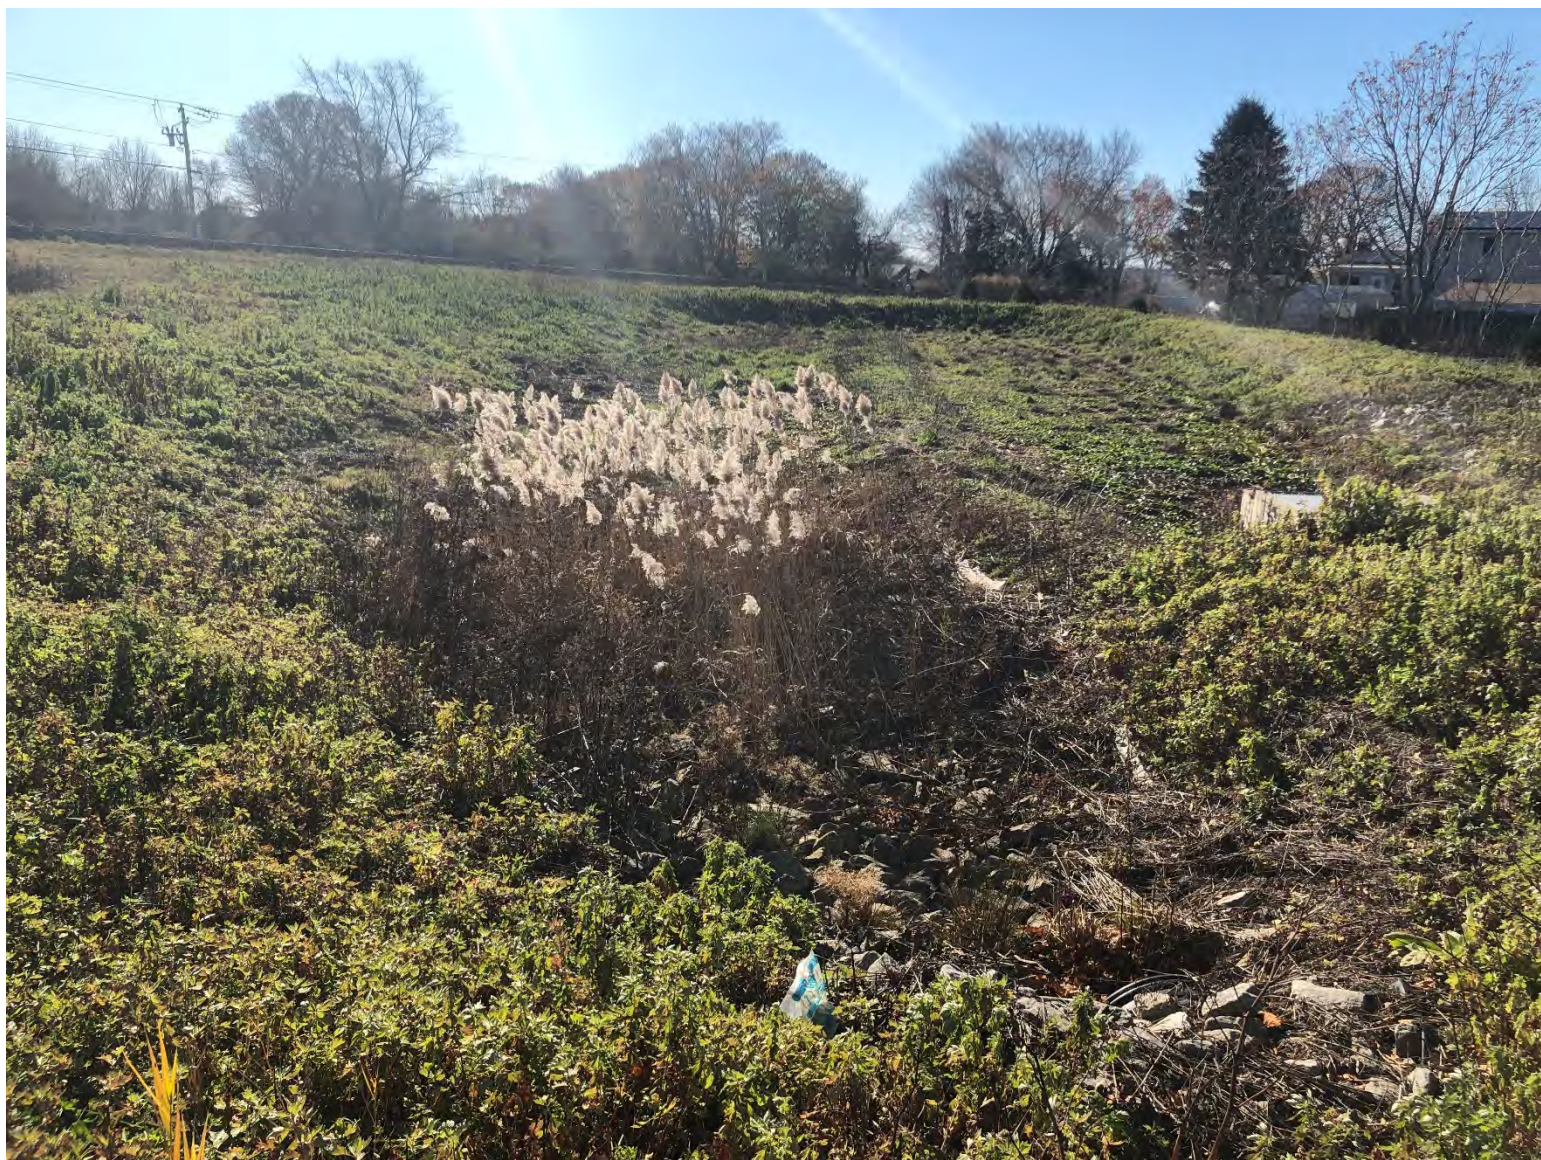
Southern view of southwestern biofilter

The basin was cut earlier in the year. The dominant plant species in the basin are Curl Dock and Soft Rush. Other plant species include Reed Canary Grass, Bidens, Tussock Sedge, and Wool Grass. Phragmites is growing in the forebay as noted in the previous monitoring report. Mugwort (exotic invasive) is the dominant species growing on the side slopes and central berm, also noted in the previous monitoring report. The biofilter is fully vegetated and the side slopes are established. There is no sediment in the riprap spillway.

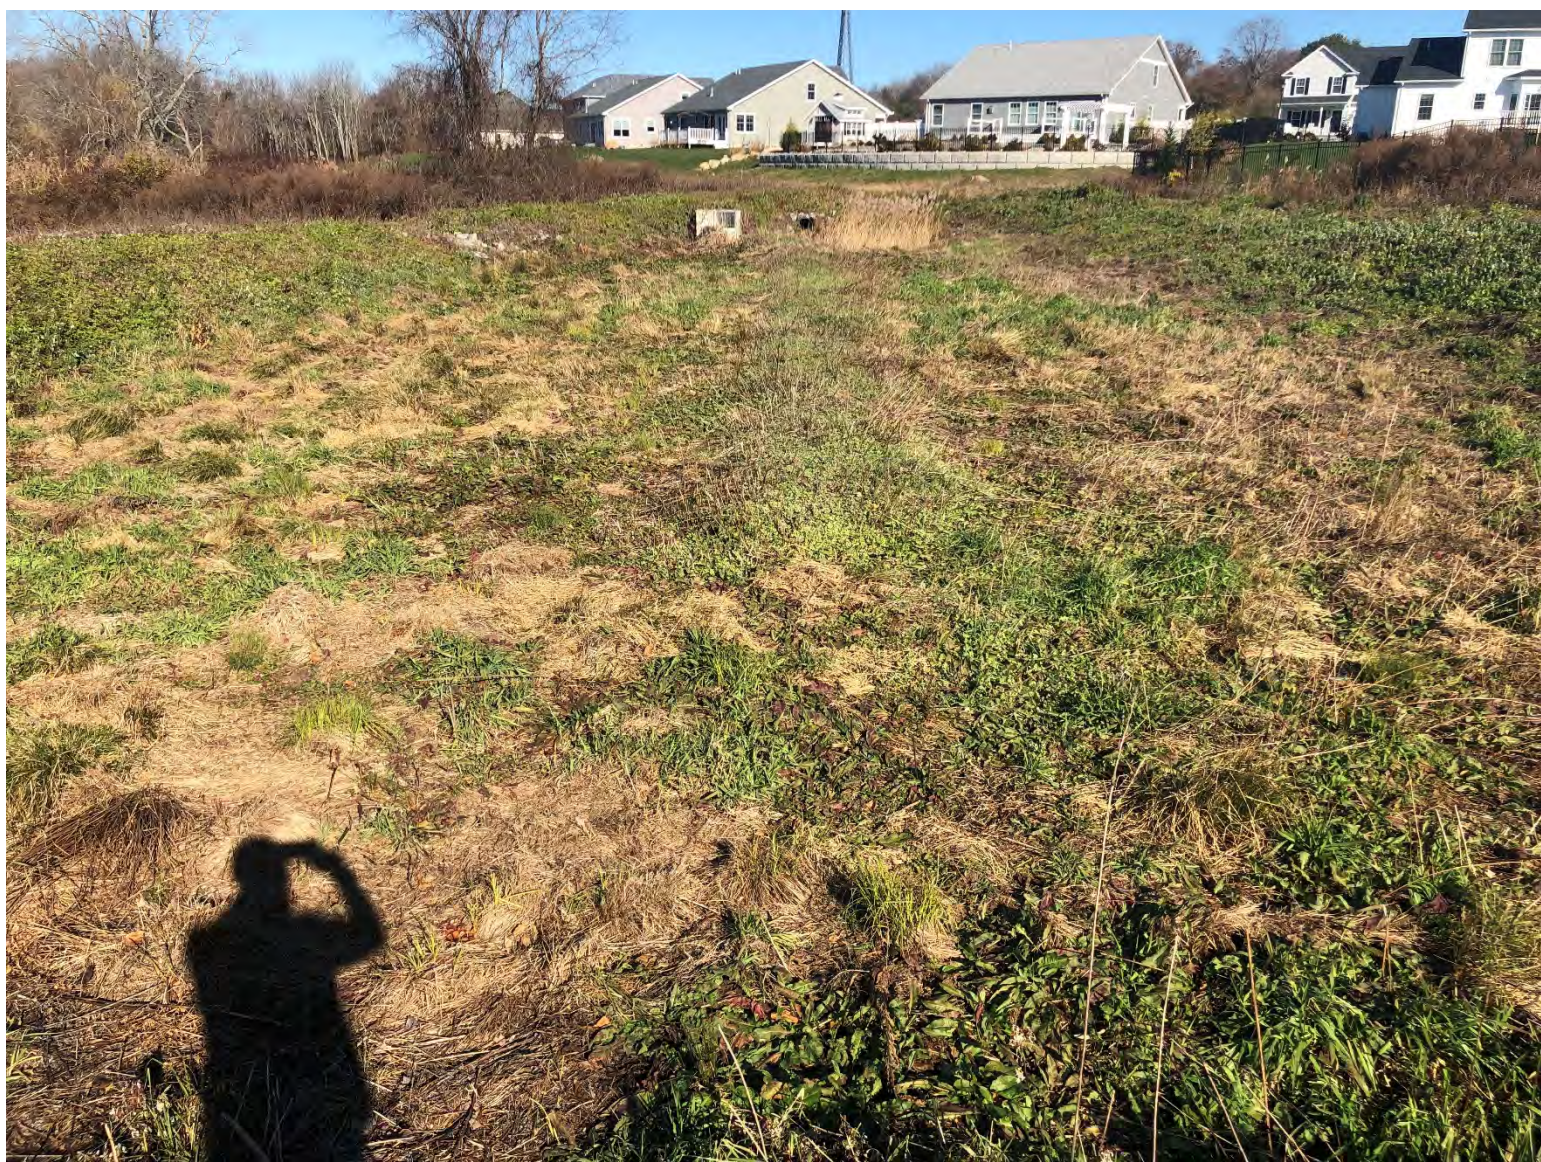
Northern view of southwestern biofilter

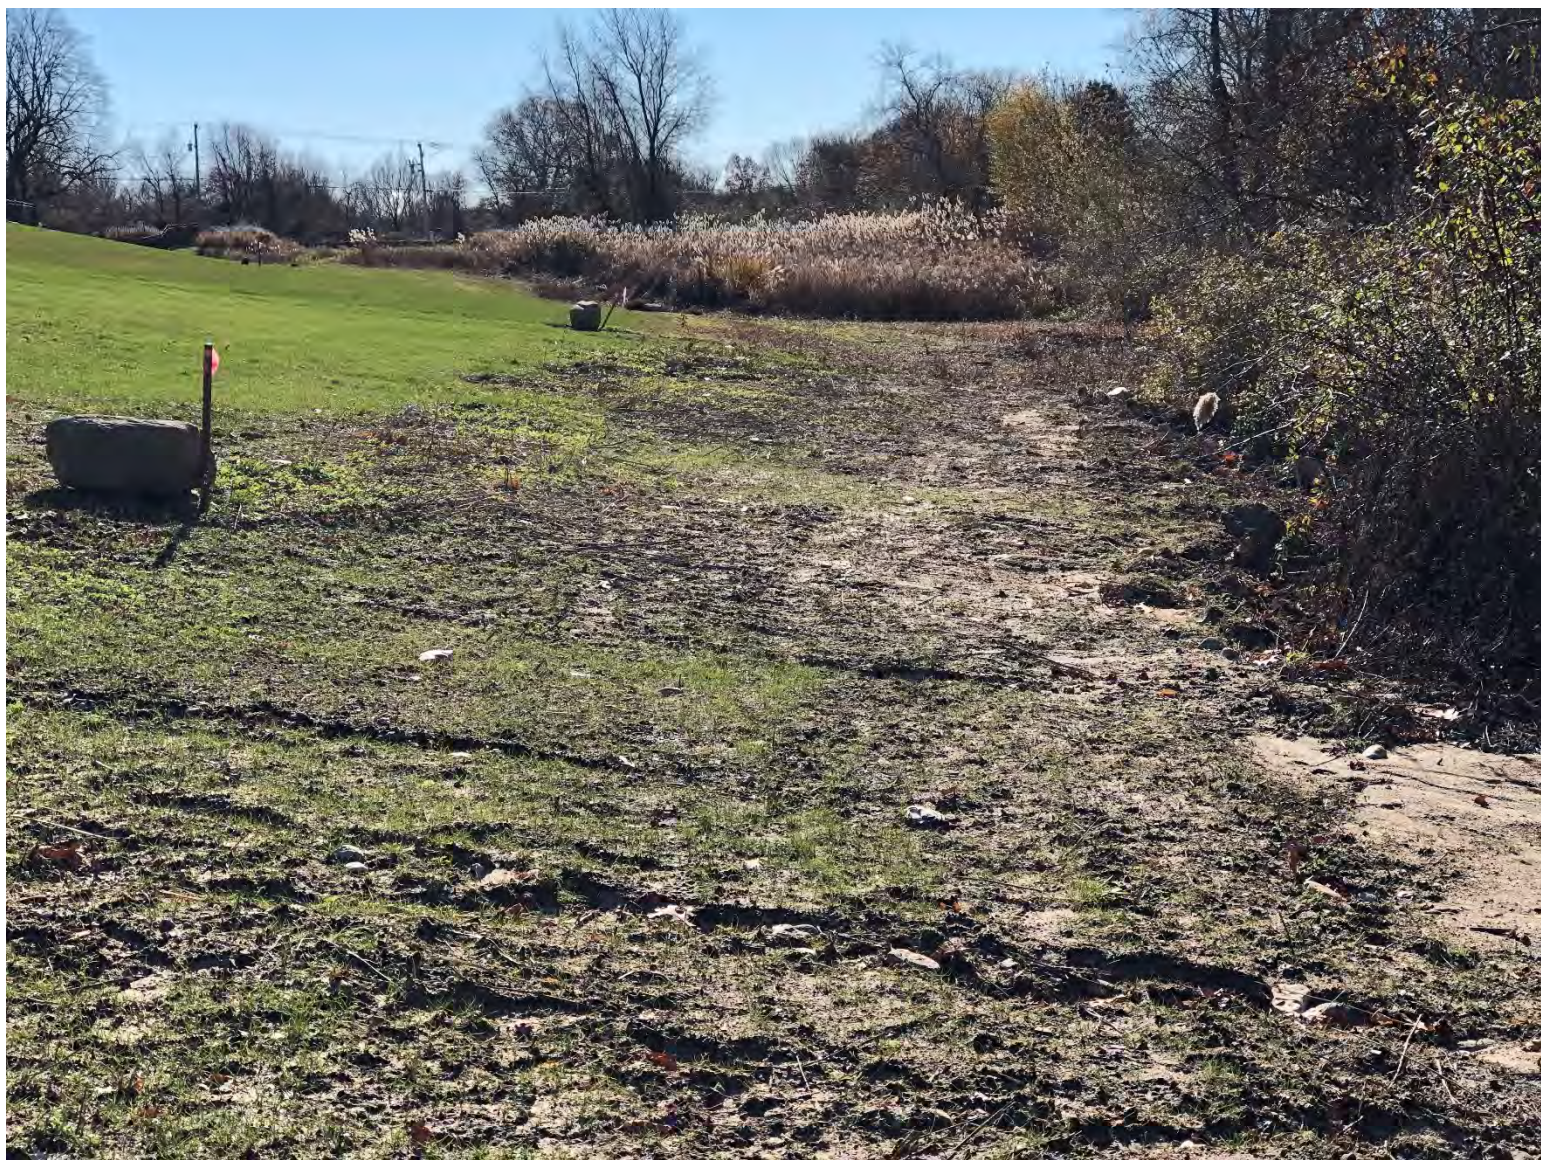
The majority of the wetland buffer has been mowed up to the stonewall. In 2020, Phragmites was the dominant plant species and formed a monoculture in the southern section. Other plant species in the wetland buffer include Mugwort, Goldenrod, and Japanese Honeysuckle. The three shrubs which were present in the wetland buffer died or were mowed.

Mowed wetland buffer

1. The wetland buffer should not be mowed.
