# TURNER ENVIRONMENTAL, LLC

*Re: Status Report - Implementation of Corrective Actions  
Restoration of Riparian Habitat and Channel Stabilization  
Rope Ferry Condominiums  
54 Rope Ferry Road, Waterford, CT*

**Photographs of Restoration Plantings**

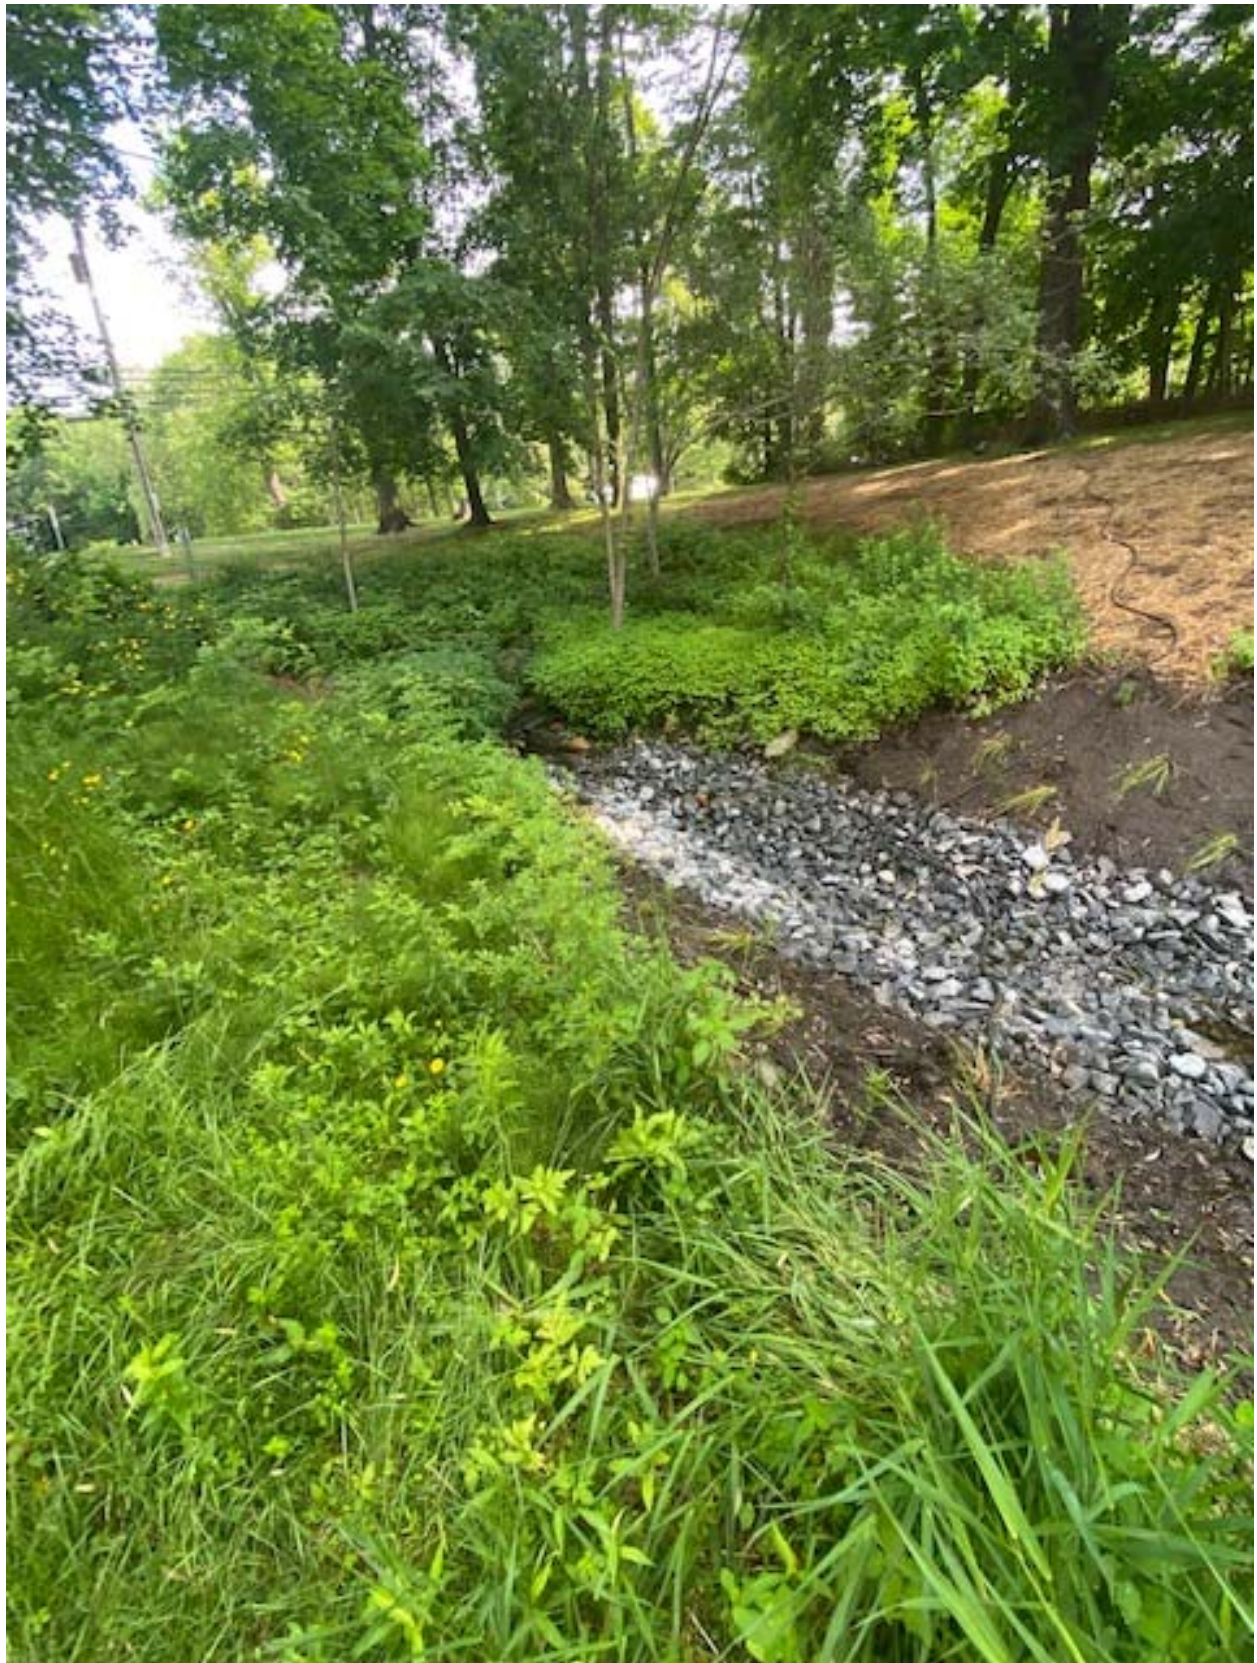
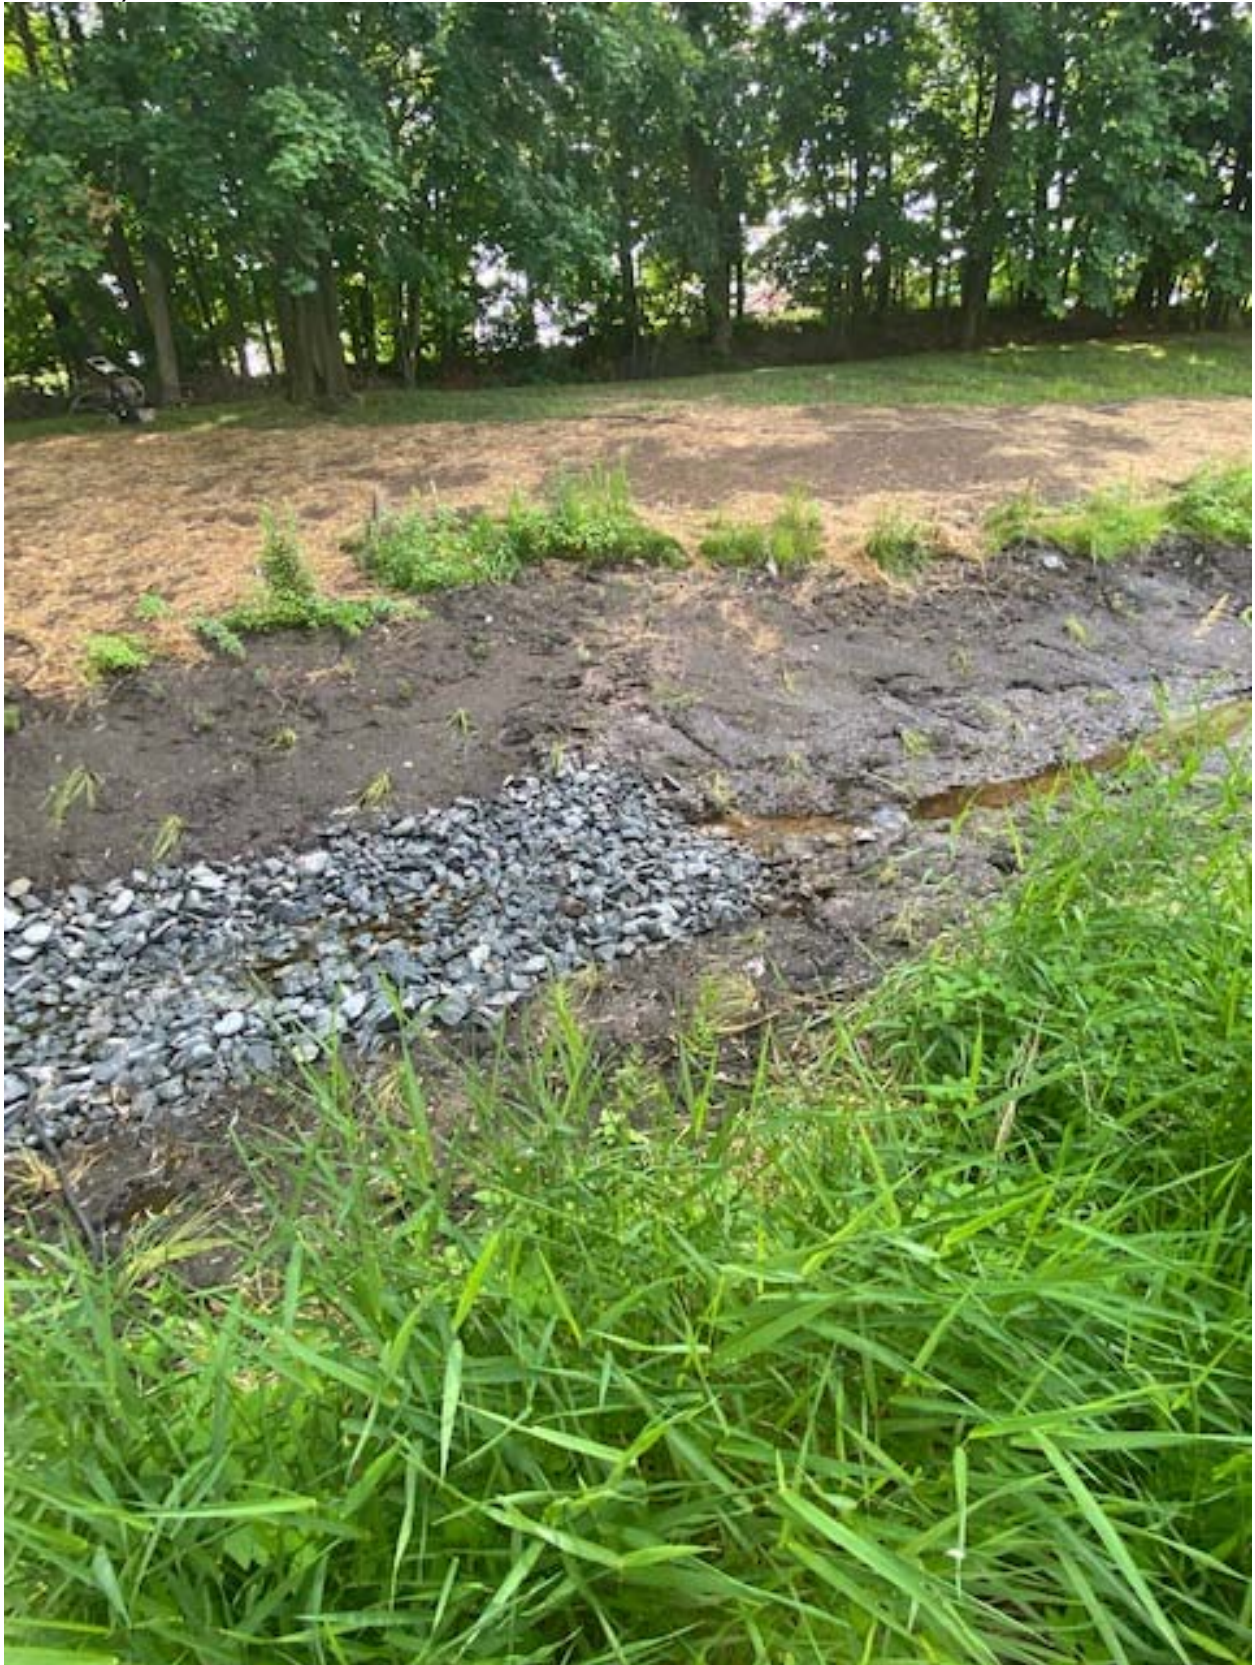
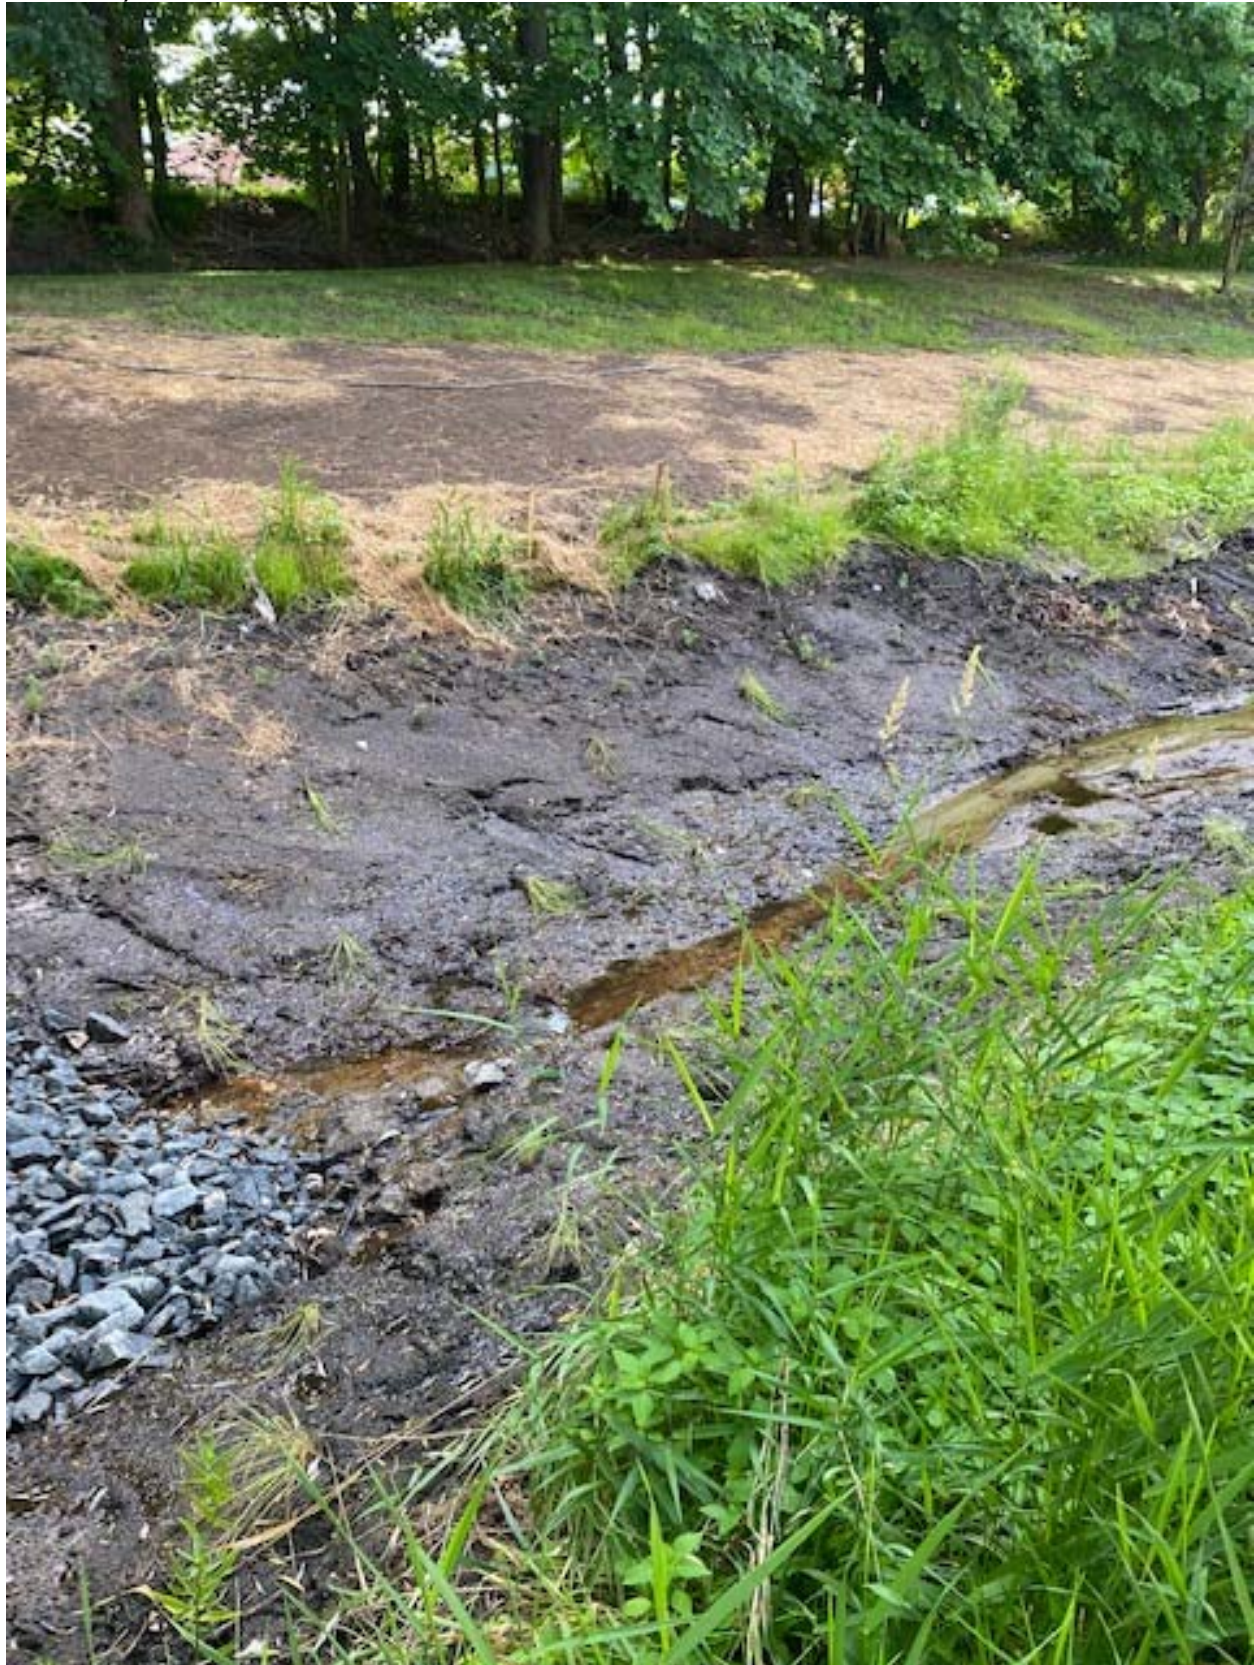
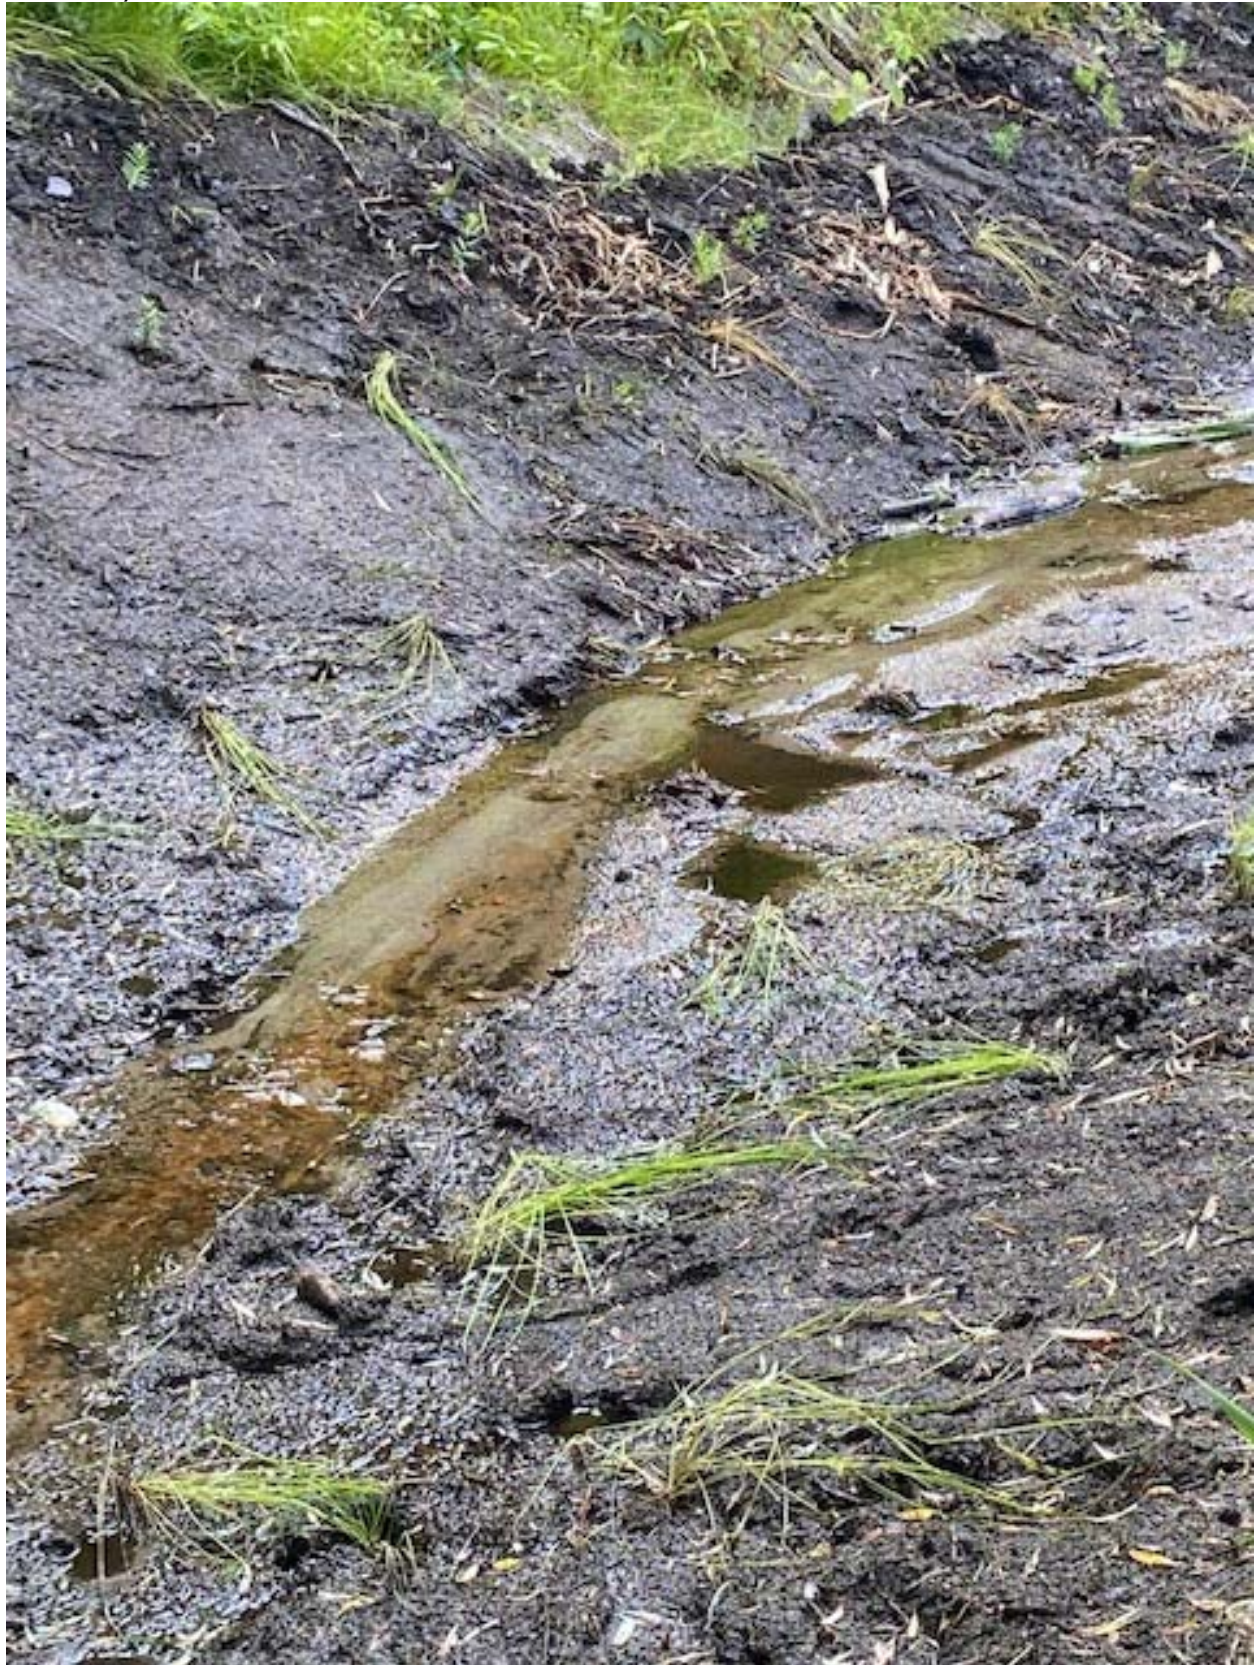
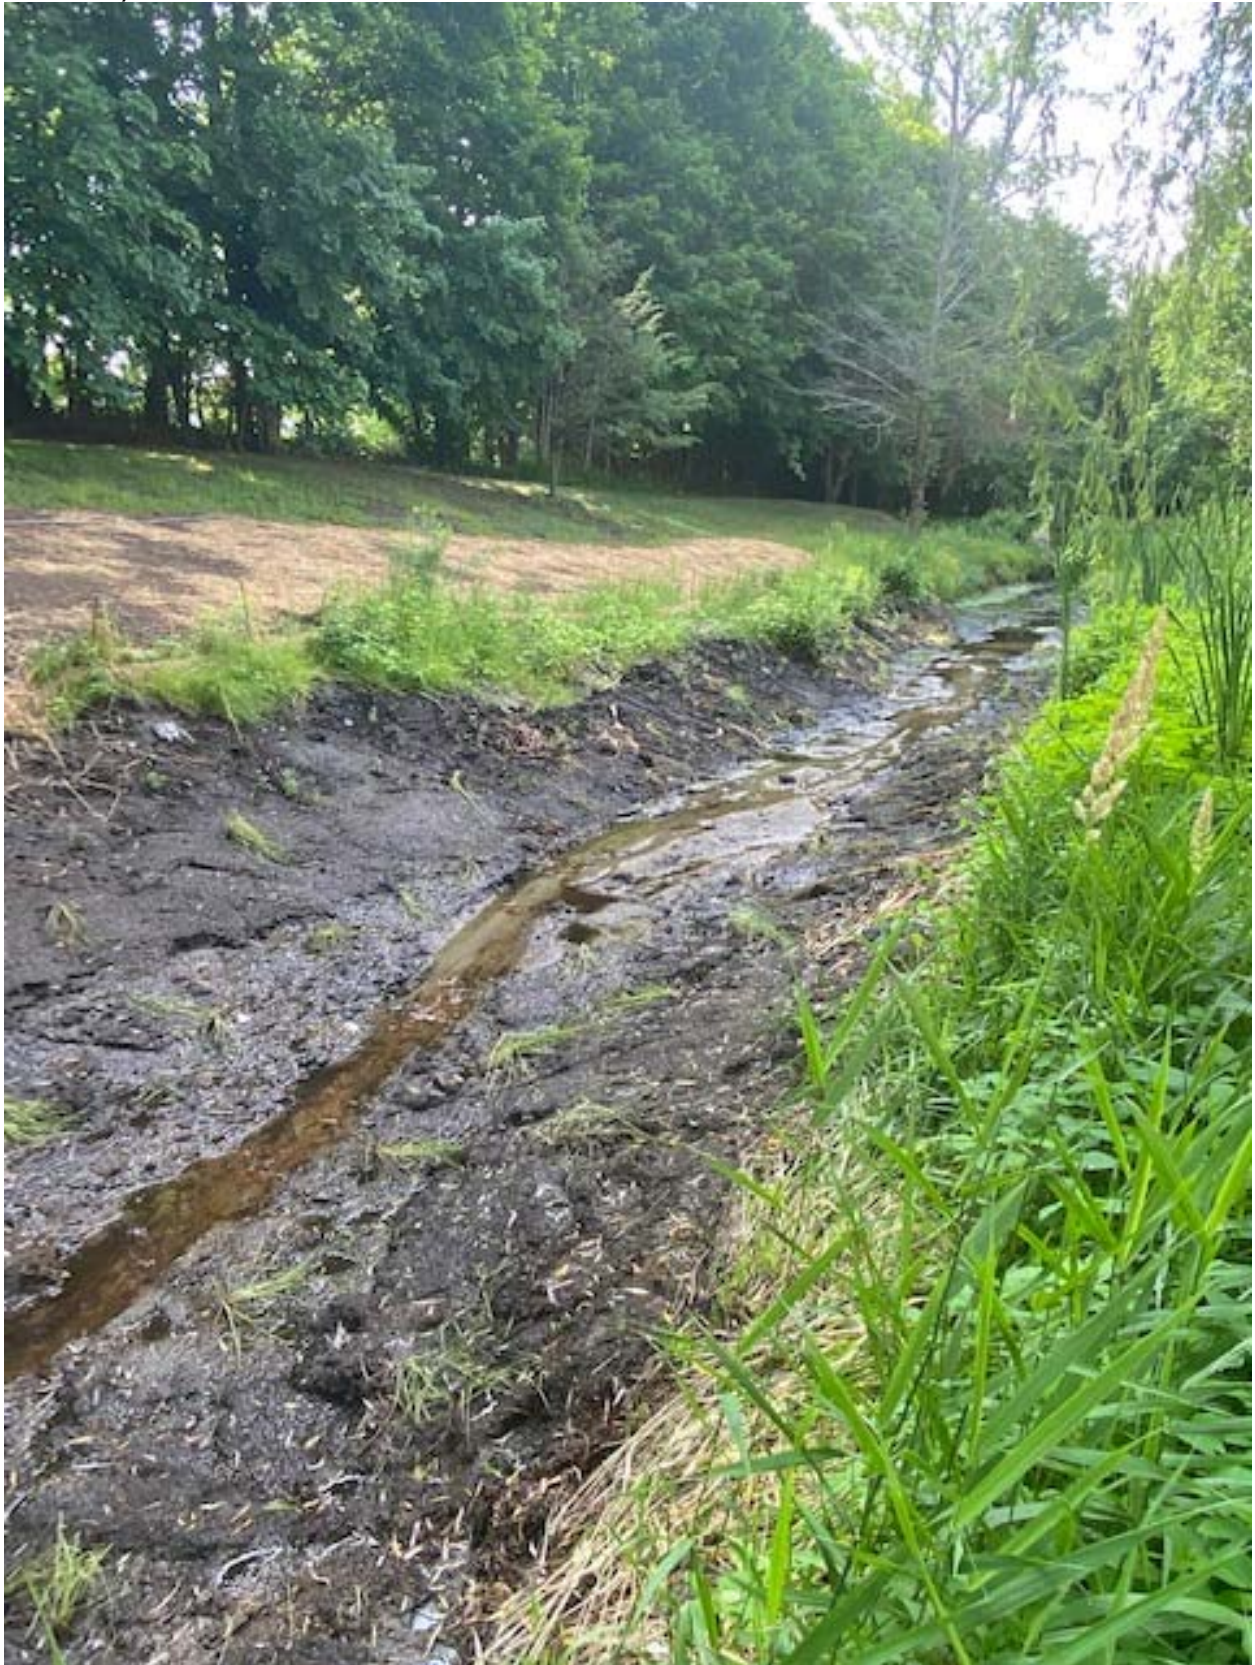
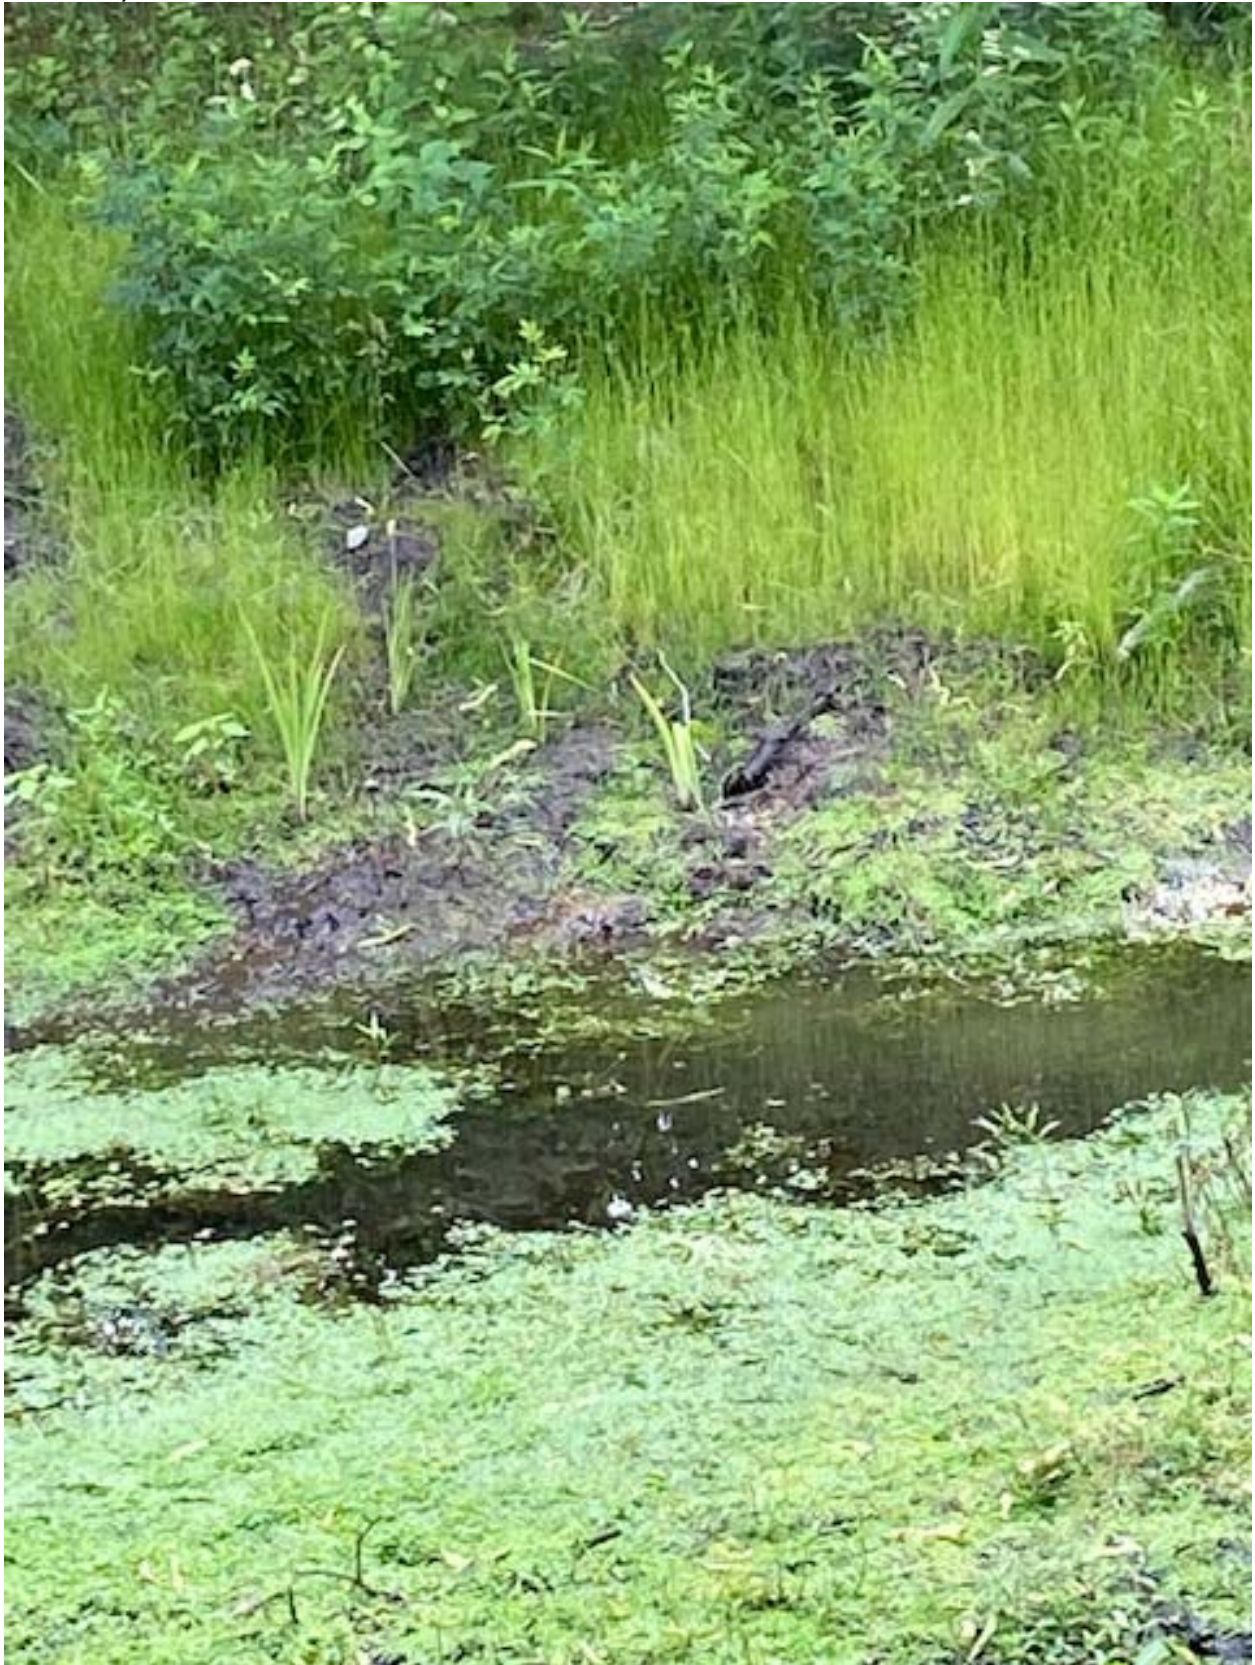
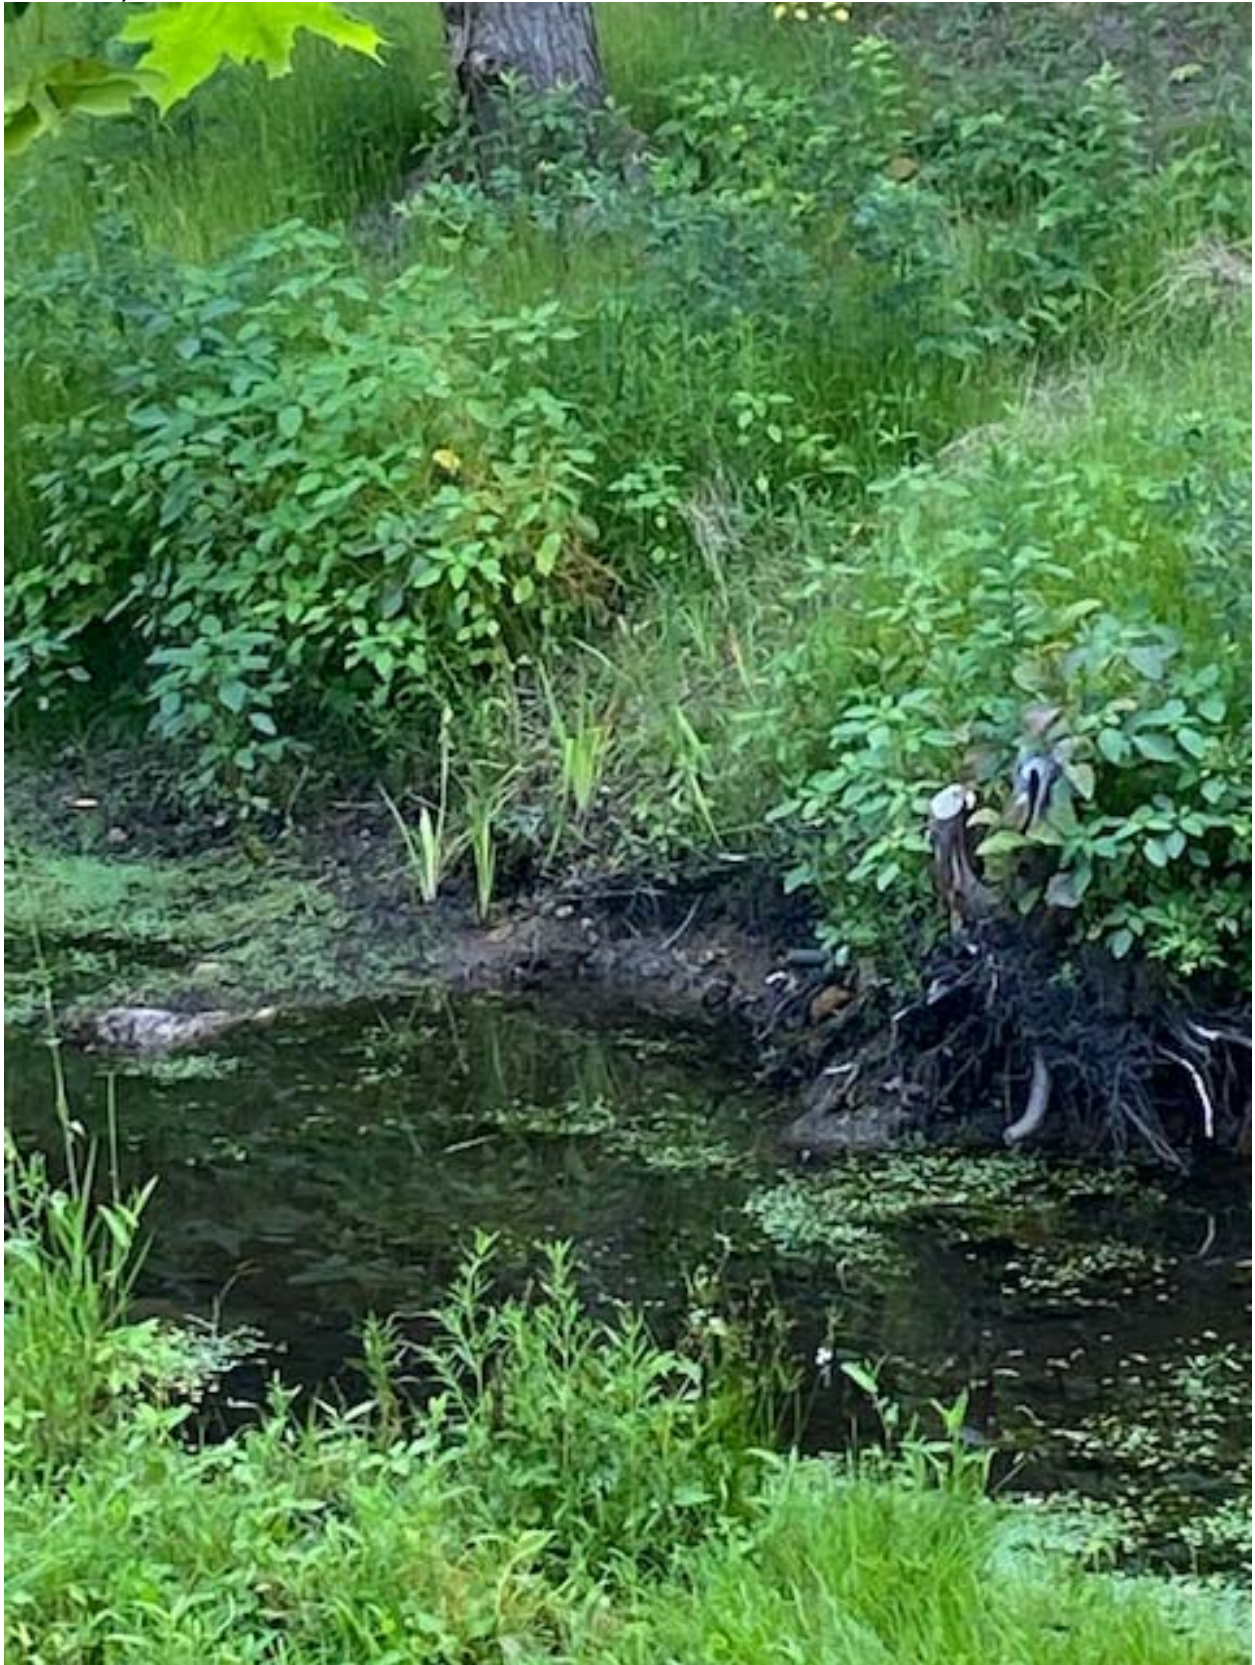
Site work was initiated on June 12, 2021 and completed on June 16, 2021. The plantings as specified in the approved plan were installed June 19, 2021. The stream channel was redirected more toward a more central location away from the eastern bank of the stream that enters the Rope Ferry pond. The steep bank slopes were reduced by moving material from the west to the east side of the stream.

Approximately fifteen feet of additional rip rap was installed where the stream enters from the north and the stream entry was relocated approximately two feet further west. This effectively relocated the stream channel approximately two feet west for much of the length of the previously disturbed area.

150 Tussock Sedges 2" dia. plugs, these were planted in a saw tooth pattern on both sides of the stream.

50 Blue Flag Iris 2" dia. plugs in the emergent vegetation area on the western side of the stream.
