***RE: Annual Wetland Mitigation Inspection Report – Year 1 (2021) - Inland Wetland Permit #C-20-14, 14B Shore Road, Waterford, Connecticut.***

On Behalf of the Applicant Mr. David Mortimer, I am providing the annual update on the success status of the created wetland required as mitigation for the development of the residential driveway to access 14B Shore Road as detailed in the Town's Permit #C 20-14. This report represents Year 1 of 3 consecutive monitoring years (2021, 2022 & 2023).

## **Year 1 Annual Inspection**

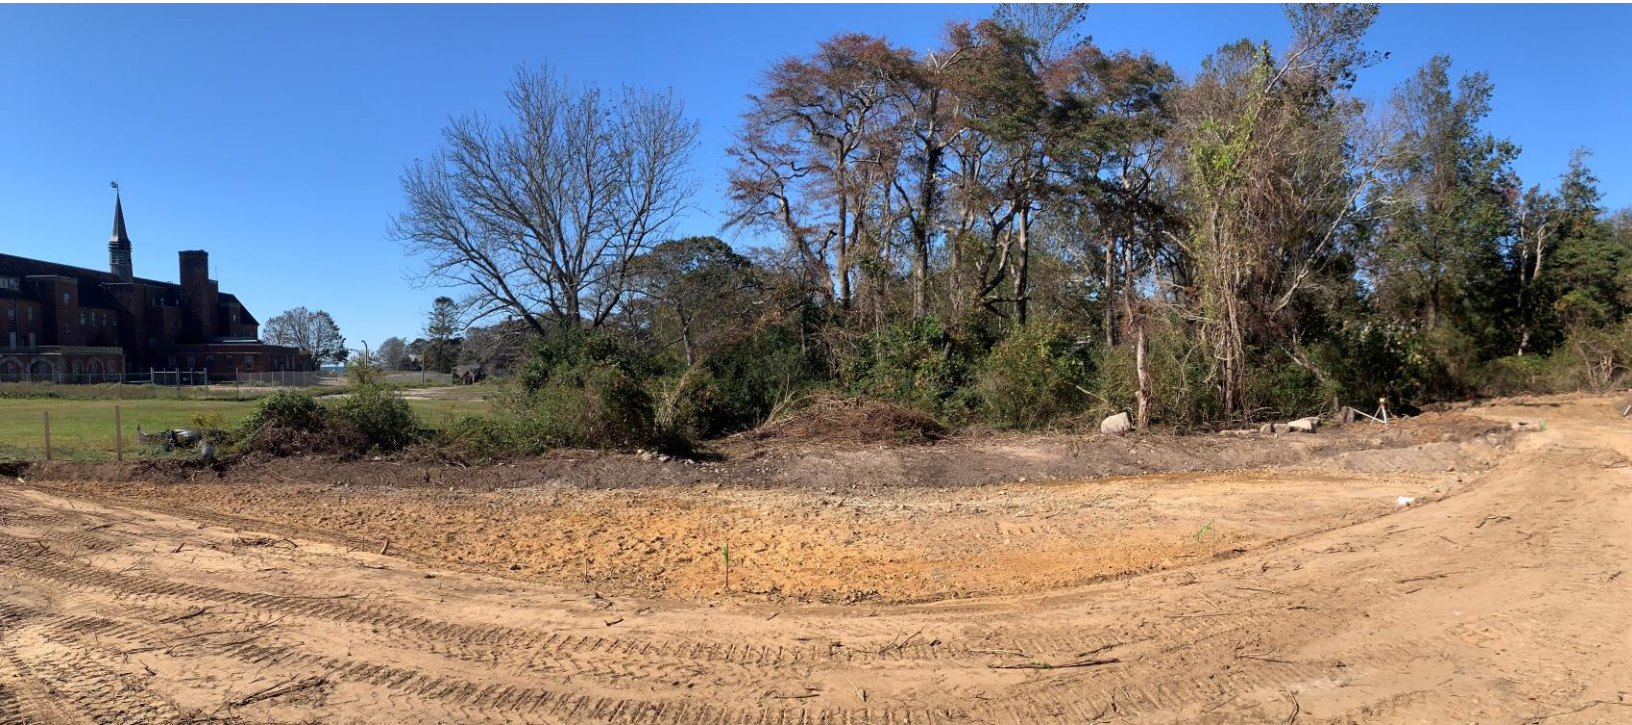
B & L Construction, Inc. started the excavation and the rough grading process in October 2020 to form the wetland creation area (Photos 1 & 2). B & L place 12" + of a rich organic topsoil consisting of a 1:1 mixture of clean topsoil and compost to provide the soil medium for the mitigation plantings (Photos 3 & 4). Wetland plants and seed mixtures were secured from New England Wetland Plants, Inc. out of South Hadley Massachusetts. A total of 84 shrubs were planted in the wetland creation area (Photo 5). Plantings were placed randomly to simulate natural variability. Below is a list of quantities and sizing of installed plantings along with seed mixtures:

Photo 1: October 8, 2020 – Rough Grading Inspection

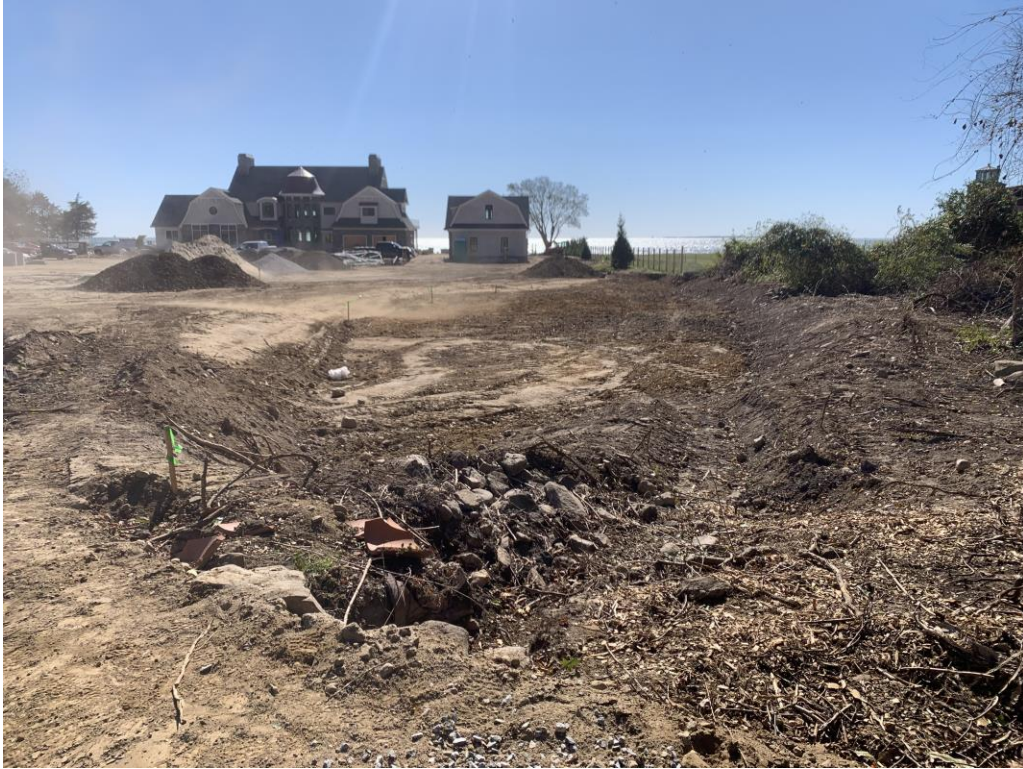
Photo 2: October 8, 2021 – Rough Grading Inspection

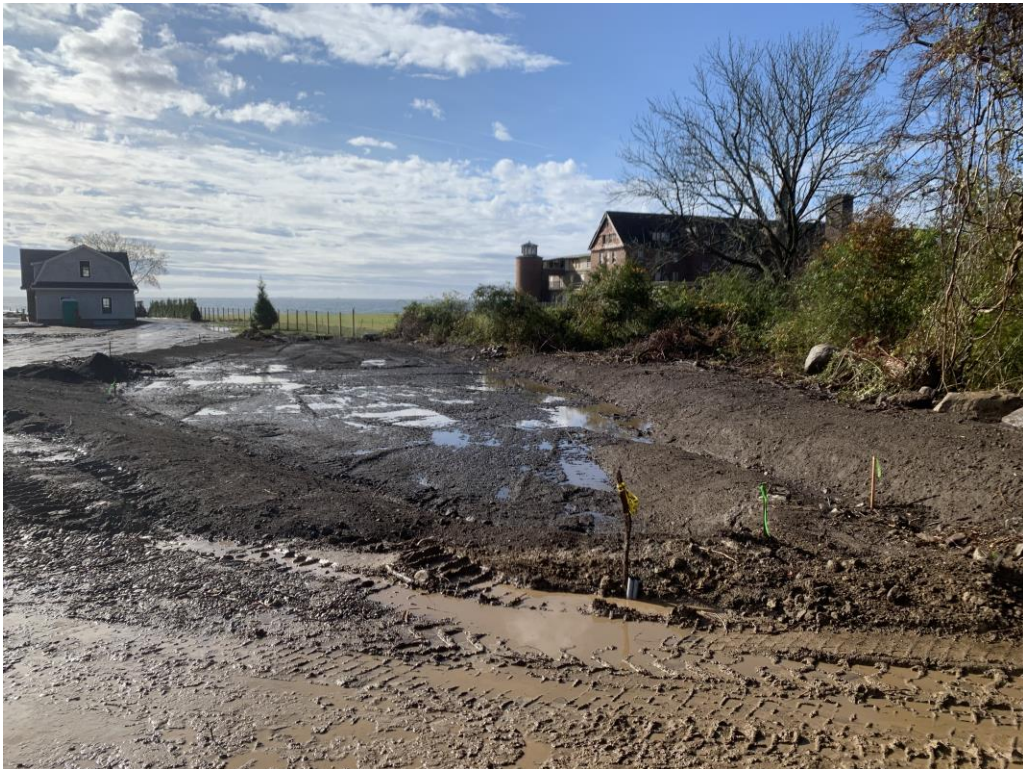
Photo 3: October 15, 2020 – Topsoil Inspection 1:1 Mix of Clean Topsoil & Compost

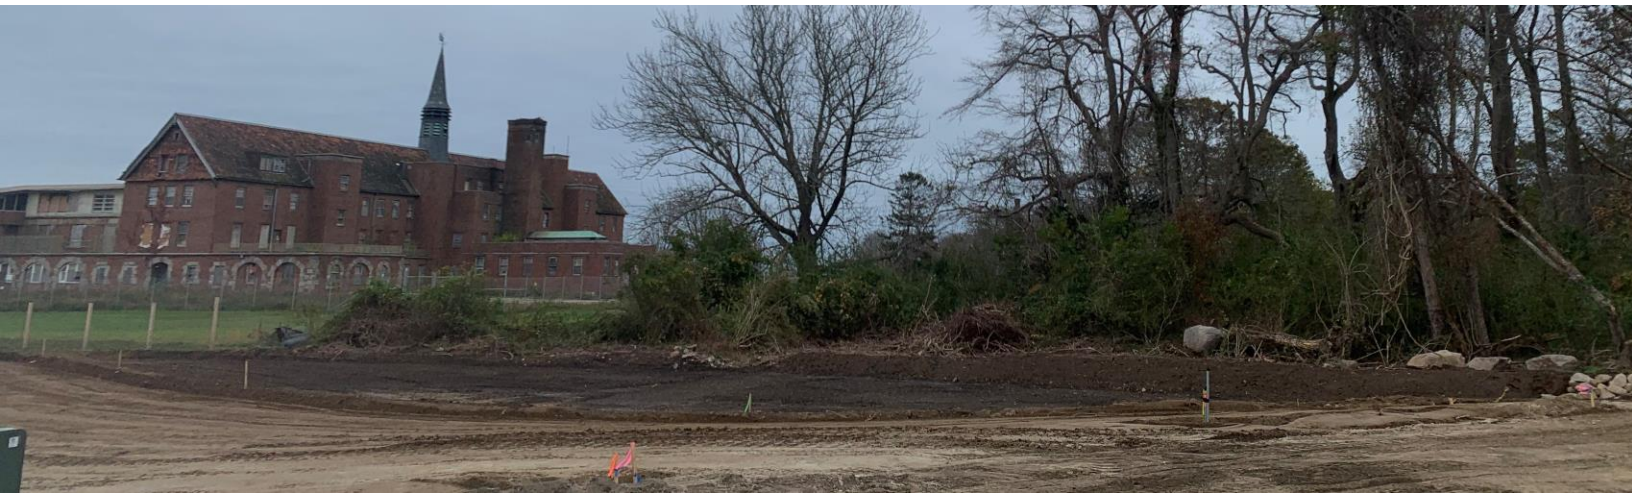
Photo 4: October 20, 2020, Final Grading / Topsoil Inspection

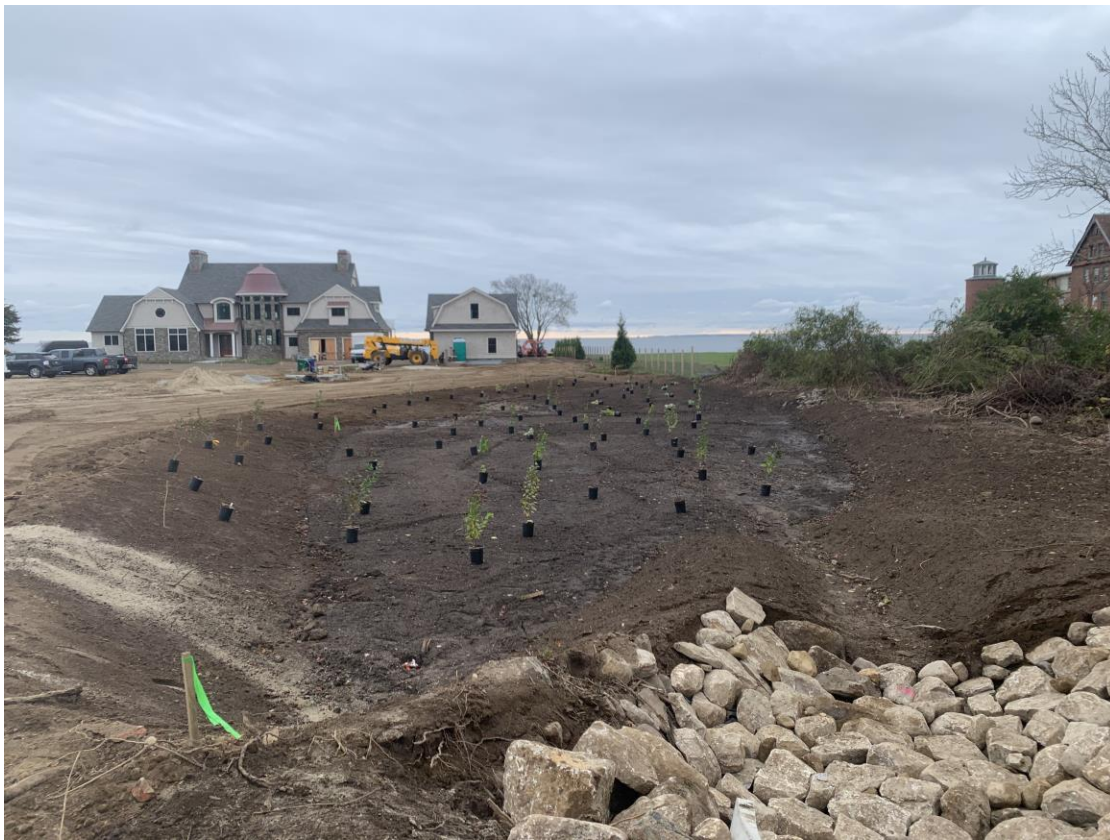
Photo 5: October 27, 2021 – Planting and seed installation

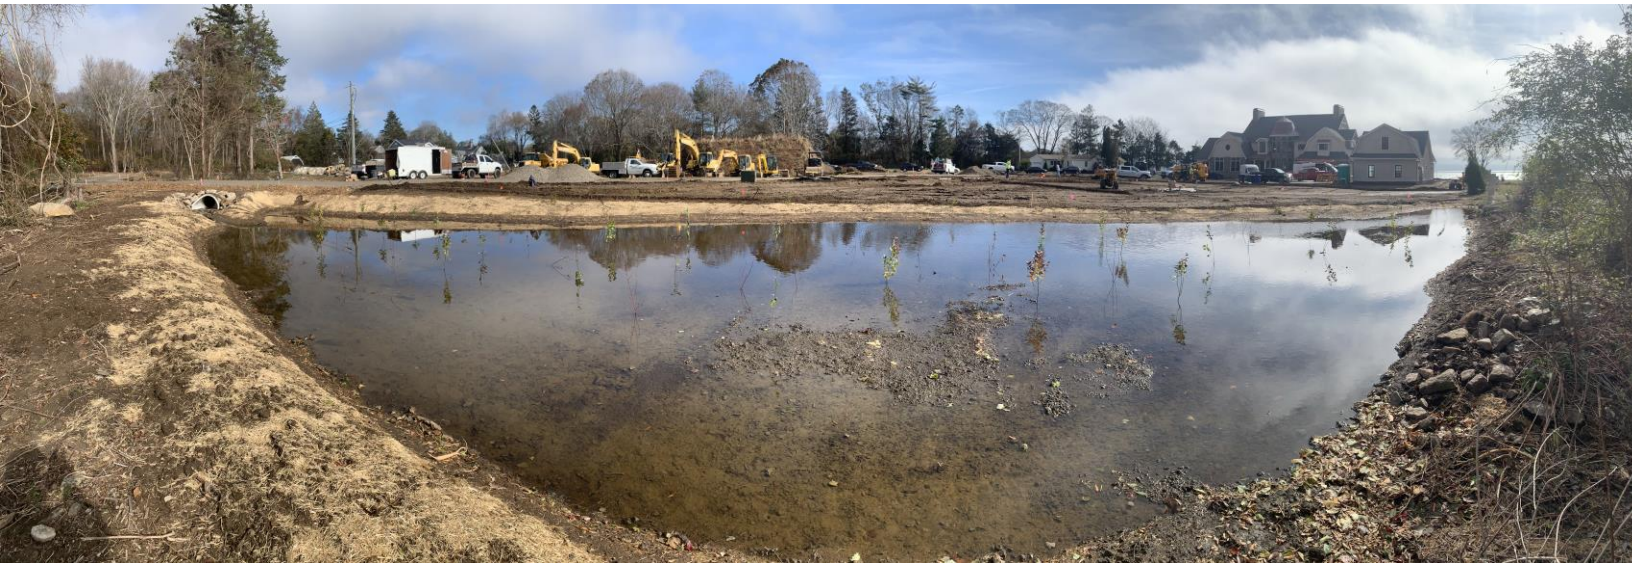
Photo 6: November 5, 2021 –Inundation of wetland mitigation, photo taken from the outlet to the mitigation area

1. All 47 shrub plantings were accounted for in various conditions, ranging from stressed too healthy. This ratio equates to a 55% survivability, which is below the target of 70% survivorship. Unaccounted prolonged hydrology has affected the long-term survivability and success of the planted shrub vegetation. To resolve the issue would require modifying the outlet structure to the created wetland to lower the standing water. However, the ability to do so is limited because the control to this structure is situated on the adjacent CTDEEP State owned property. Other engineering solutions would likely require introducing counterproductive new ground and wetland disturbance to the newly created wetland.

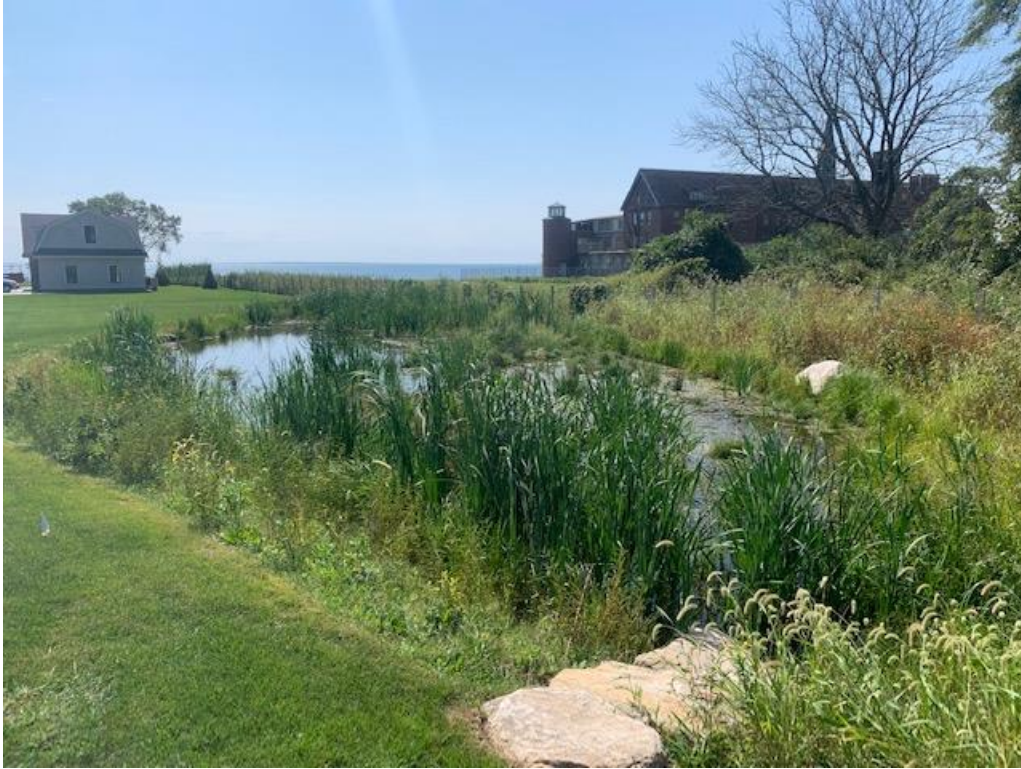
Within the next growing season, it is anticipated that the created area will transition to a cattail dominated wetland. Once Cattails take root, they can be a challenge to remove due to the robust fast growing underground rhizomes. This issue is compounded by the prolonged hydrology which attracts waterfowl which will continue the cycle of propagating the cattail seeds as the birds fly across the landscape landing in various waterbodies. The transition of the created wetland vegetation community to a cattail persistent emergent marsh, will have the unintended added improvement of water quality renovation as the thickly vegetated cattails retain sediments and nutrients at a higher function than the planned scrub-shrub wooded wetland. Because of these factors I do not recommend corrective shrub plantings to bring the count back to 84 shrubs but would alternatively suggest continued monitoring to ensure that no undesirable emergent species take root in the absence of the proposed shrub cover. The vegetated cover would be re-evaluated in the 2022 growing season.

Photo 7: Wetland Creation Area September 2021 (north end)

2. No invasive species control measures were implemented or recommended for the wetland creation area.
3. No soil stabilization measures are needed, the site is stabilized.
4. My recommendation is the Town considers the natural recruitment of the Cattails to be satisfactory in replacement of additional shrub plantings and to continue to monitor and evaluate the vegetative community for compliance with the permit conditions of Inland Wetland Permit #C 20-14 in the 2022 growing season.

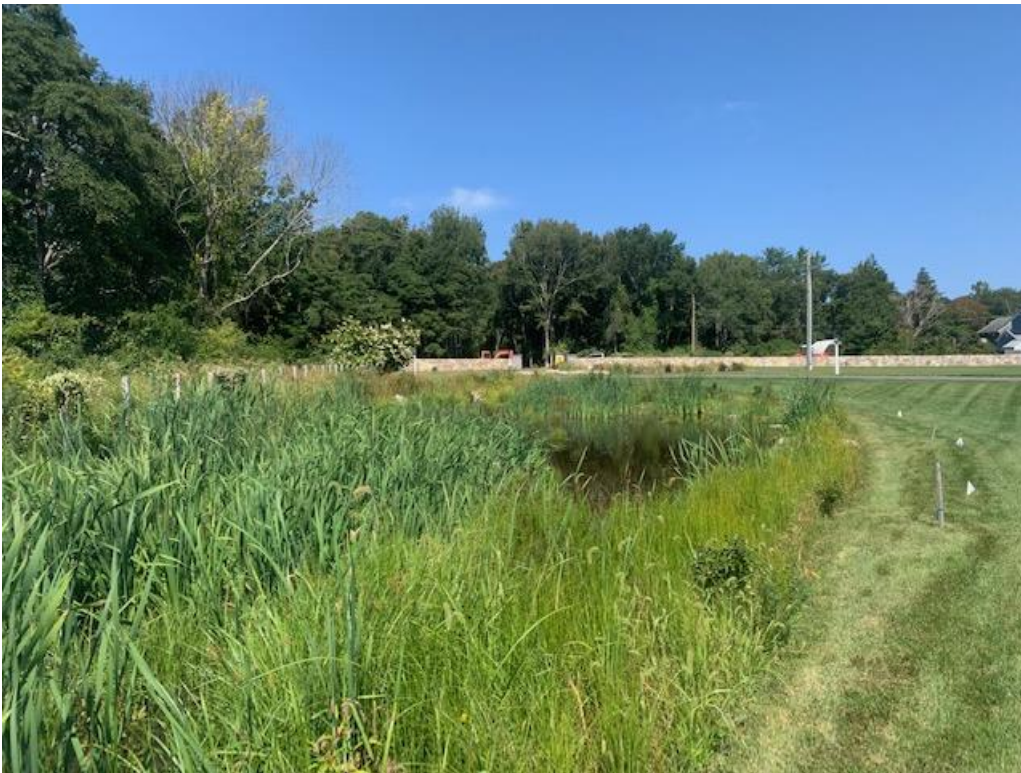
Photo 8: Wetland Creation Area September 2021 (south end)

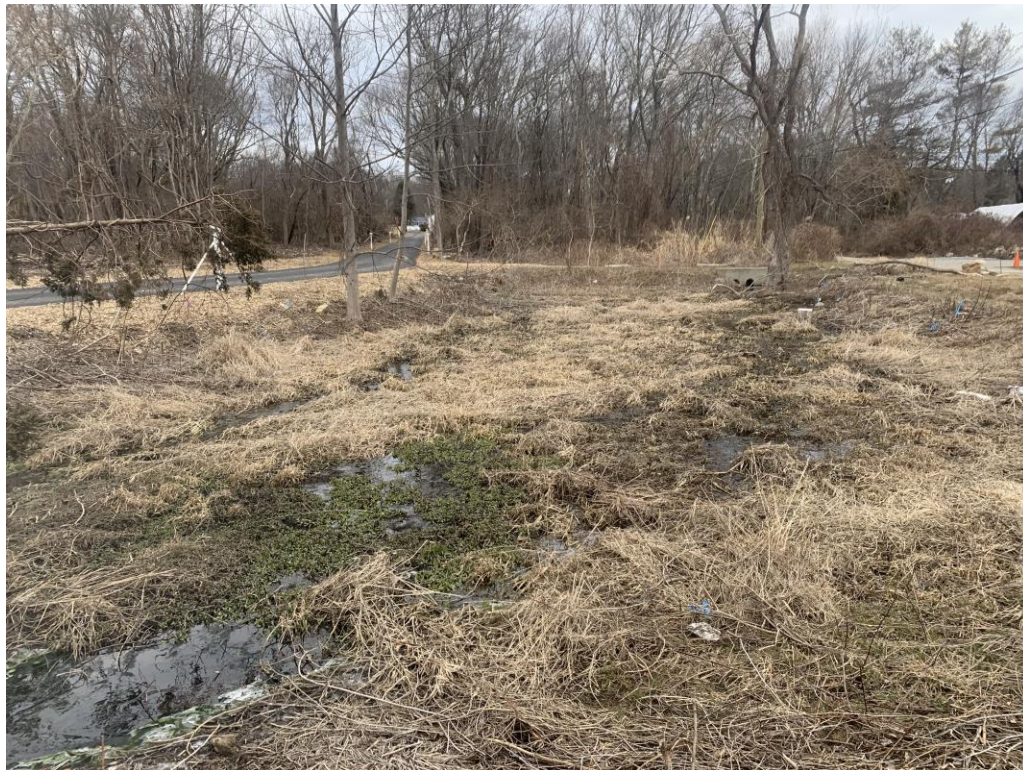
Photo 9: Wetland Upgradient of driveway crossing – area of proposed Buffer Enhancement Planting area pre-enhancement activities – November 2020

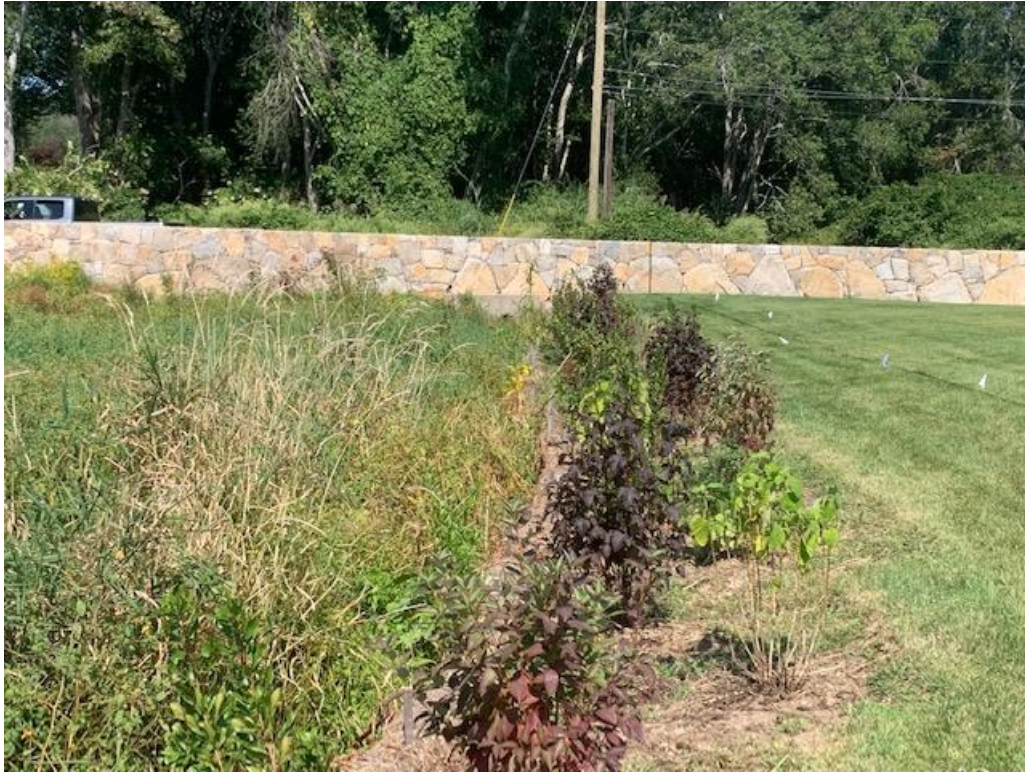
1. As of September 21, 2021, all 60 shrubs were installed and in good health.
2. A small patch of Mug wort was removed in the northwest corner of the pond. The area will be continued to be monitored and will actively remove this invasive weed. Because of the small discrete patch, the vegetation was removed by and bagged for disposal.
3. No corrective actions are required.
4. Site will be monitored during the 2022 growing season.

Photo 11: Example of Buffer Enhancement Plantings – September 2021

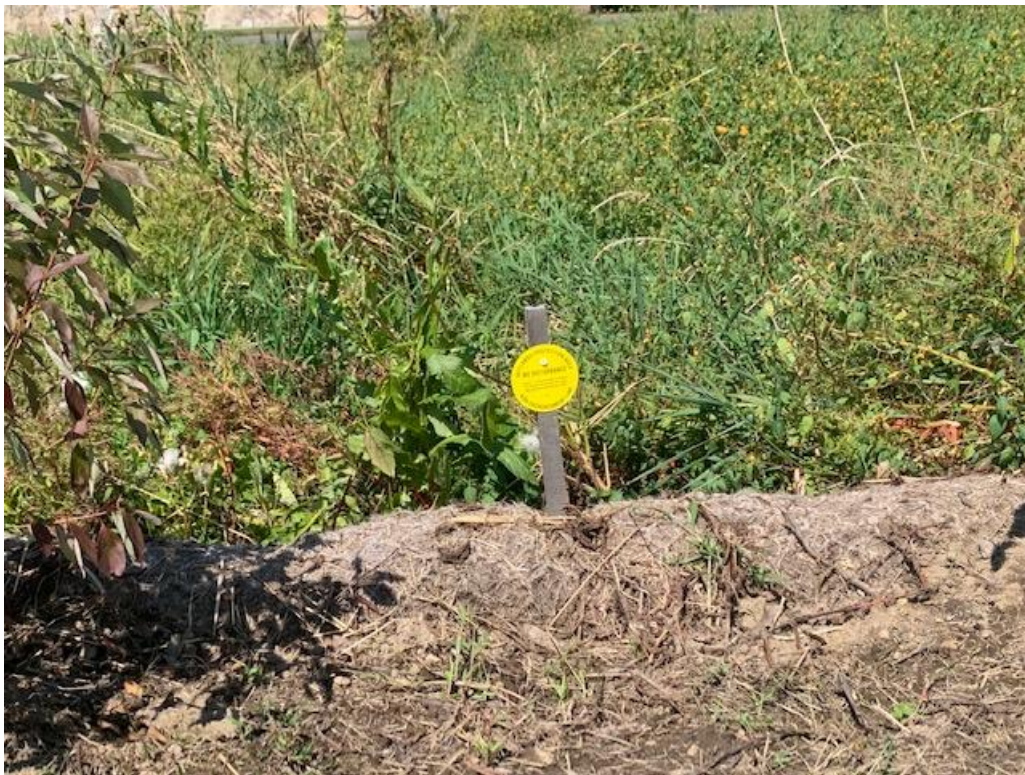
Photo 12: Wetland Placard September 2021

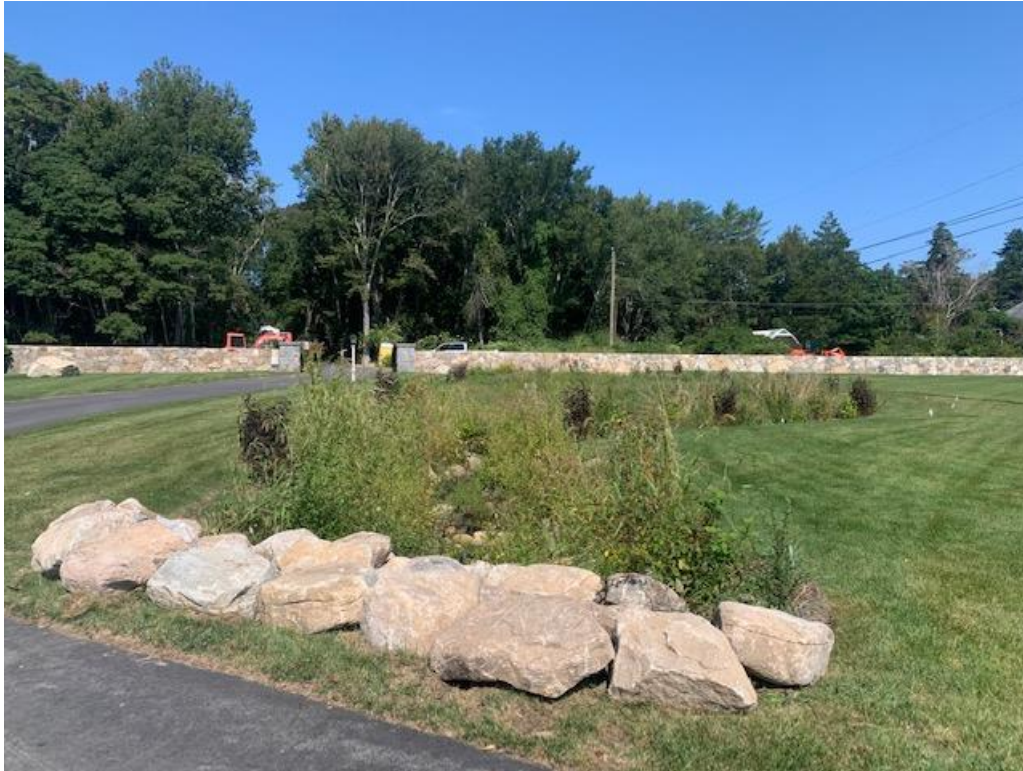
During the long lead time securing plant stock during the pandemic and waiting for seasonal plugs stocks to grow large enough to be available for purchase; the site naturally revegetated, and all bare soil was sufficiently covered. This natural recruitment of vegetation was sufficient to stabilize the area and therefore negated the addition of seed and plugs.

Photo 12: Final Vegetated Cover – September 2021

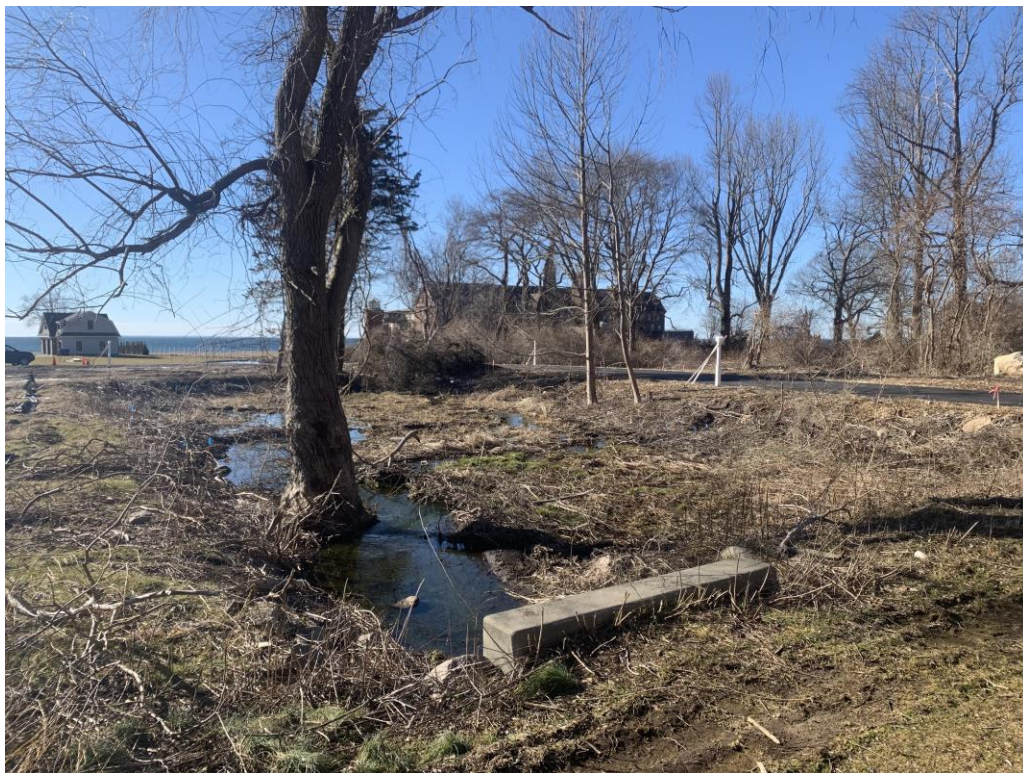
Photo 13: Wetland Prior to Enhancement Activities – November 2020
