**RE:** *Application Review: App. # C22-15. 47-Unit Residential Subdivision, including affordable units; 141 Clark Lane. Owners: L & M Archambault; Applicant Kingstown Properties, LLC*  
*Carya Job No.: 23- WFD 3*

Carya Ecological Services, LLC has conducted a preliminary review of the above-referenced application by Kingston Properties, at the request of several property owners of abutting homes on the east side of Clark Lane, including Arlene Sherman (119 Clark Lane).

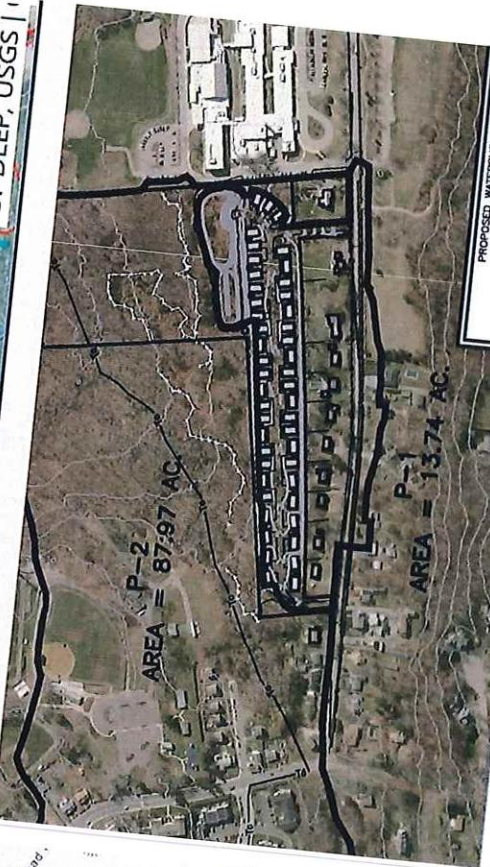
PROPOSED WATERSHED MAP  
PREPARED FOR  
KINGSTOWN PROPERTIES LLC  
PROPOSED AFFORDABLE HOUSING DEVELOPMENT  
CLARK LANE  
WATERFORD, CONNECTICUT  
SCALE 1" = 300'  
DATE 5/27/2023  
DRAWN BY: JCH

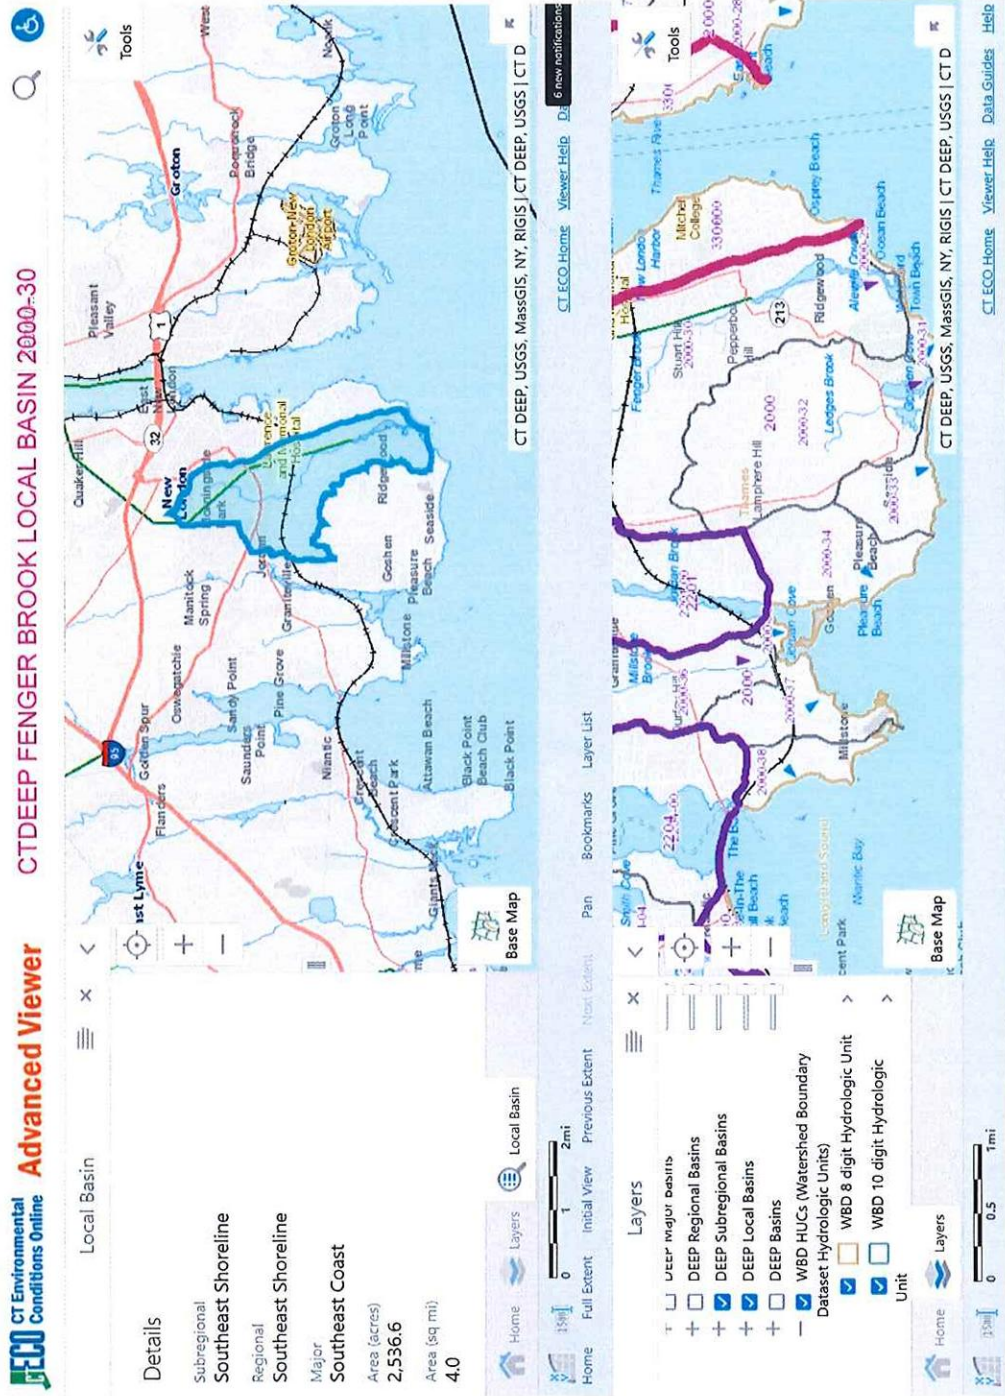
NOTES: Red line delineates CT Major Basins. Basin #2, the Southeast Coastal Major Basin, includes all except the Thames River shorelines areas. Purple line delineates the Regional Basins. Fenger Brook, Alewife Cove, and East & West sides of Jordan Cove are in Basin # 20, the Southeast Shoreline Regional Basin. Jordan Brook is in Regional Basin #22, the southeast western complex. The blue-highlighted Fenger Brook CTDEEP Local Basin 2020-30 (above) flows entirely into Alewife Cove, the receiving estuary for Fenger Brook. The 8 and 10-digit Hydrologic Unit codes, with tan and gray boundary lines, also separate the Jordan Brook watershed from the Fenger Brook and Ledges Brook watersheds (combined). The CTDEEP system separates the Local Basins of Fenger Brook and Ledges Brook. Ledges Brook drains into Goshen Cove, not Alewife or Jordan Coves.
