Structural Stabilization, Exterior Rehabilitation and Programming  
Nevins Cottage  
57 Rope Ferry Road, Waterford, Connecticut

**PROGRAMMING MEETING**

Meeting Date: July 31, 2020  
Location: Conference Call

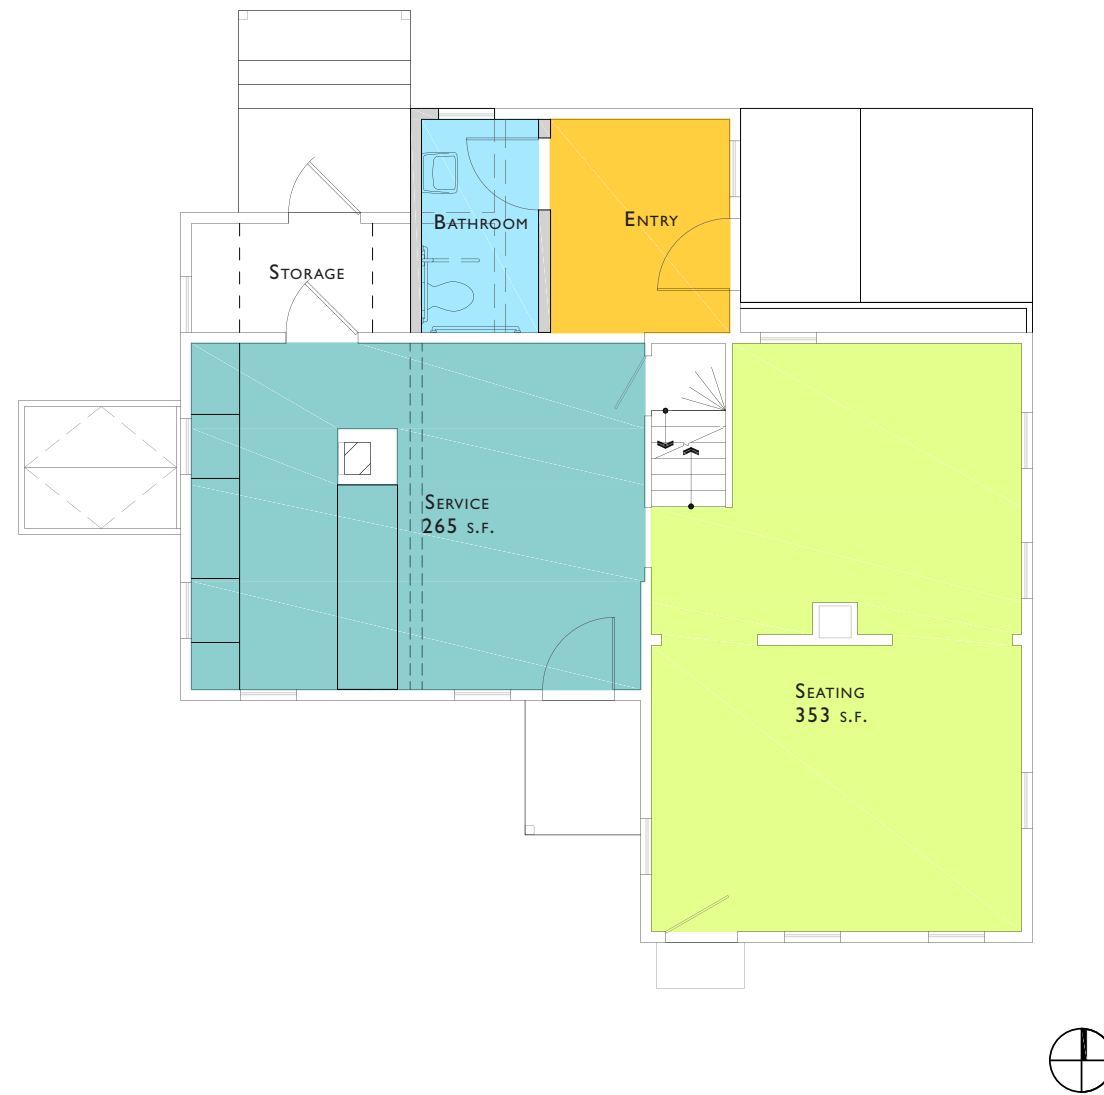
DESIGN OPTION FOR NEVINS COTTAGE  
 FROM 2014 WATERFORD TOWN CENTER VISION & STRATEGIC PLAN

| 1.4 | <p>Information learned from prior feasibility study of Nevins Cottage</p> <p>Adaptive reuse of Nevins Cottage for low impact public use was considered in the 2014 study and a schematic plan generated to illustrate possible reuse layout.</p> <ul style="list-style-type: none"> <li>To preserve two spaces for main 'program' areas a handicap accessible entry and toilet room were placed in a new addition on the north side of the Cottage (generally in the location of the 'Den' but with an expanded footprint driven by the size requirements for entry into an accessible public building and toilet room.)</li> </ul> | | |

| 1.5 | <p>Feedback on 2014 plan</p> <p>With regard to the 2014 plan, it was mentioned that the illustrated handicap ramp is shown to end facing east at the side of the very narrow driveway. Any ramp termination will need to have a landing away from traffic (agreed.) It was noted that parking on the site is quite limited.</p> | For future planning | |
