**TOWN OF WATERFORD, CT  
PLANNING & DEVELOPMENT**

Date: August 13, 2025

Re: **Application #C 25-08 – 125 Old Colchester Road**  
**Application Review Comments**

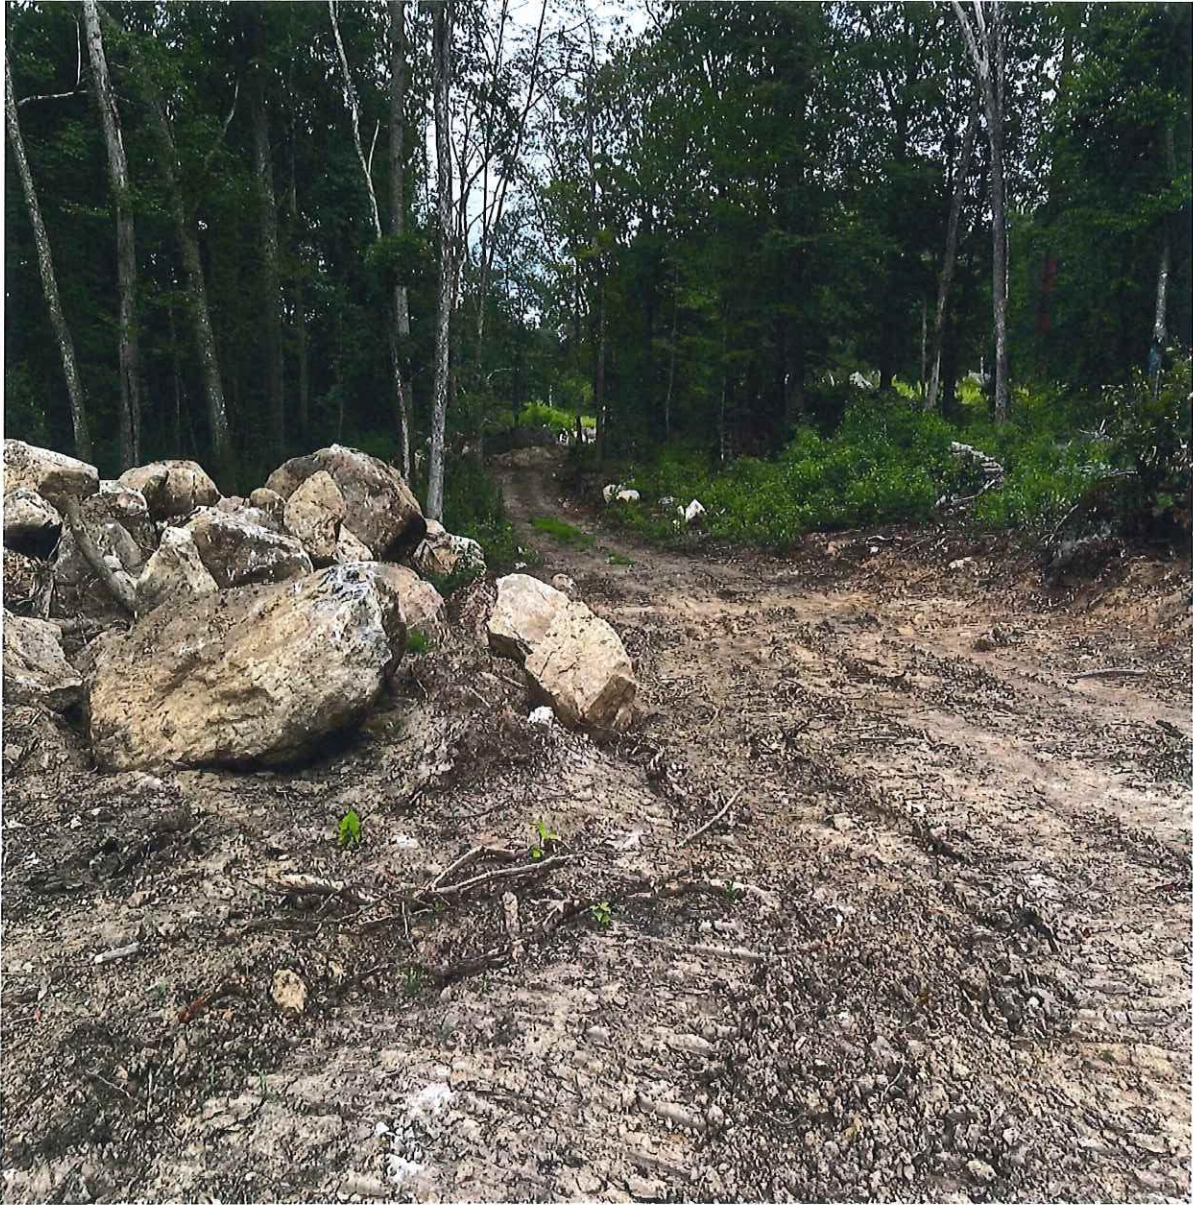
The inland wetland permit application was received on July 24, 2025. Staff conducted a site review on July 31, 2025. At that time it was observed the driveway access was rough graded, large boulders lined the south edge of the driveway cut, and a portion of the site has been cleared and rough graded where the house and garage are proposed. No limits of disturbance were observed to be marked and no soil and erosion control measures installed.

**Existing access drive looking west towards Old Colchester Rd.**

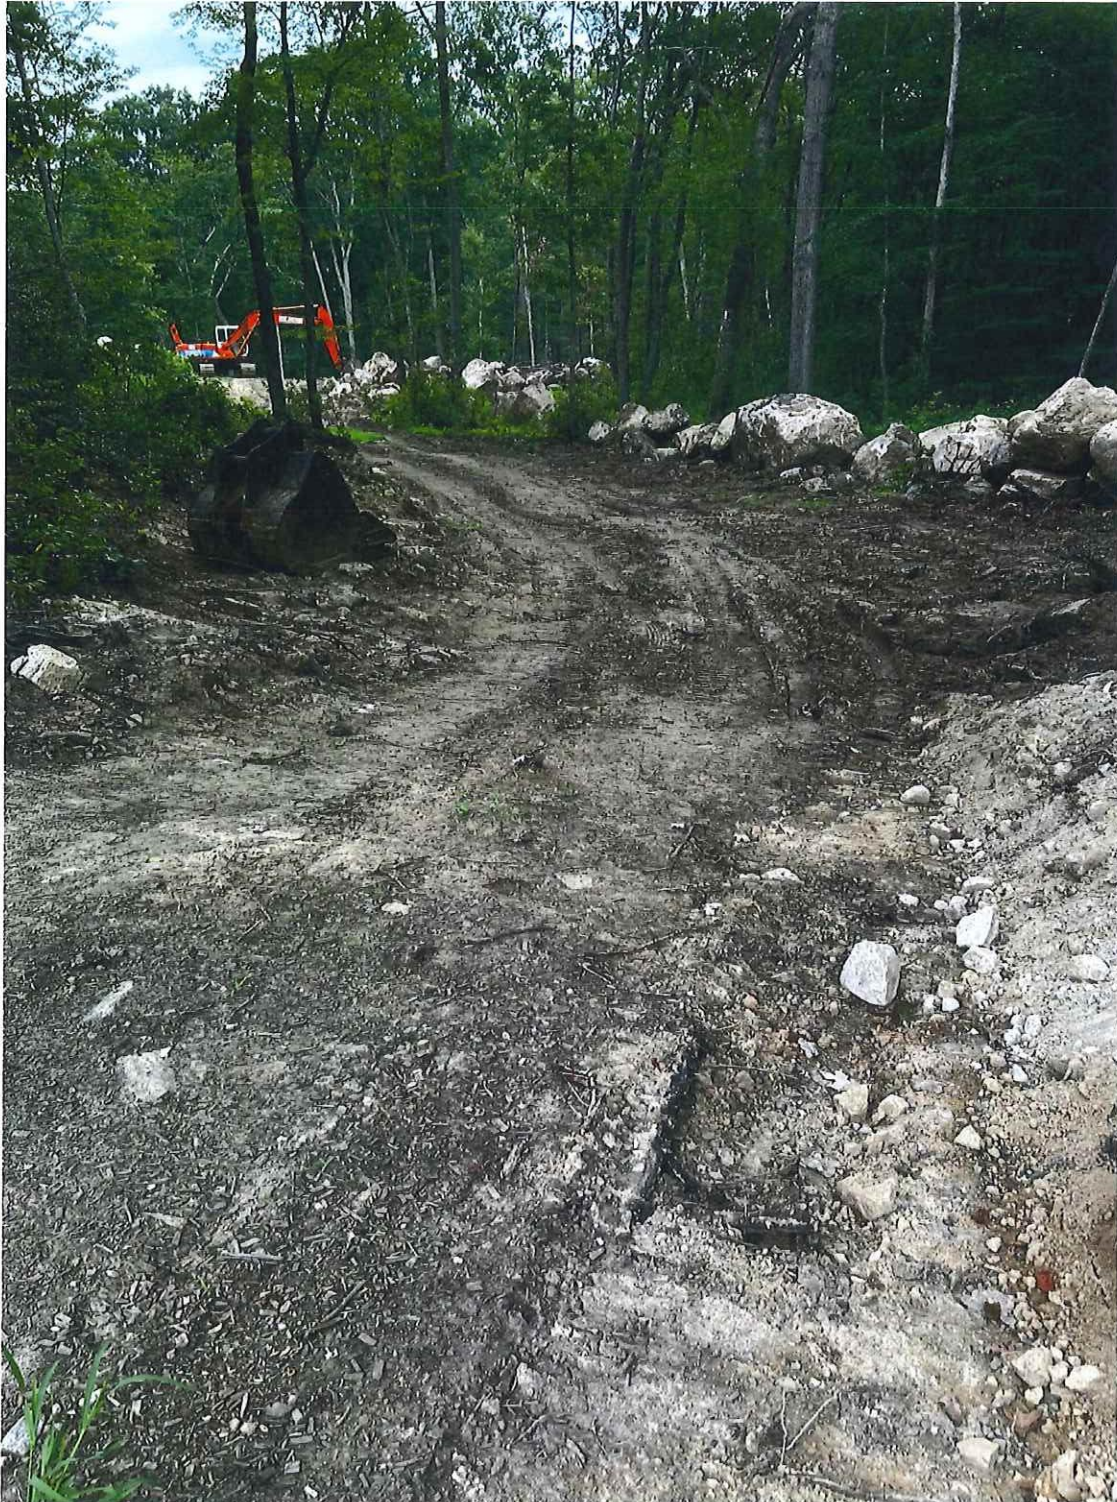
Access drive looking east towards house site. Boulders lining limit of grading. 125 Old Colchester Rd

The Commission may consider establishing a wetland non-encroachment boundary line at the proposed limits of clearing and grading to preserve vegetative cover and soil stabilization adjacent to and upgradient of the wetland resources.

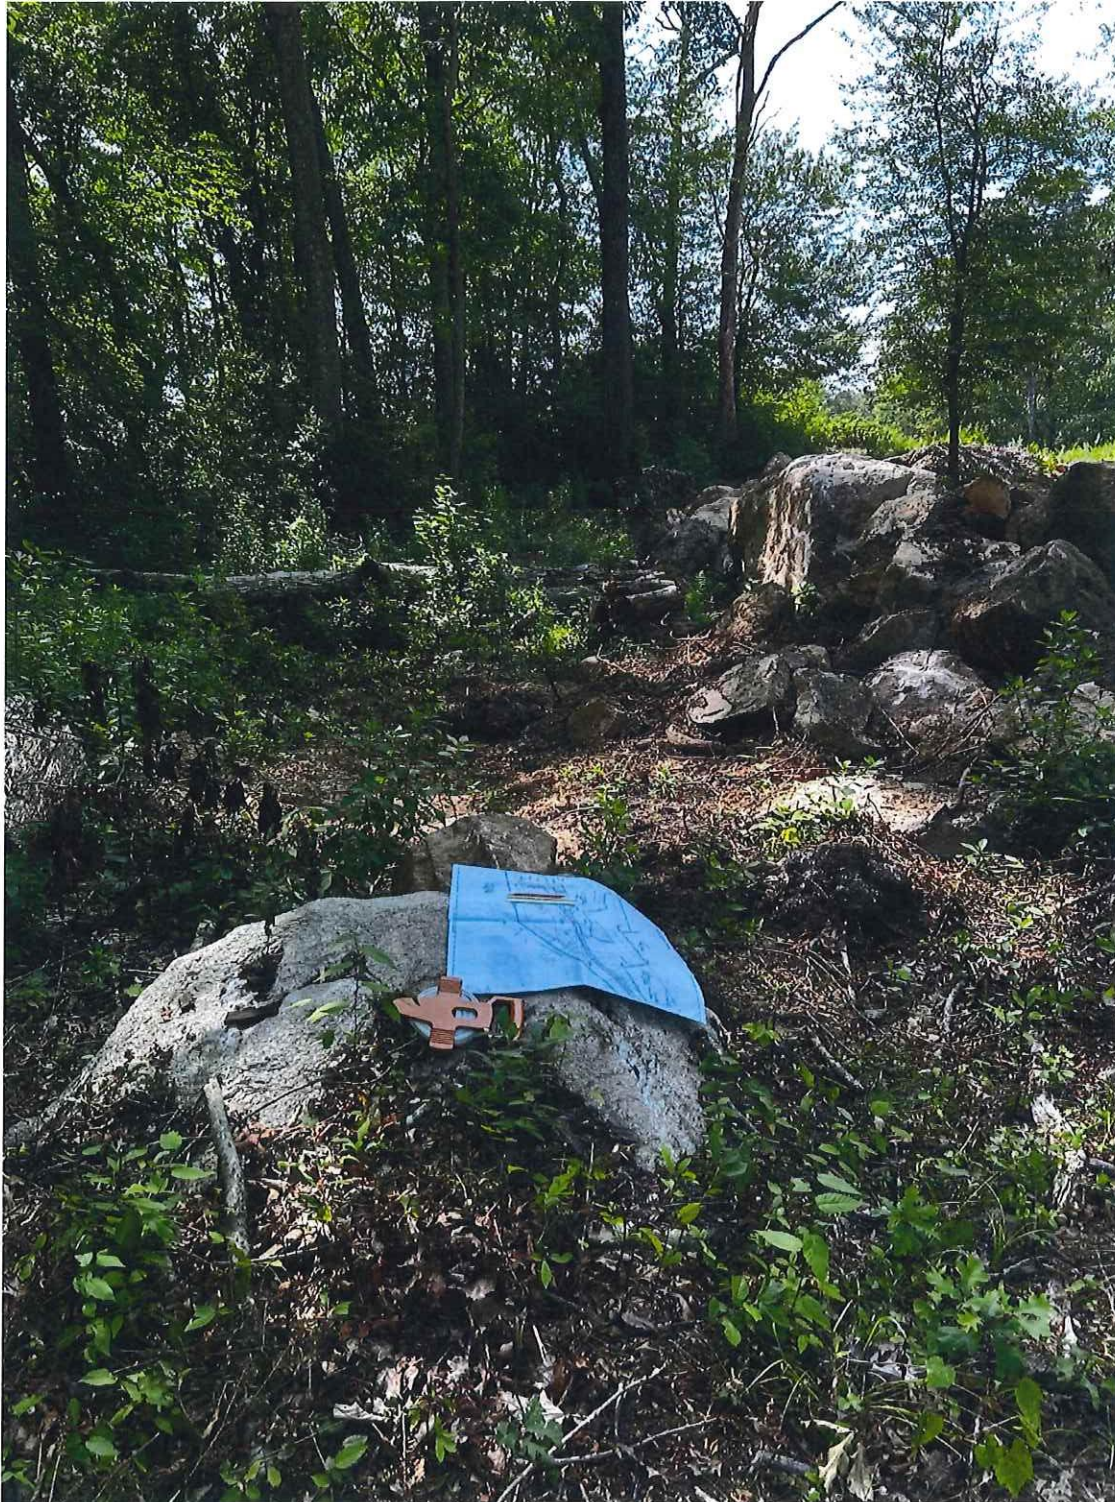
The wetland boundary south of the driveway and east of the proposed house and septic location were re-flagged on 8/12/2025. Staff inspected the site on the same day and field measured the proximity of the driveway clearing to the wetland boundary. In general, the proposed clearing limits for the driveway as indicated on the site plan are consistent with existing field conditions. The access driveway follows the pre-existing timber haul route in this location. Large boulders were placed in the location of the proposed sediment control fencing. This barrier will serve as a clear demarcation for the edge of driveway construction activity. A small area of disturbance was noted to extend south of the boulder barrier where fallen trees and stumps were removed. It is anticipated the area will revegetate based on the surrounding ground cover.

**Area of upland disturbed between driveway access and wetland flags #4 and #5: 125 Old Colchester Rd.**

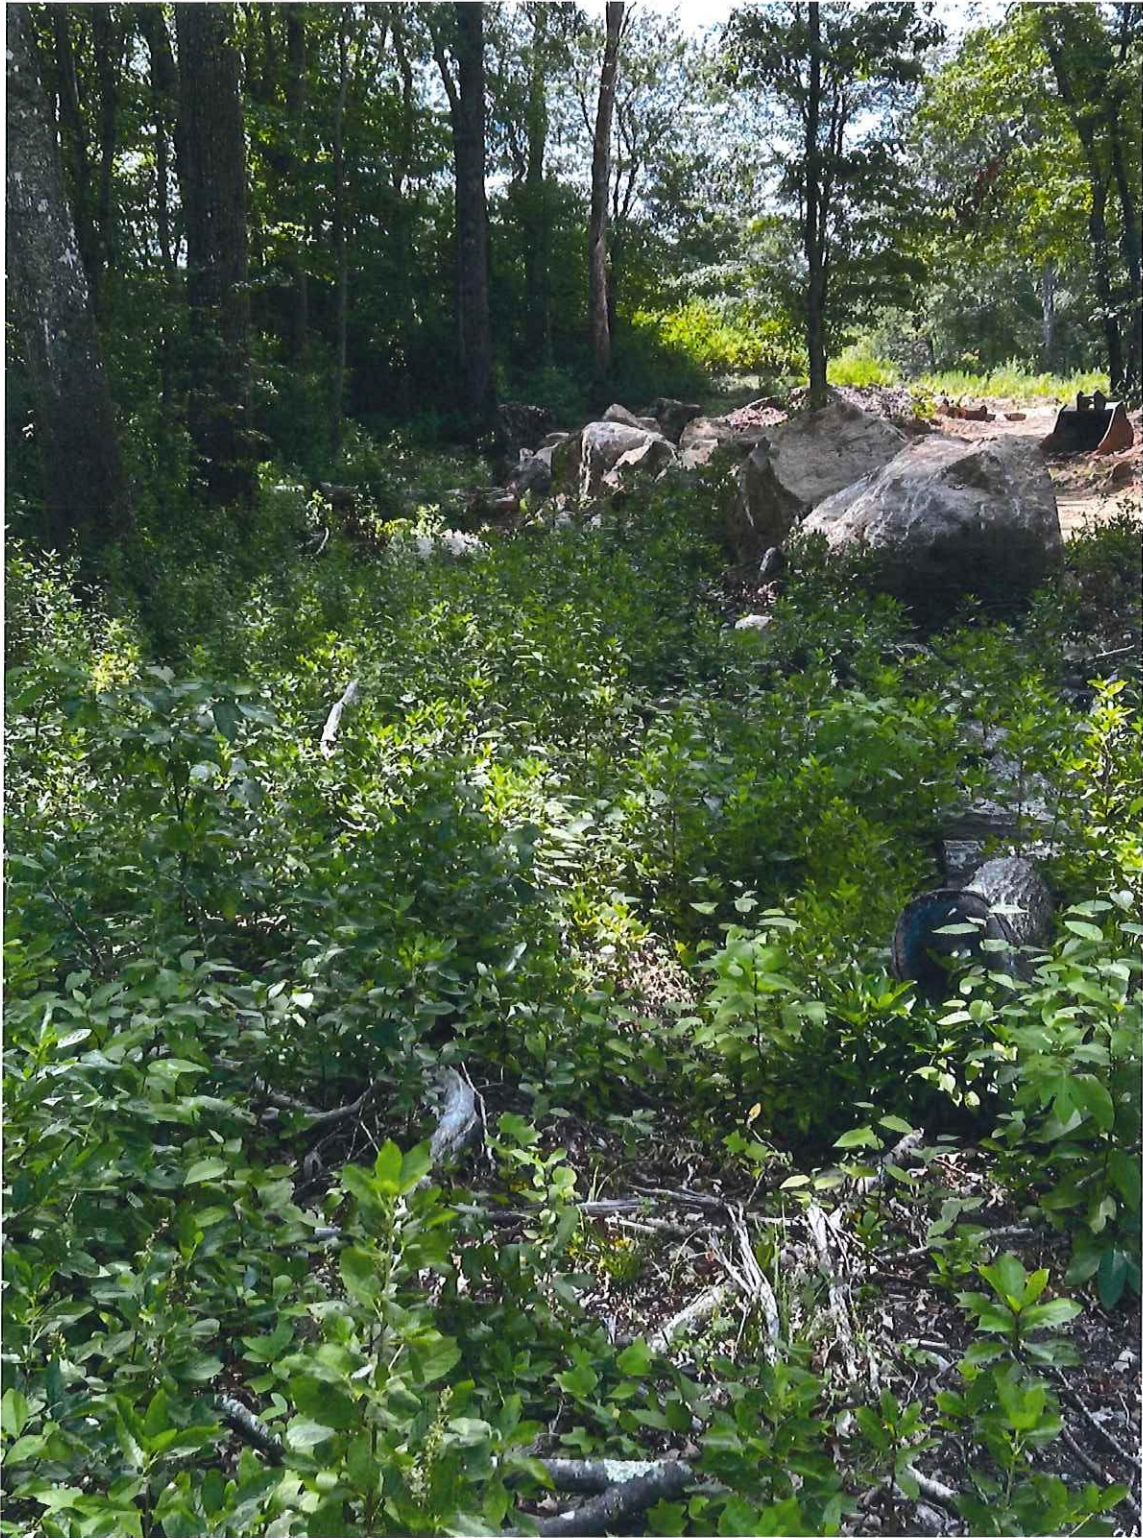
**Vegetated upland between driveway access and wetland flags #6-#8: 125 Old Colchester Rd; 8-12-2025**

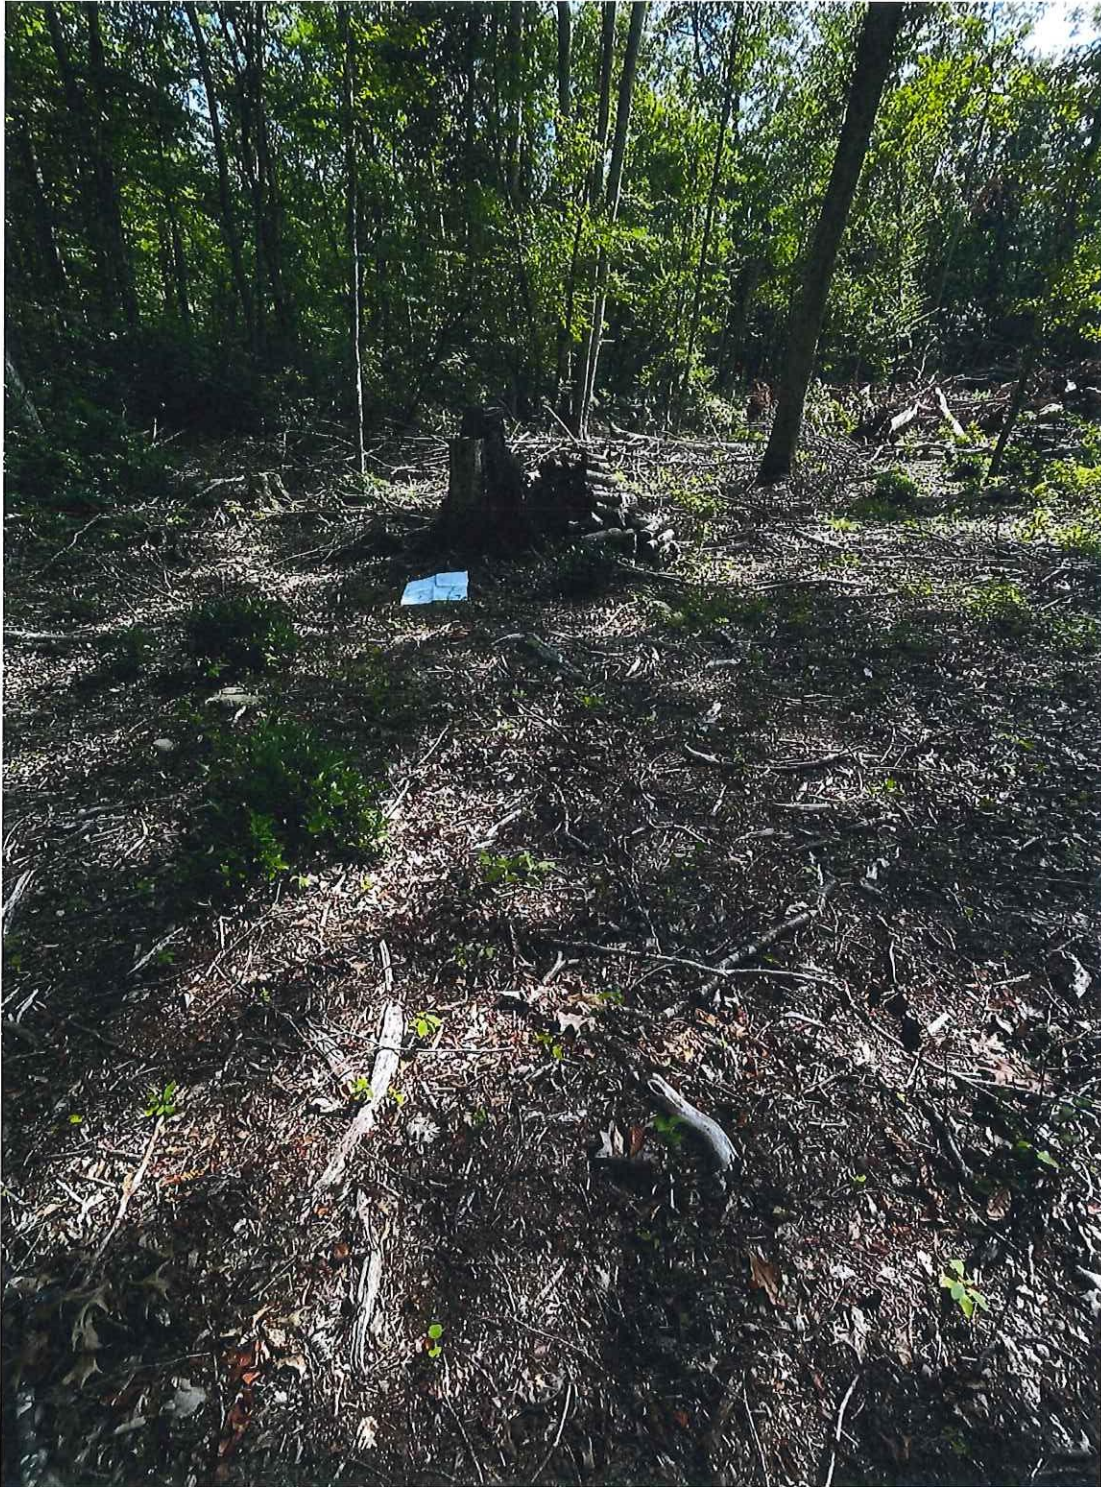
The wetland boundary east of the proposed house and septic area was reviewed. No encroachment of fill or site excavation has occurred within the 100 ft. upland review area (URA) of this wetland. As previously mentioned, the upland review area has been timbered. The ground surface is covered with remnant slash piles in areas. The owner is cutting this downed material for firewood.

**Timbered upland review area west of intermittent channel wetland flag #31- #29: 125 Old Colchester Rd.**

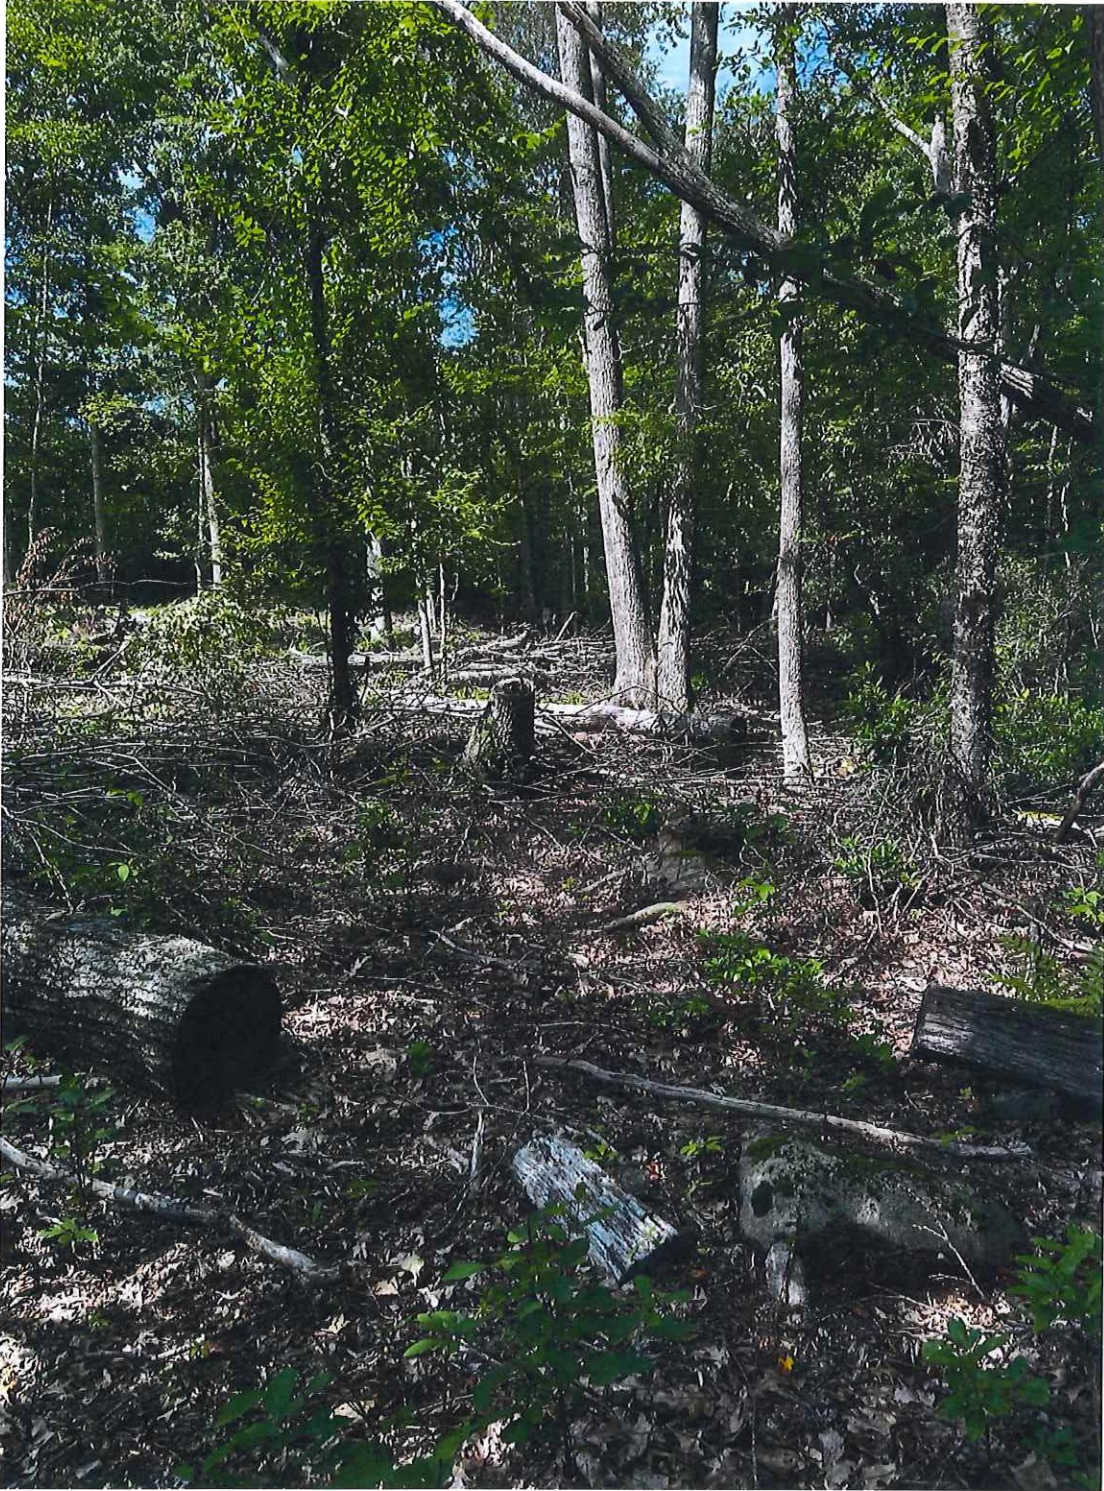
**Timbered upland review area west of intermittent channel wetland flag #25- #28; 125 Old Colchester Rd.**
