**WETLAND ASSESSMENT**

Re: LEARN - Early Childhood School  
51 Daniels Avenue, Waterford, Connecticut  
APT Job No: CT3611350

# Wetland Inspection Report

## WETLAND INSPECTION

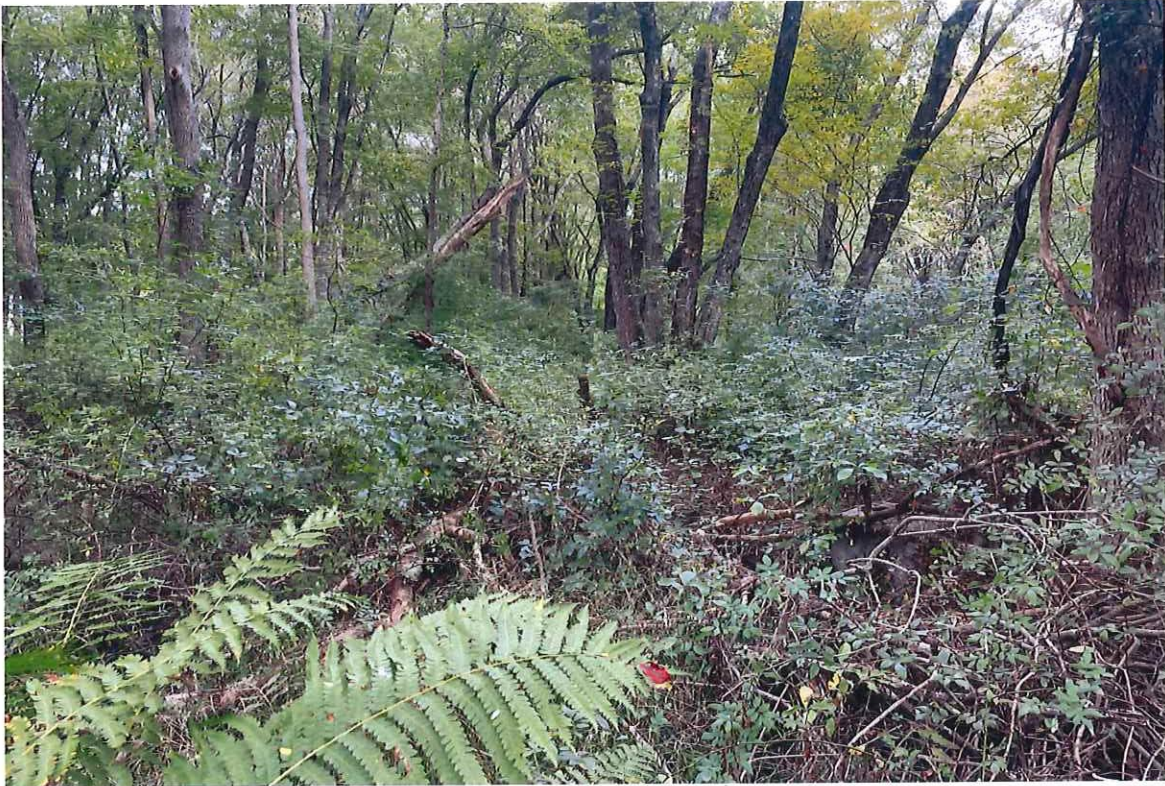
Wetland 1 is located in the northeastern portion of the subject property, primarily located on the adjacent parcel, consisting of a forested complex dominated by red maple and black gum, with co-dominant of swamp white oak. The understory contains sweet pepperbush and highbush blueberry with multiflora rose along the delineated wetland boundary. The complex is characterized by seasonally saturated edges with a distinct slope break separation to the abutting upland forest to the west that is located on the property. A relatively large depressional area located entirely off the subject property is present within the interior of the wetland generally devoid of vegetation and presents indicators that a foot or more of inundation is present during peak flooding periods. Indicators include buttressed roots and moss trim lines. This depressional area was re-evaluated during the April 12, 2025 inspection to verify vernal pool breeding activity, during which time two (2) vernal pool indicator species spotted salamander (*Ambystoma maculatum*) and wood frog (*Lithobates sylvaticus*) were observed breeding within the flooded extents. Two distinct pockets of breeding within the central and southern portions of the flooded areas were observed with water depths ranging from 1.5 to 3 feet.

Photo 1: Overview of Wetland 1 looking southeast.

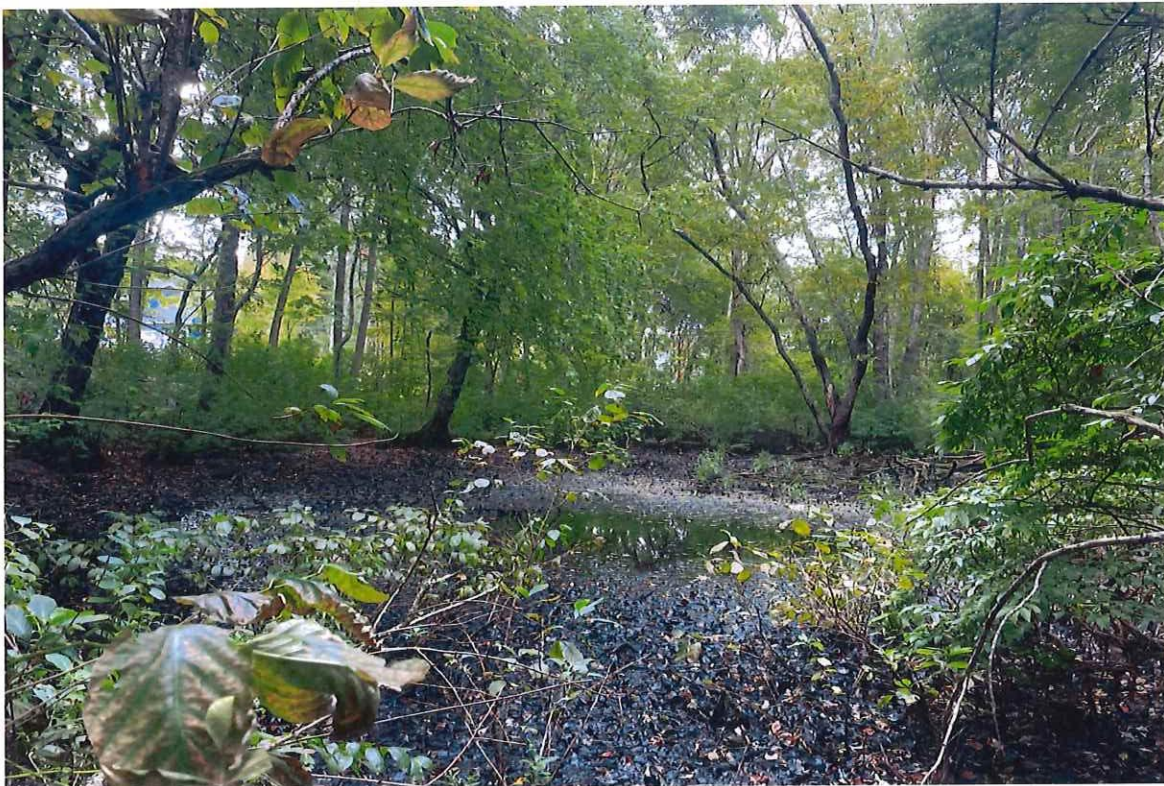
Photo 2: View of southern portion of Wetland 1 looking south at potential vernal pool.

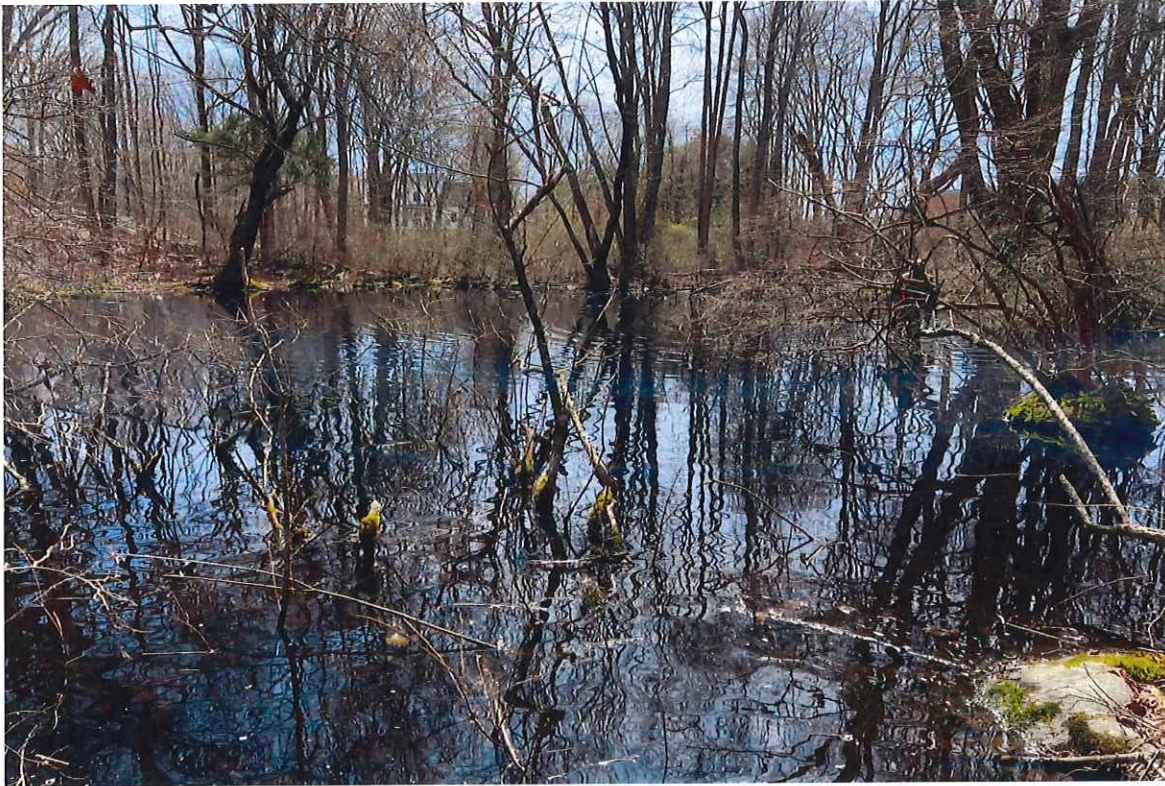
Photo 3: View of Wetland 1's southern vernal pool habitat looking south.

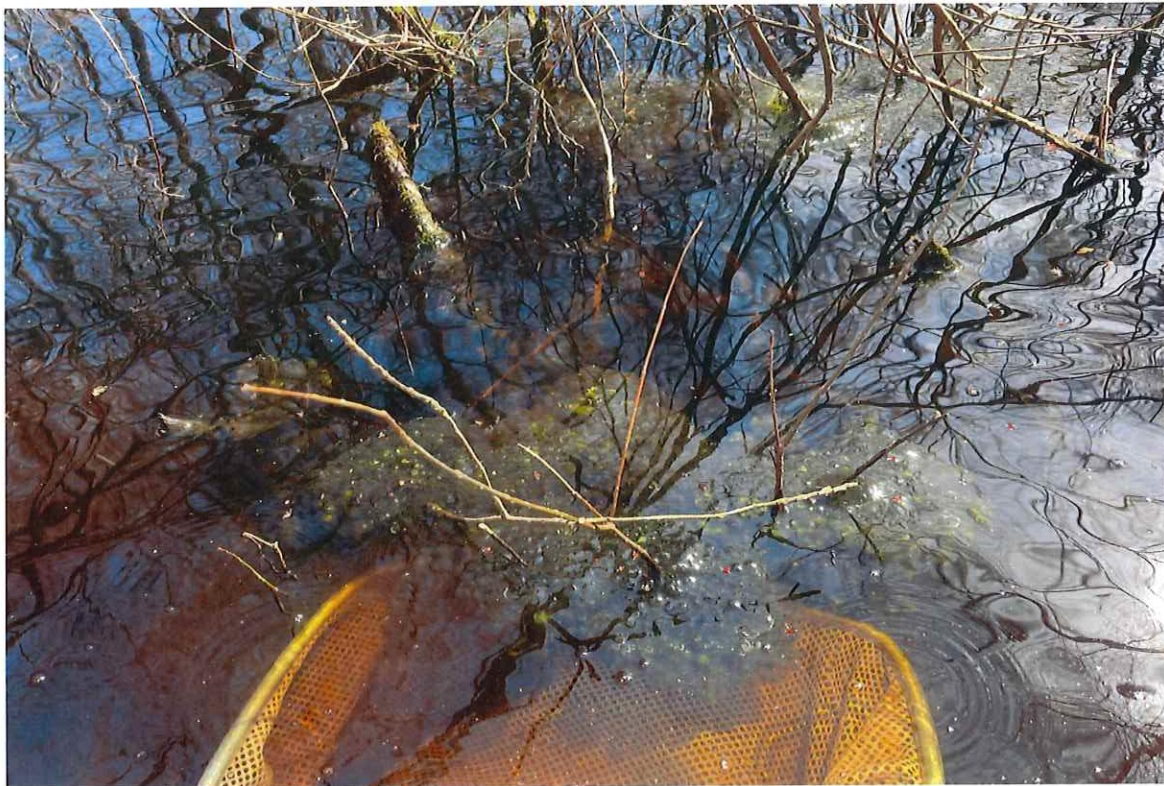
Photo 4: View of wood frog egg masses in Vernal Pool 1.

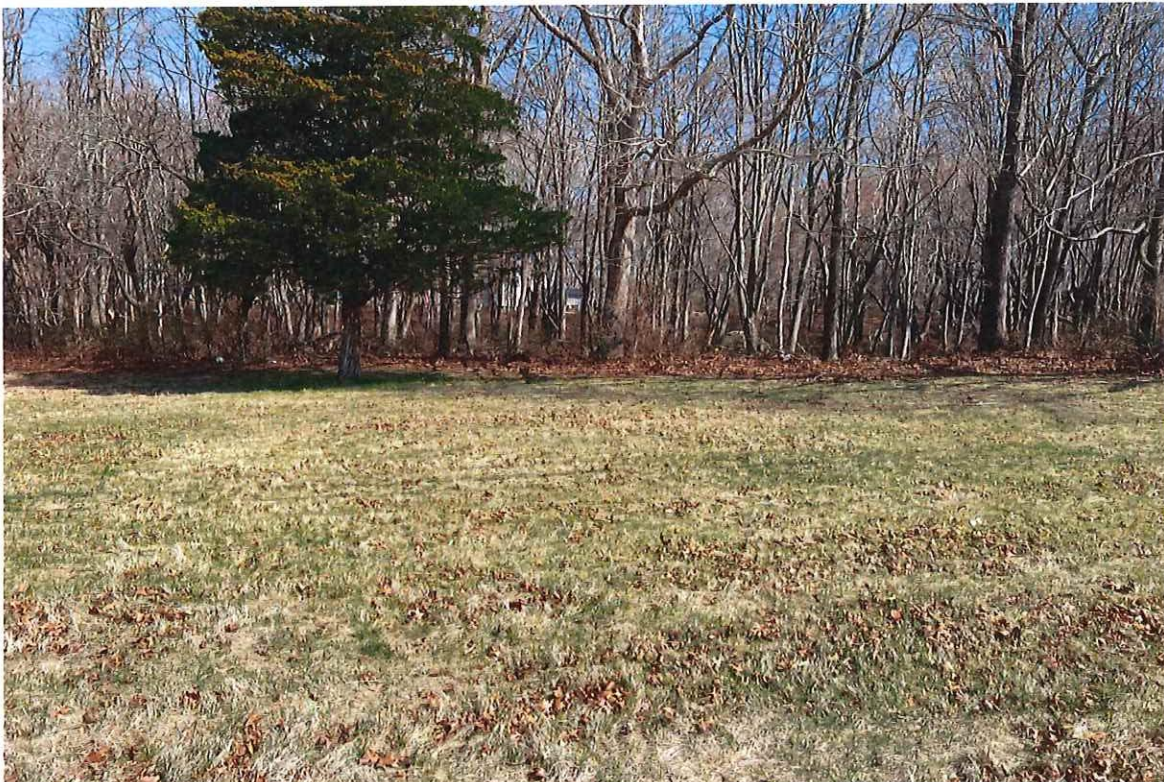
Photo 6: View of wetland and vernal pool upland enhancement area looking east;  
Wetland 1 and Vernal Pool 1 in background in forested area.

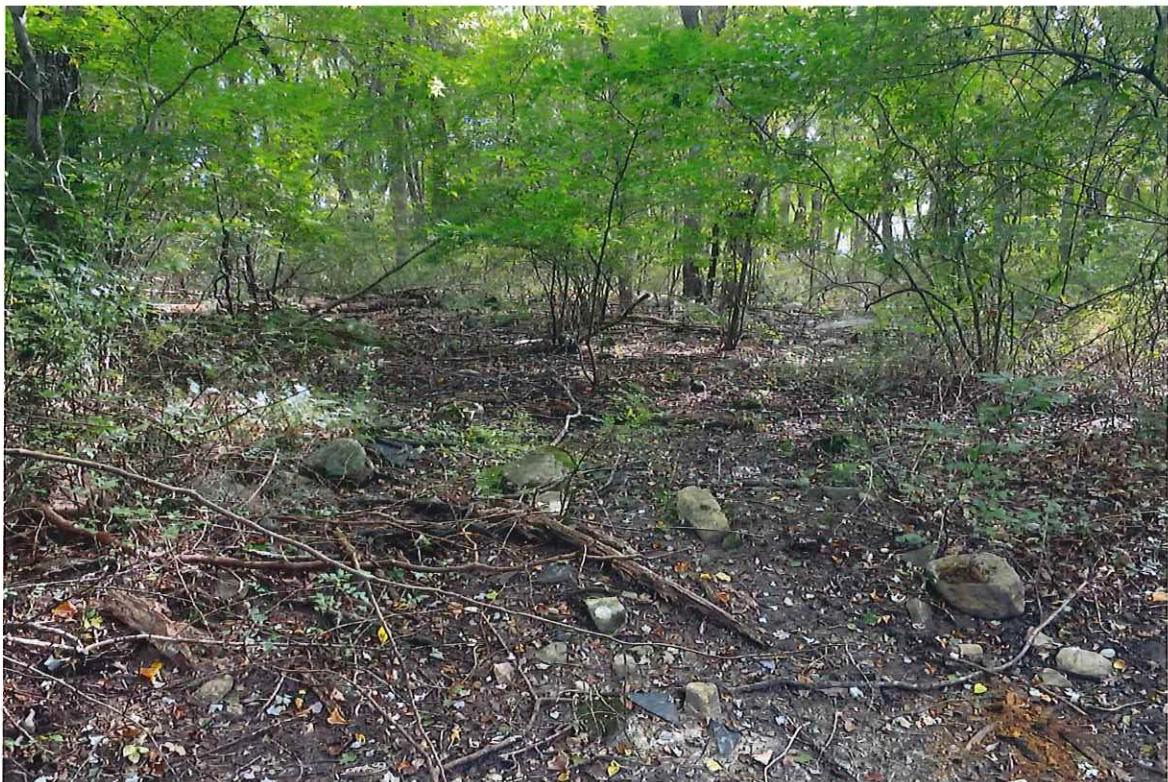
Wetland 3 is located off the southwest corner of the subject property on the adjacent property. This wetland feature is located at the base of a hillslope within a depressional area with a distinct slope break and rocky poorly drained soils. This isolated feature is dominated by red maple with spicebush and highbush blueberry within the understory. Small areas of shallow seasonal flooding were observed within the depression, which were confirmed to not support vernal pool breeding habitat due to their shallow flooding and short-duration hydroperiod.

Photo 8: View of Wetland 3 looking west.

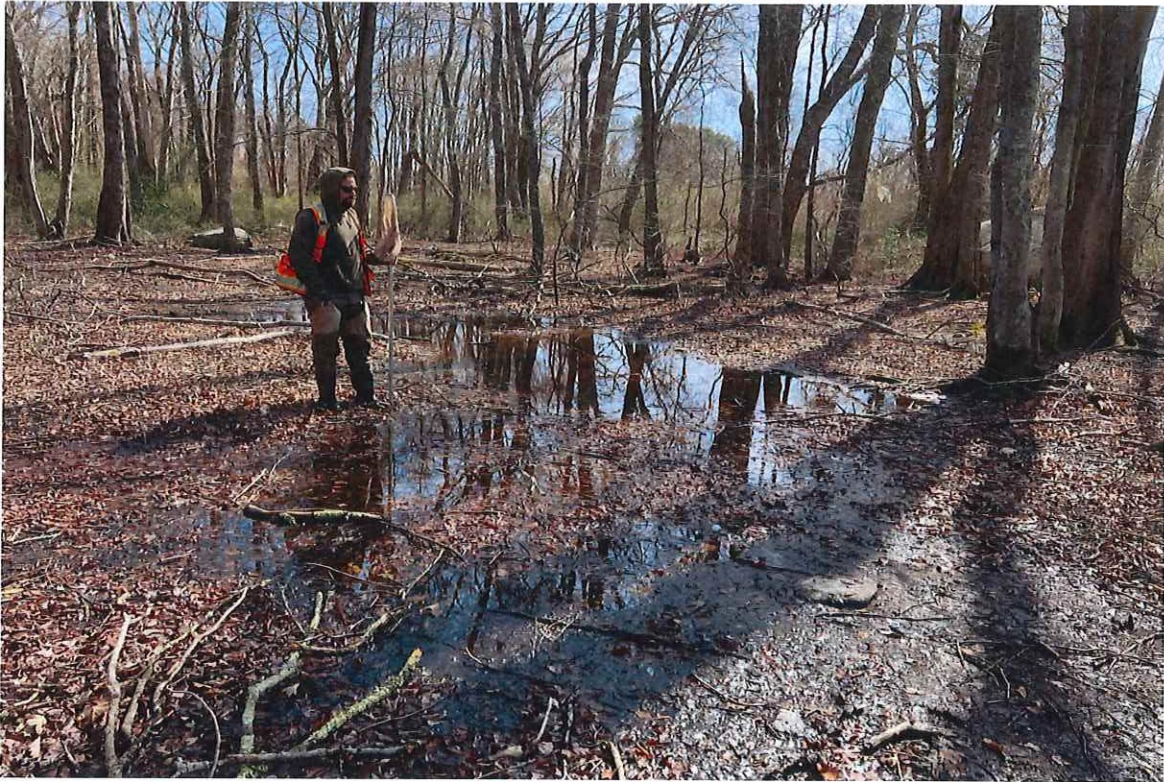
Photo 9: View of Wetland 2 Potential Vernal Pool 2 area looking south.  
Area contained less than 2 inches of inundation with no breeding observed.

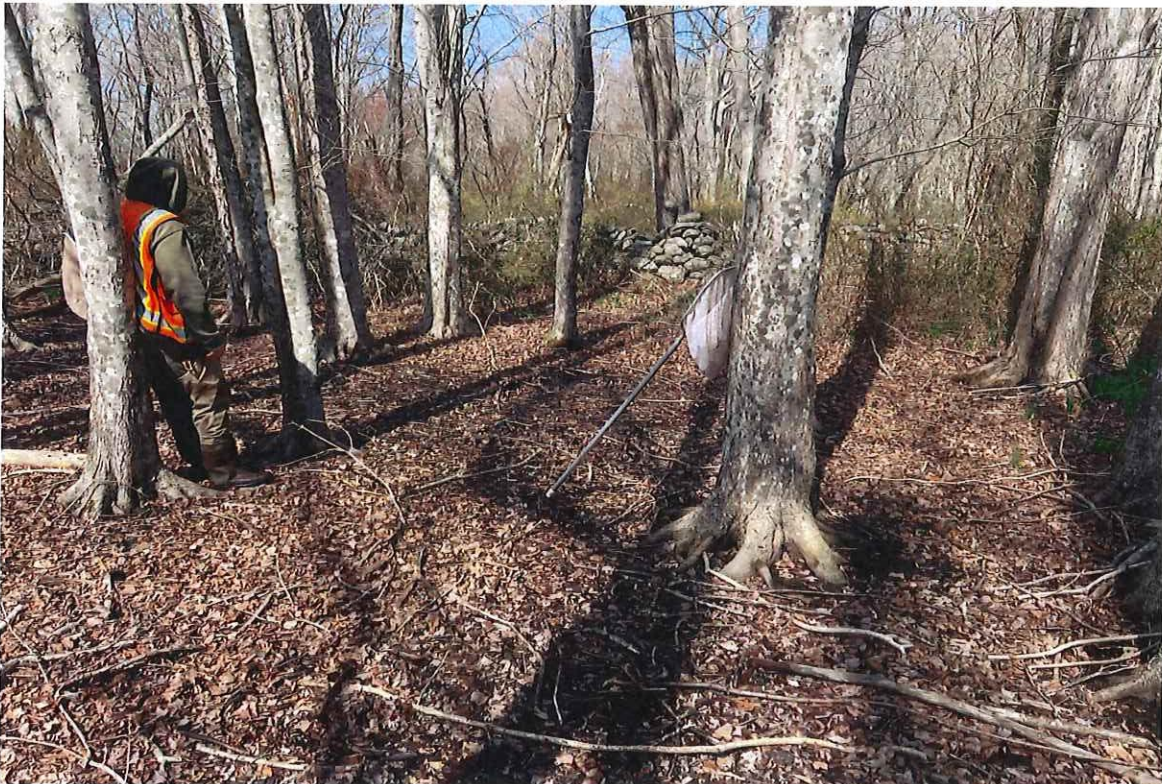
Photo 10: View of Wetland 2 Potential Vernal Pool 3 area looking south.  
Area void of any inundation with no breeding observed.
