**TOWN OF WATERFORD - DPW FACILITIES  
CAPITAL IMPROVEMENT PLAN  
PROJECT CONSOLIDATION FORM-FY 2022-2026**

The O'Neil Theatre Complex - Mansion House Building Evaluation Survey

The O'Neil Theatre Complex -Mansion House Building Evaluation Survey

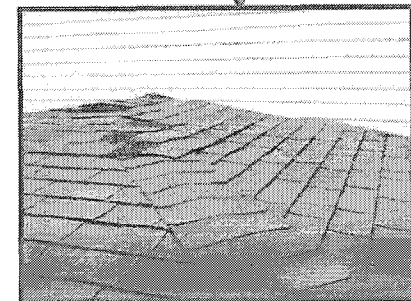
CEO's Office  
Almost Flat Roof  
With Damaged  
Shingles – As  
Such it Leaks in  
Heavy Rains

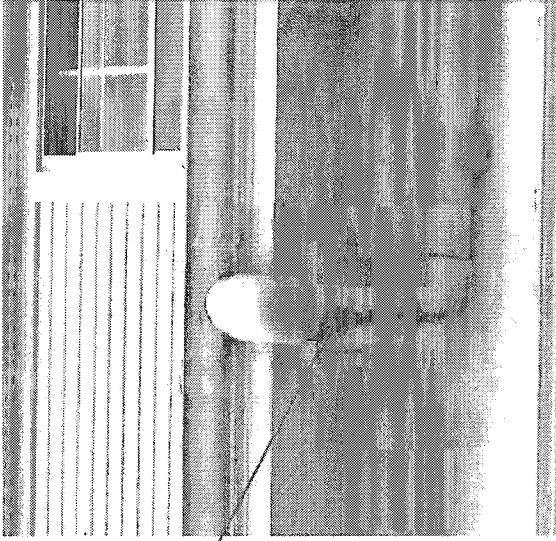
**East Elevation – Third Floor Clapboard & More Than 100 Nails Pushed Out and Away**

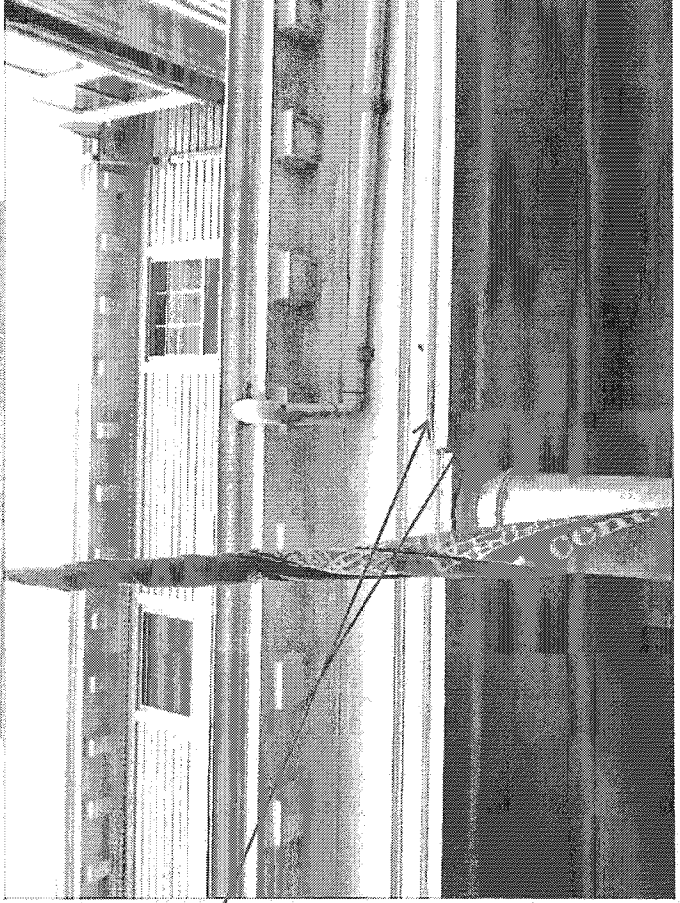
A Leaking Gutter Drain Line is Compromising The Capital of This Doric Porch Column – Along With the Surrounding Trim Work

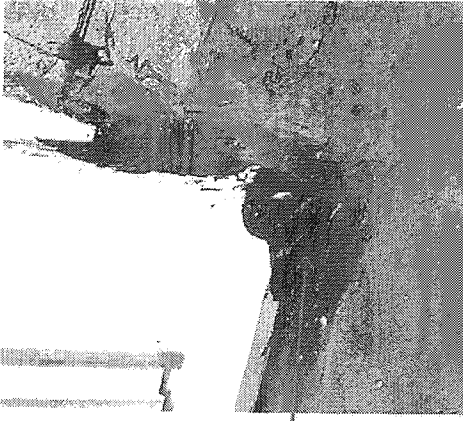
Western Elevation Flat Roof Problematic Leaking – The Flashing Around Both The Dormer Window & Chimney #5 (page 7) Have Had Temporary Repairs Made to Them

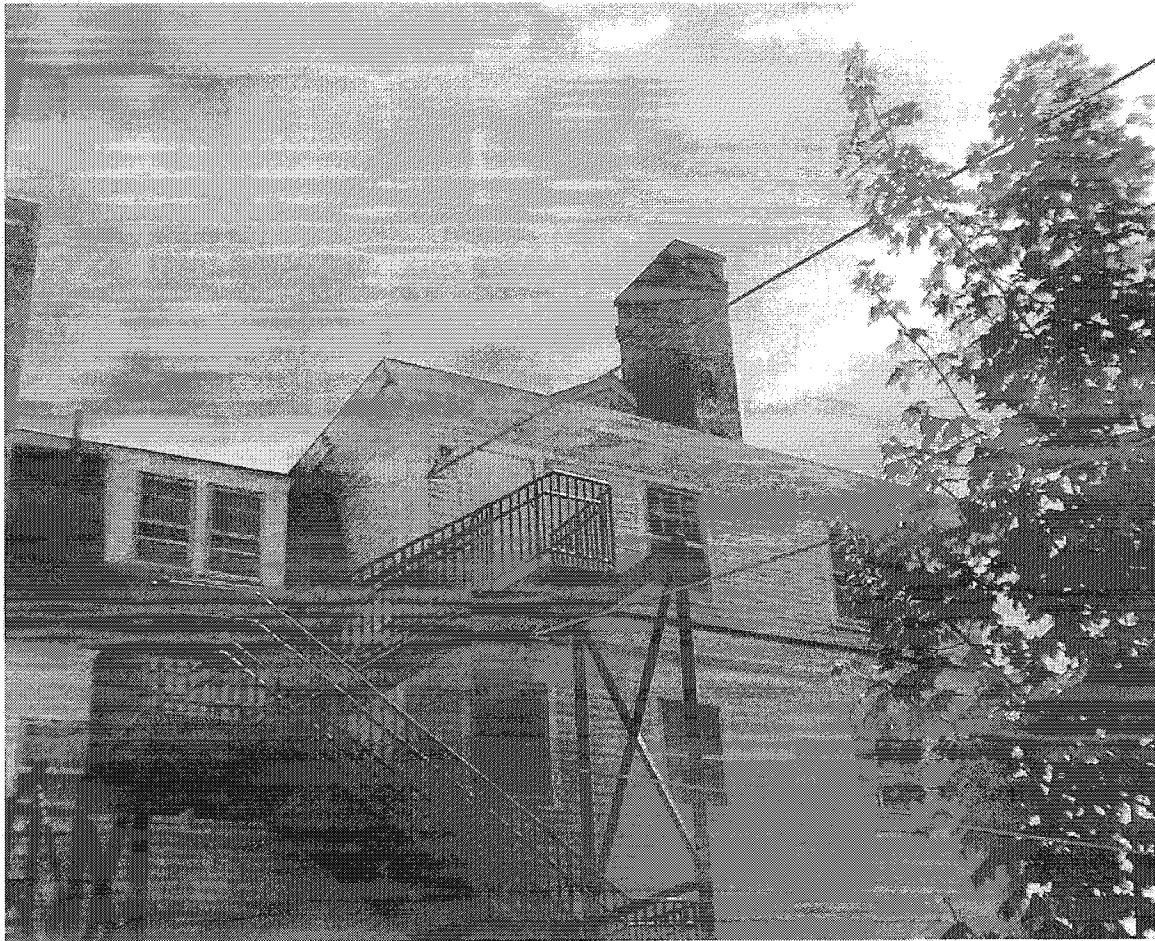
Western Elevation-The Primary Issues Here Are Very Much The Same – The Decomposing of The Drainage System – Along With The Concerns Regarding The Scheduling Preventive Maintenance
