**2021 Monitoring Report**

**Restoration of Riparian Habitat and Channel Stabilization**

**Rope Ferry Condominiums  
Waterford, Connecticut**

September 29, 2021

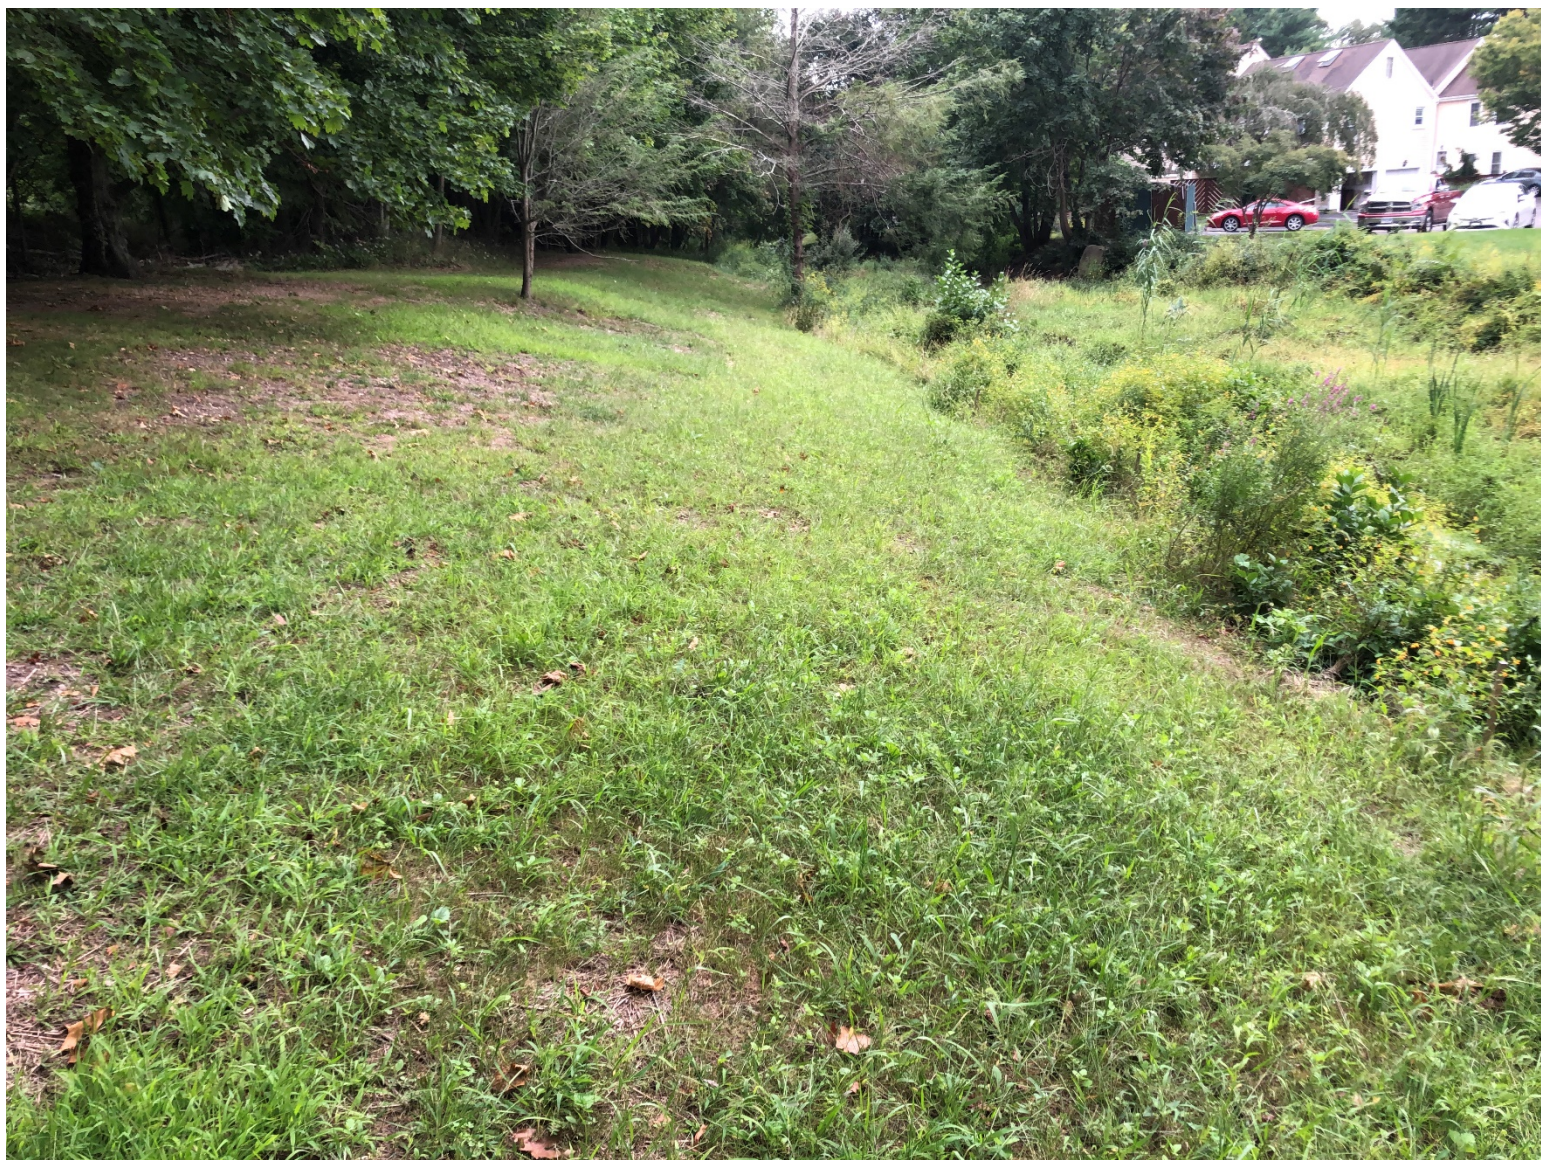
Grass area on east side of brook  
September 8, 2021

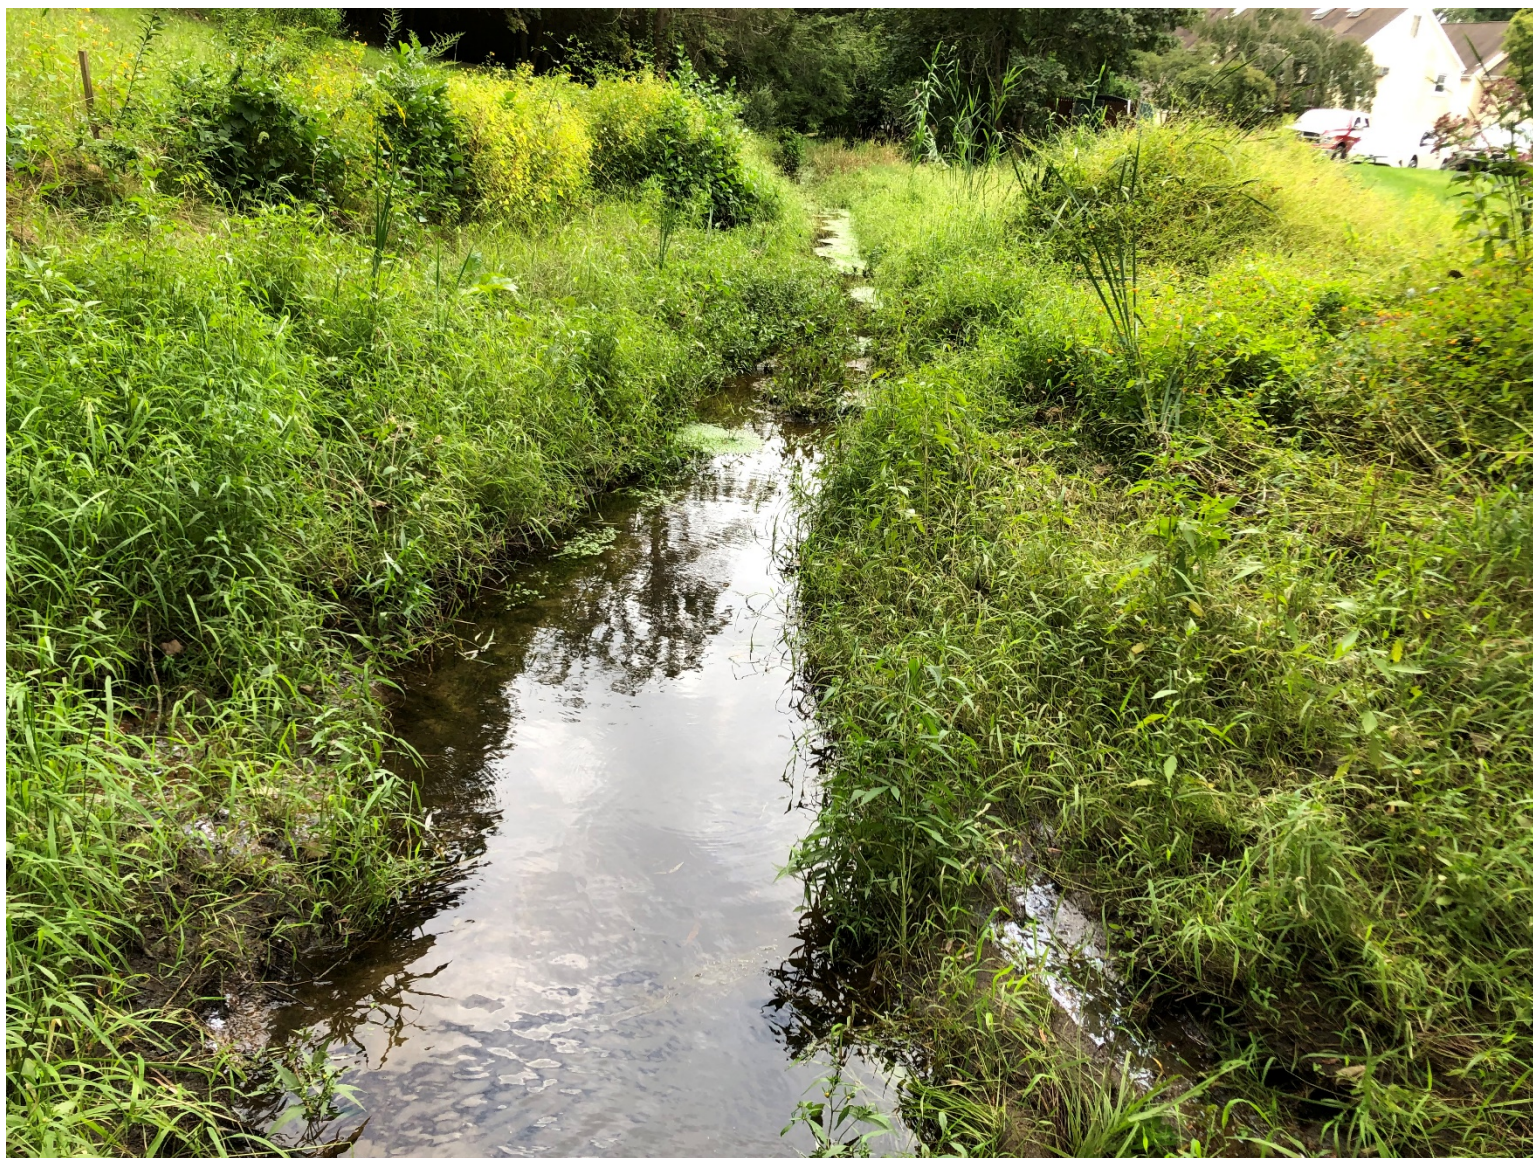
The side slope and edge of the stream channel is stabilized with a dense stand of native vegetation.

Southern view of vegetated brook bank  
September 8, 2021

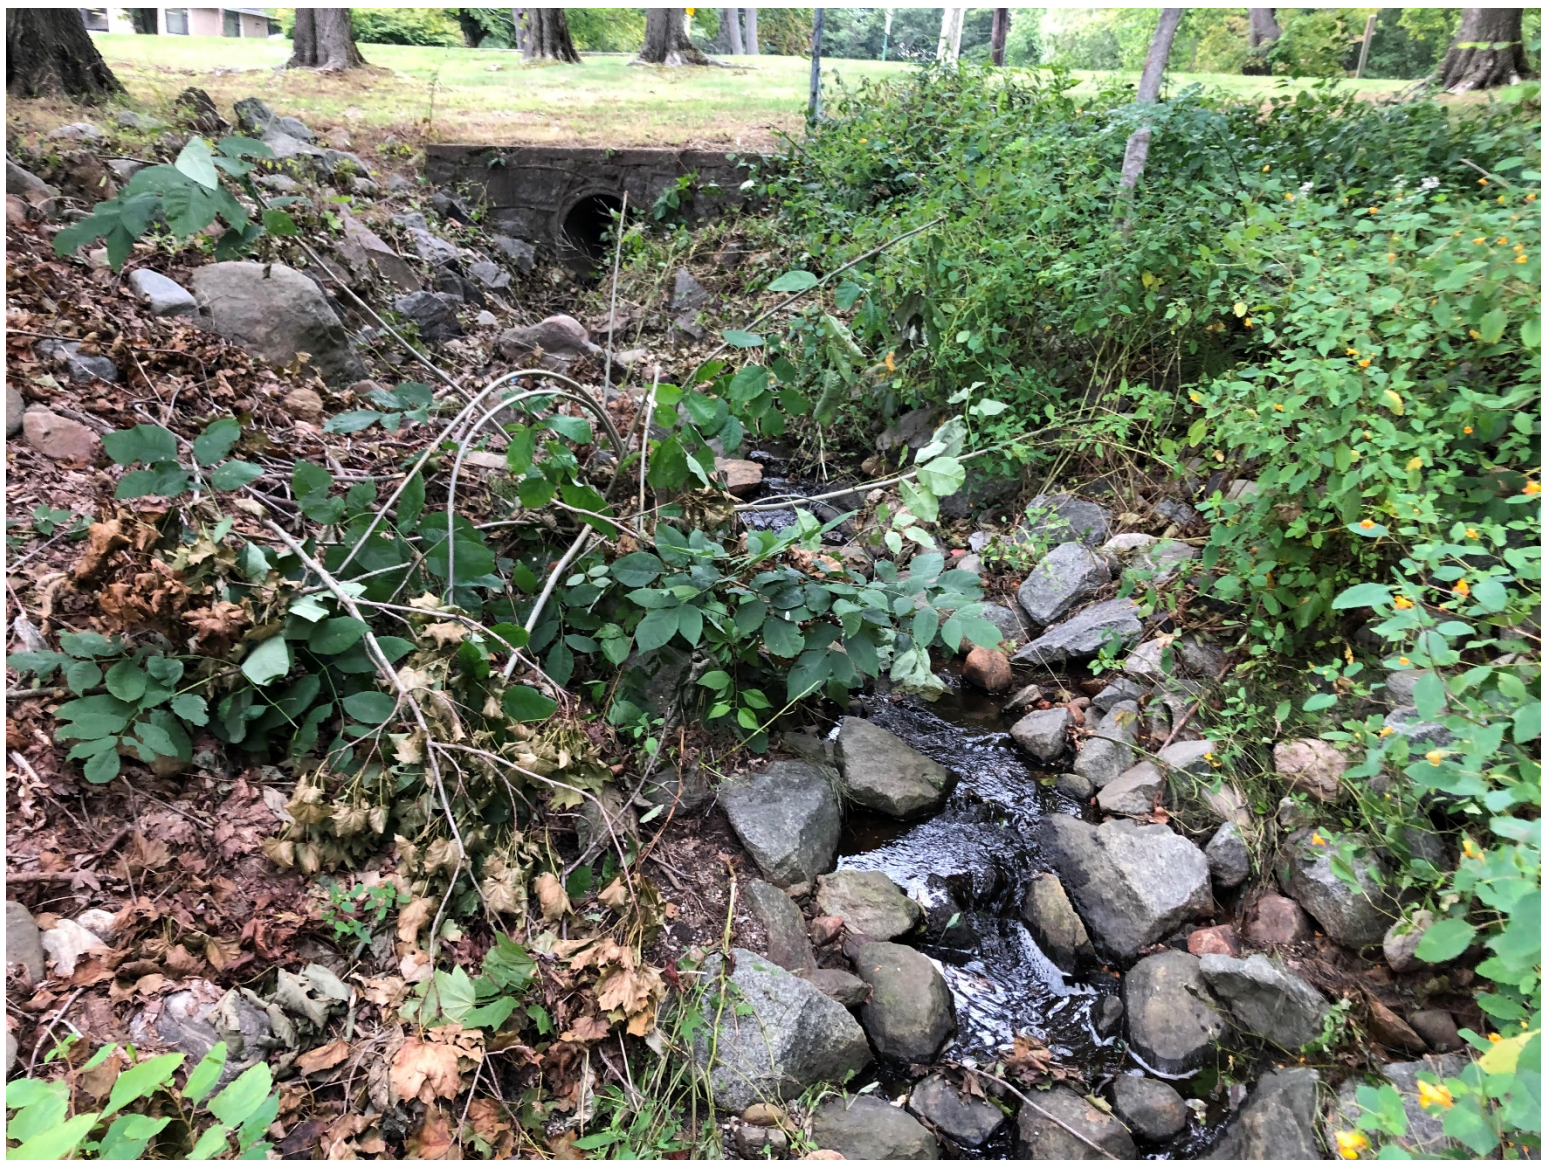
The rip-rap was placed in the stream channel below the pipe outfall on the bed of the stream.

Rip-rap at pipe outfall  
September 8, 2021

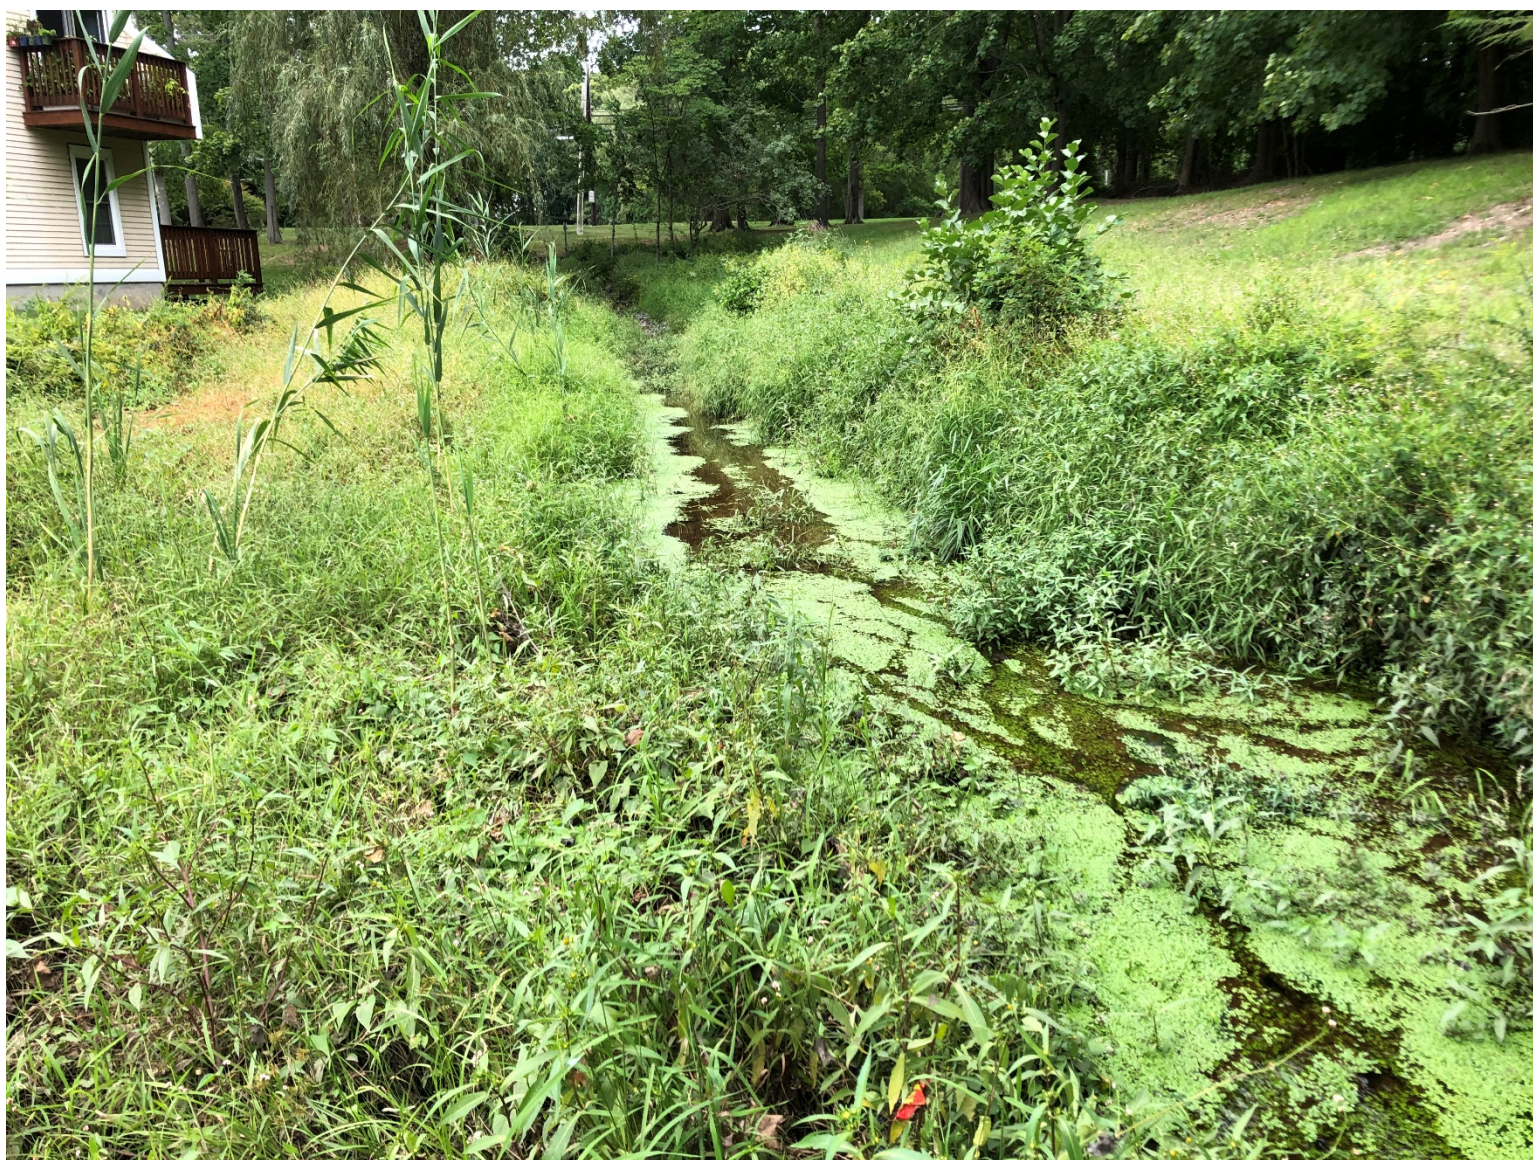
Northern view of vegetated brook bank  
September 8, 2021
