## **Oswegatchie Fire Station Building Committee Minutes**

**March 5, 2024**

Oswegatchie Fire Station  
441 Boston Post Road, Waterford CT

Temporary Framing Inspection  
REPORT #2 -- March 4, 2024

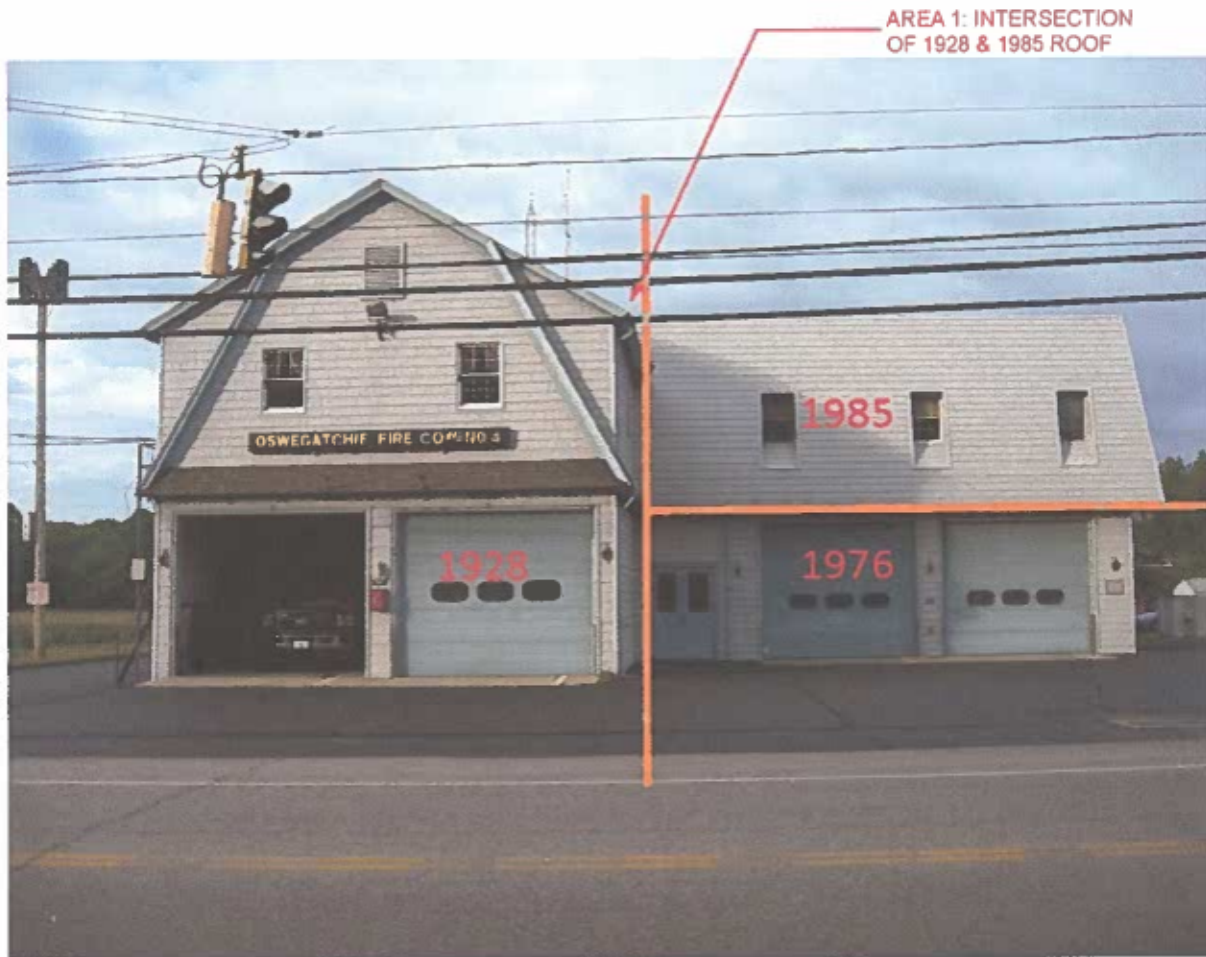
PHOTO 1

In addition, an area on the roof intersection between the 1928 & 1985 (Area 1, see Page 4) was observed where the sheathing (the decking between the roof joists) appears moisture saturated, with significant water damage, though no leaks were seen on the day of the inspection.

The two areas mentioned above, where roof soft spots, indicating water saturation of the decking, were flagged, should be repaired as long as the Buildings' functional life is extended in the foreseeable future, and best time to repair these areas in the coming Summer time.

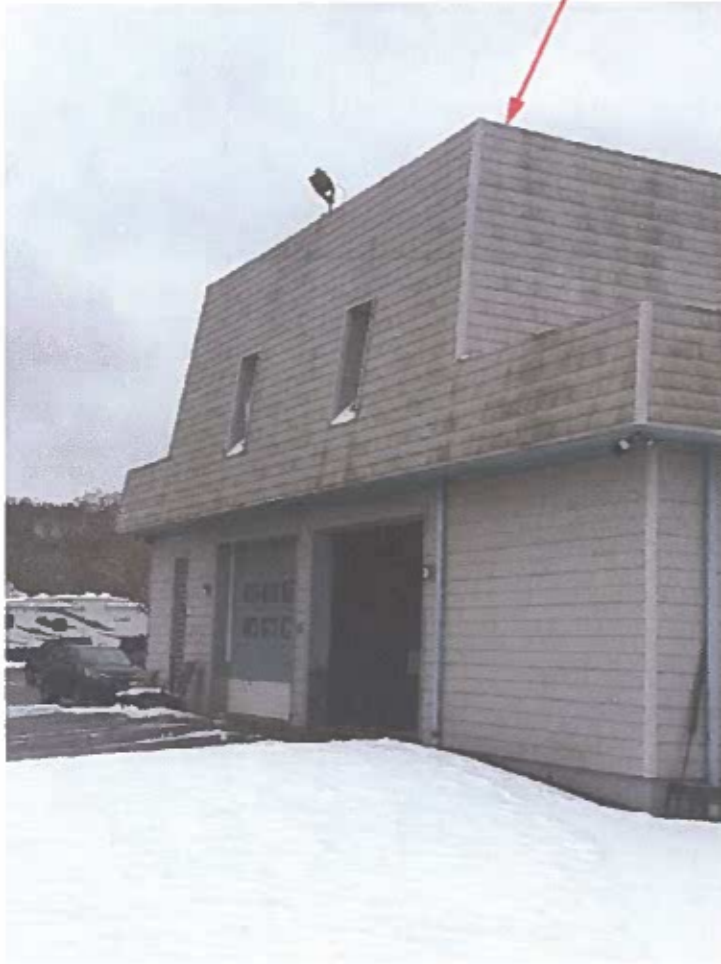
**PHOTO 2**

Furthermore, another that was pointed out is a soft area on the flat section of the roof on the 1985 building, see Area 2, Photo 2 on page 5. This section has not been supported by our office.

**AREA 2: FLAT ROOF SECTION  
(1985 BUILDING)**
